- LaGrange Park Public Library
- Water Infiltration Investigative Study
- April 28, 2015
- Kluber Project No. 15-357-960

Re: Water Infiltration Investigative Study
Kluber, Inc. Project No. 15-357-960

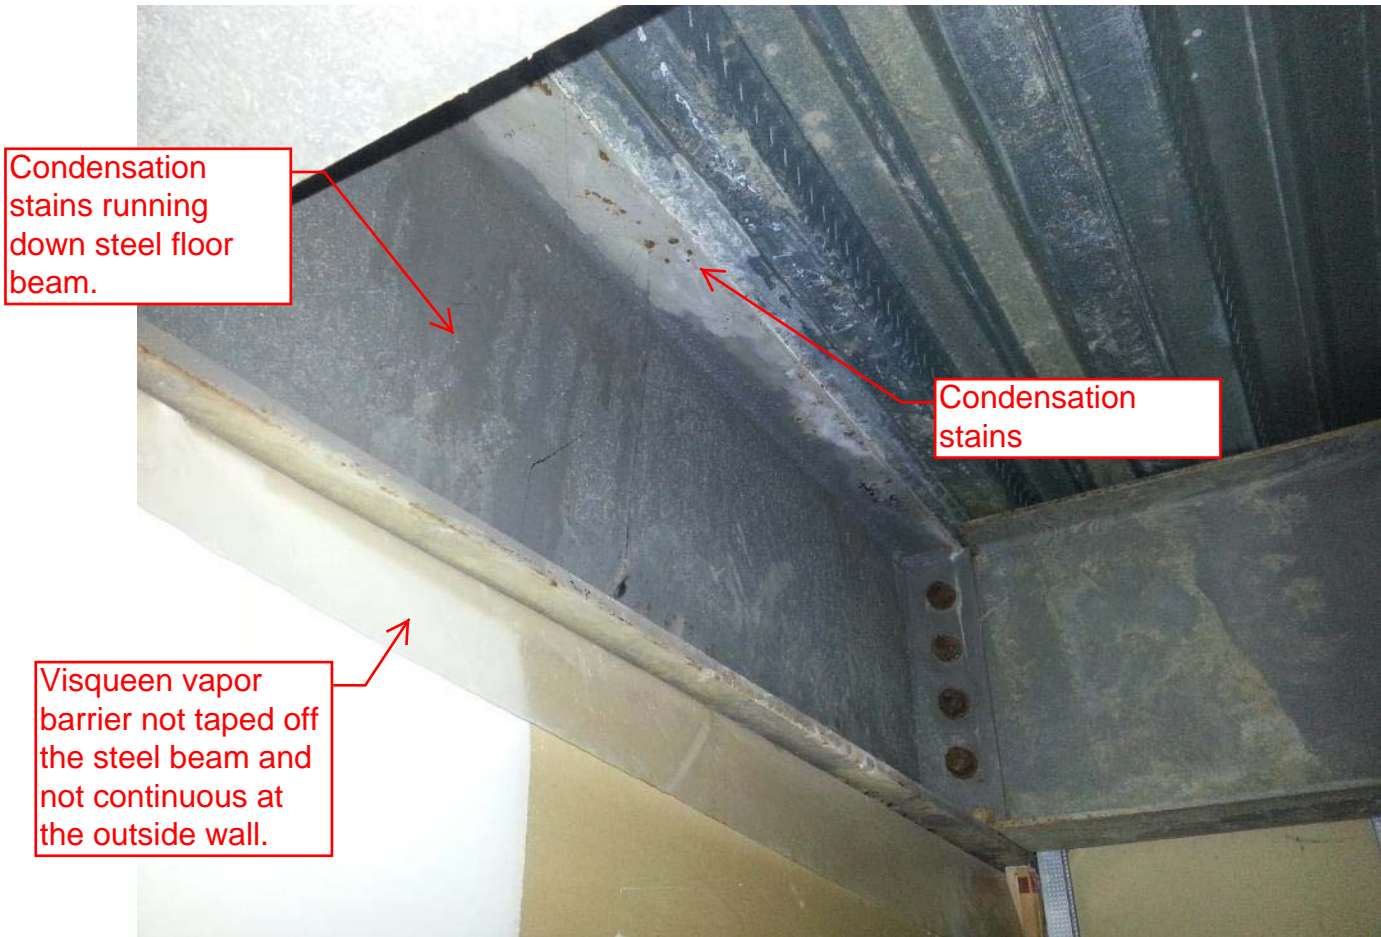
Interior ceiling cavity at the First floor stacks; East end. Note what appears to be some condensation marks on the upper flange of the steel floor beam. This could be because of the dew point falling inside the wall cavity.

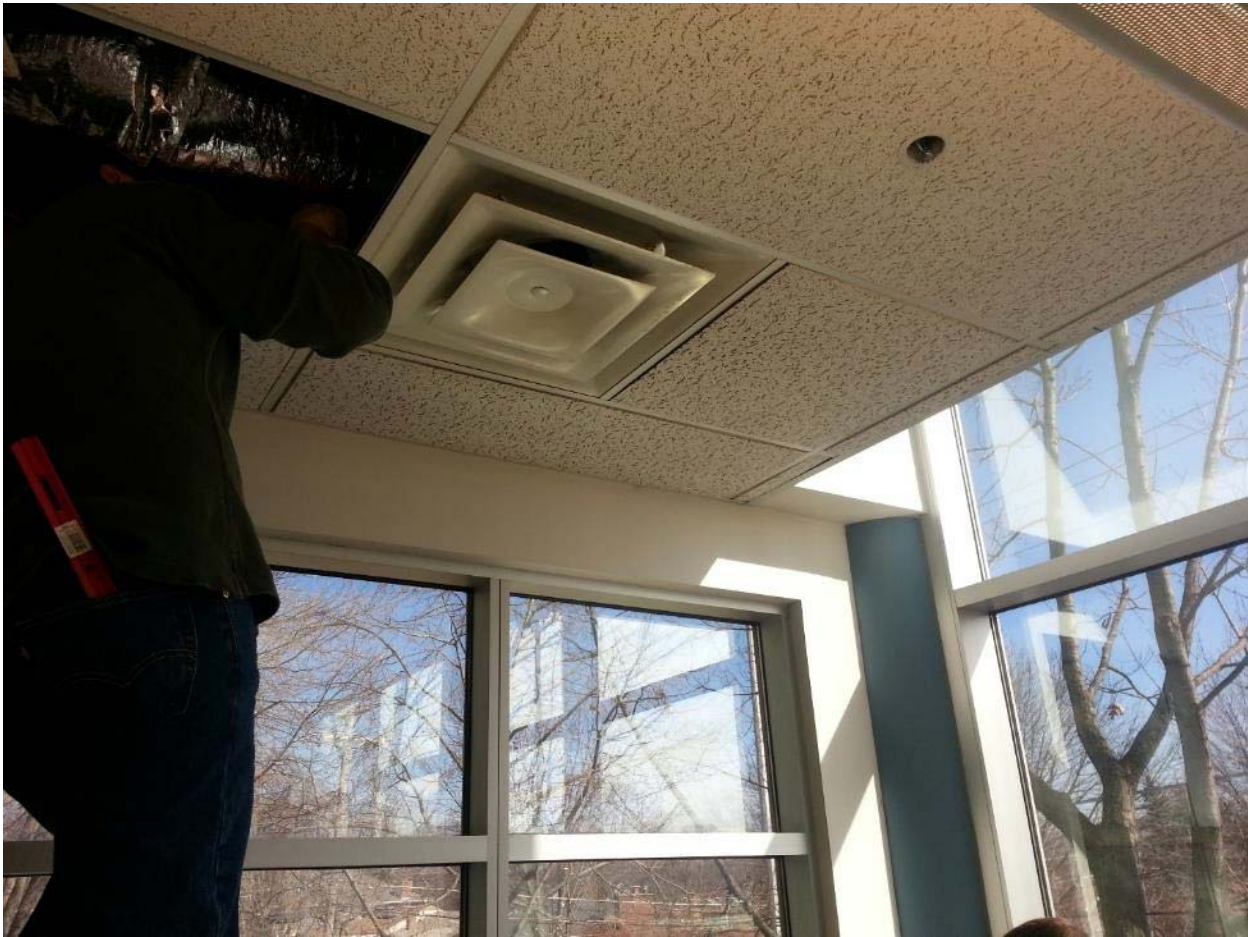
Description:
First floor at the NE round column. Above ceiling investigation being performed.

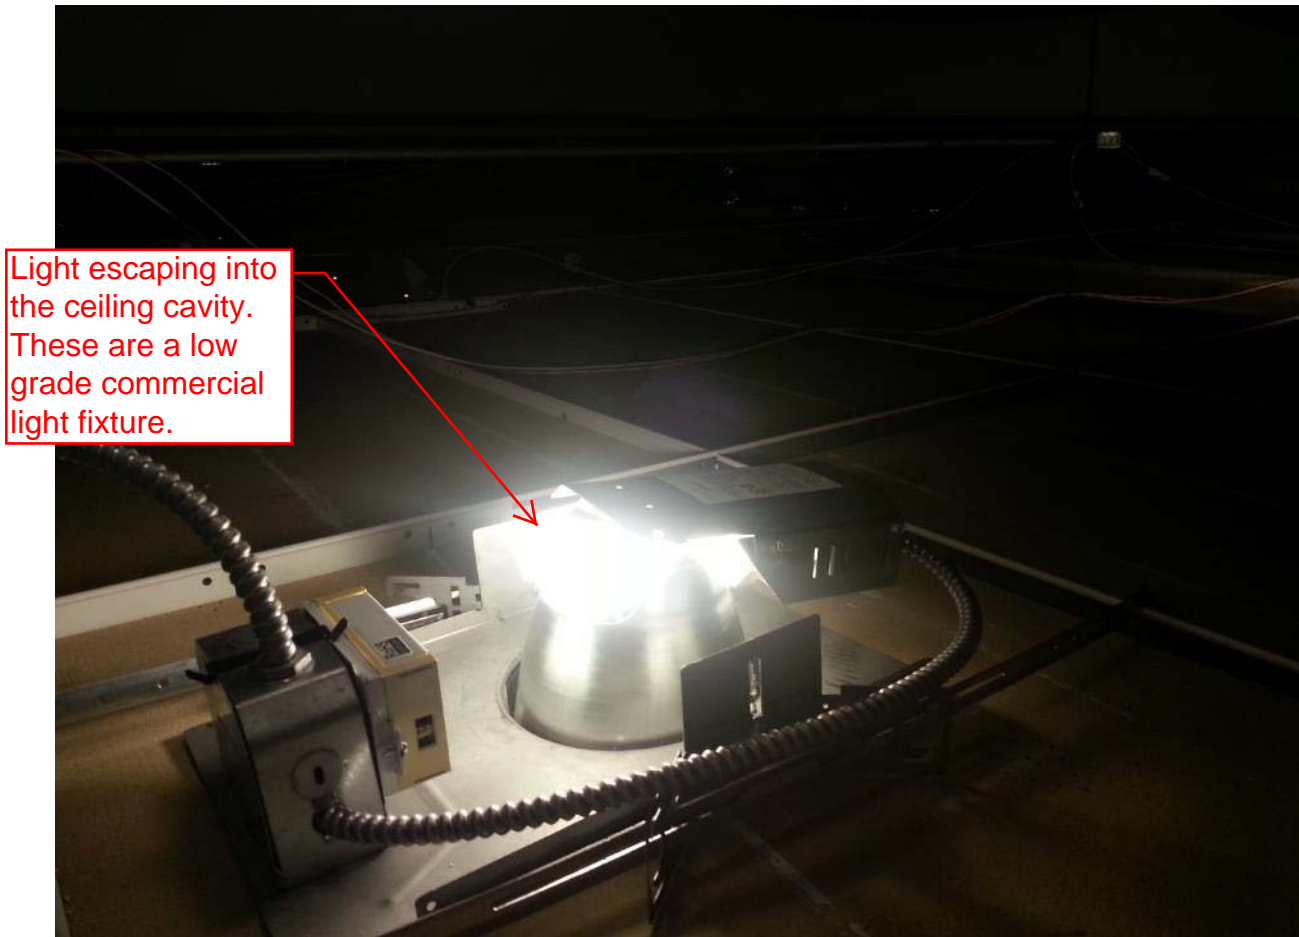
Existing can light fixtures above the accessible ceiling cavity. Note the open design of the can light trim “illuminates” the ceiling cavity and adds additional heat to the ceiling cavity. In the future, the Owner may wish to replace these inefficient can lights with LED type. Note that additional heat in the ceiling cavity could be contributing to the water damage at the exterior walls.

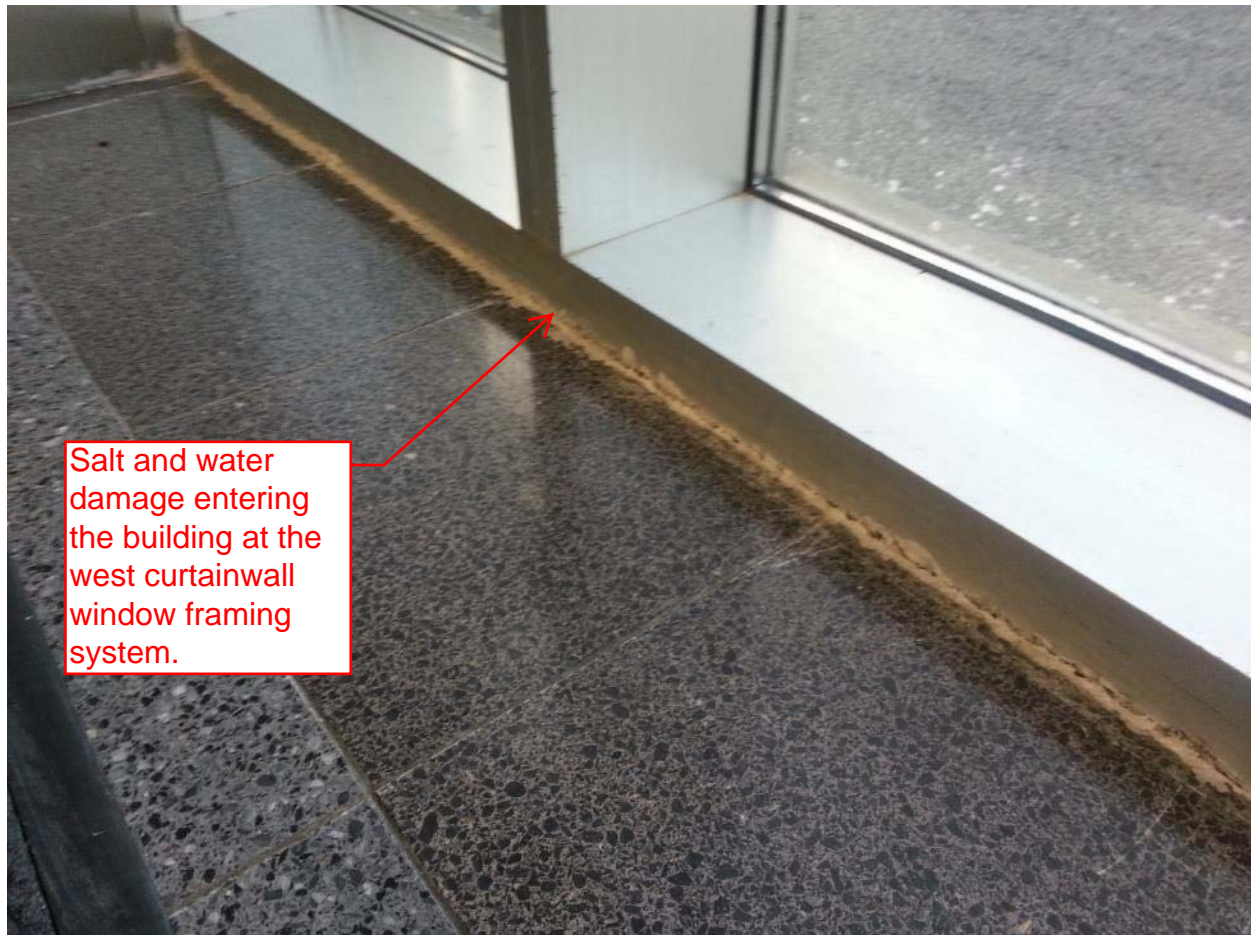
Front lobby entrance curtainwall sill at the West Façade. Note the calcium deposits at the floor tile line likely from the placement of de-icing salt at the exterior driveways. An inspection of the exterior windows at this location indicated that there is no sub-sill window flashing installed or any exterior caulk to prohibit water infiltration.

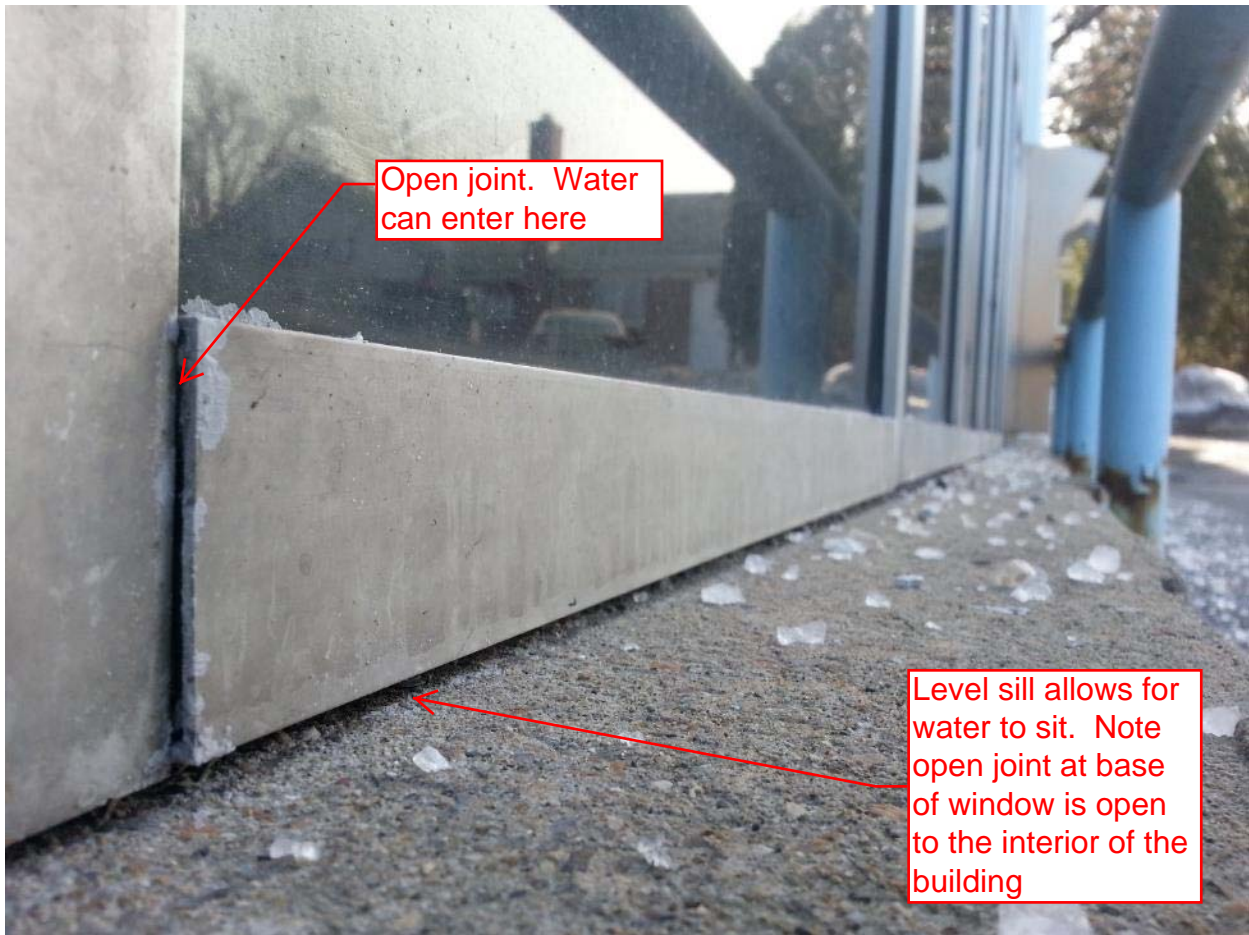
This is a photo of the west façade curtainwall window framing system at the sill line. Three conditions are evident. There is no sub-sill flashing installed. There is no caulk joint installed and the concrete ledge that the window sits on is nearly level. This means water from a driving rain can find its way into the building. Previous photo A1757 seems to indicate the presence of water infiltration. Note the rock salt on the top of the curb. As this salt dissolves, it finds its way into the building at the open joint in the window system.

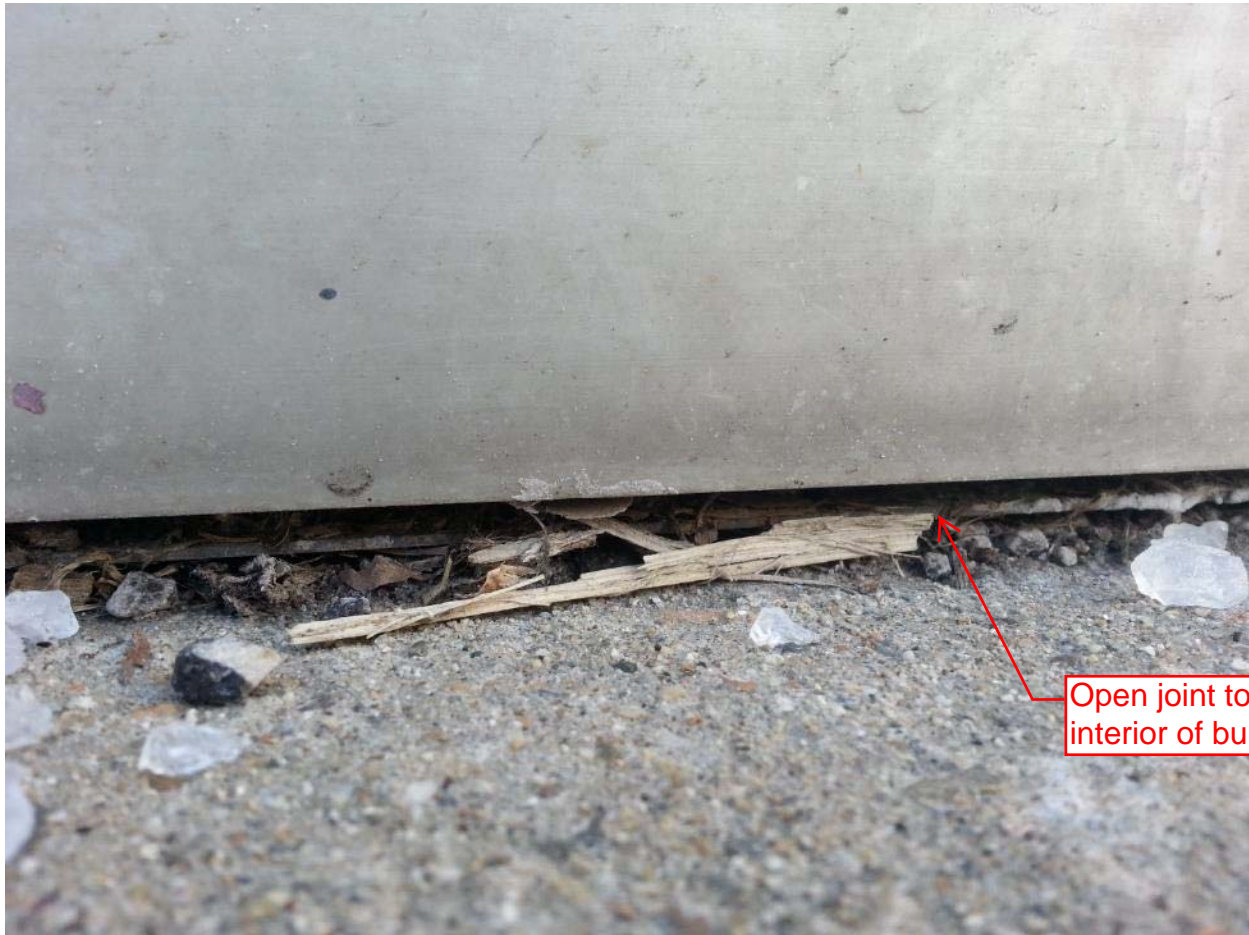
Open joint is west façade curtainwall framing member. Note the debris that has gotten into the joint from the exterior and the lack of a caulk joint. Water is entering the building here.

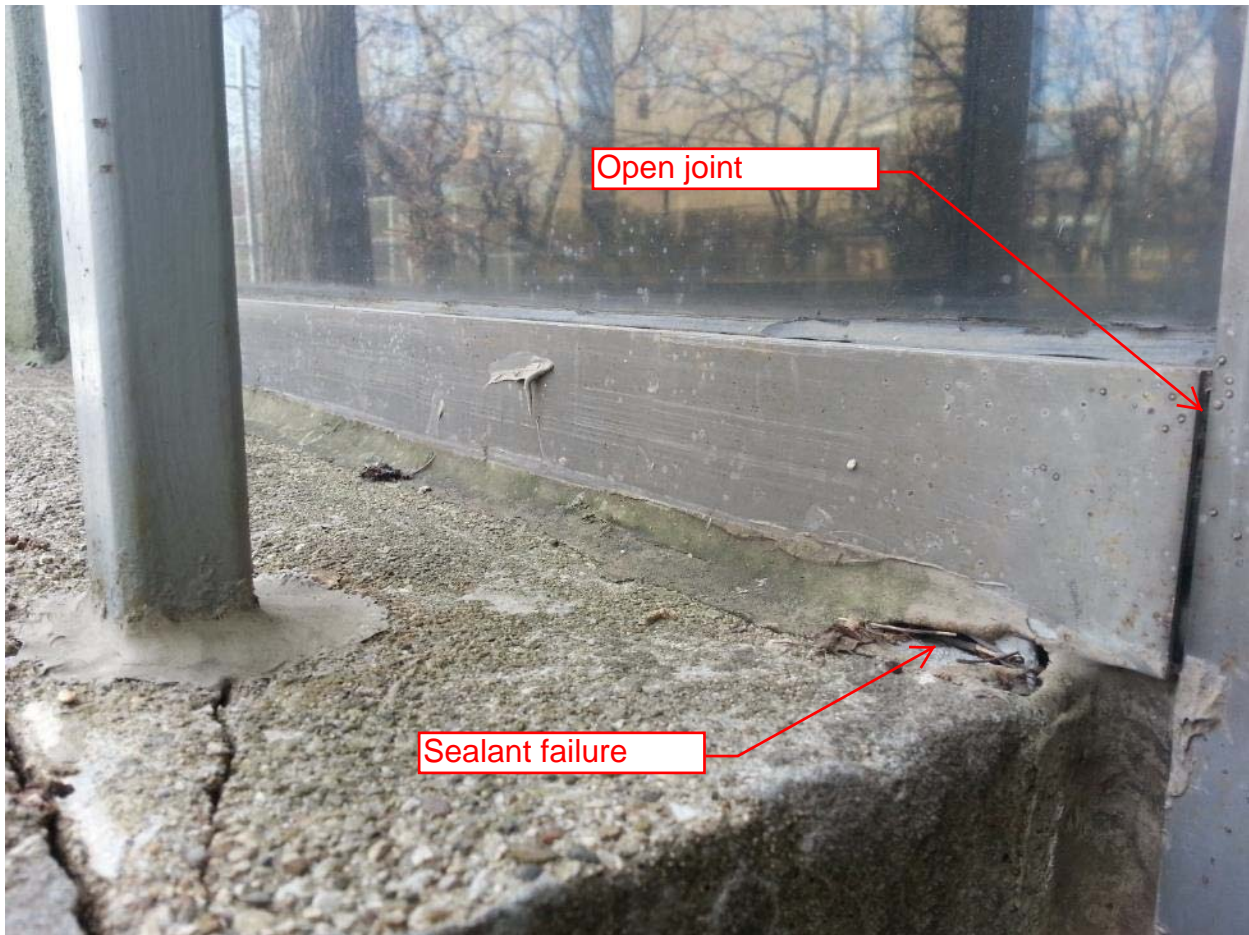
This is the sub-sill flashing installation immediately to the east of the Children's Department, lower level exist doorway to the NE building exterior. Note that the sealant joint is not continuous and an open joint is visible where the aluminum window framing horizontal meets the vertical member allowing water infiltration into the building. We also note that the concrete ledge to the exterior side of the window does not slope away from the window but is nearly level, allowing for water to sit at the caulk joint.

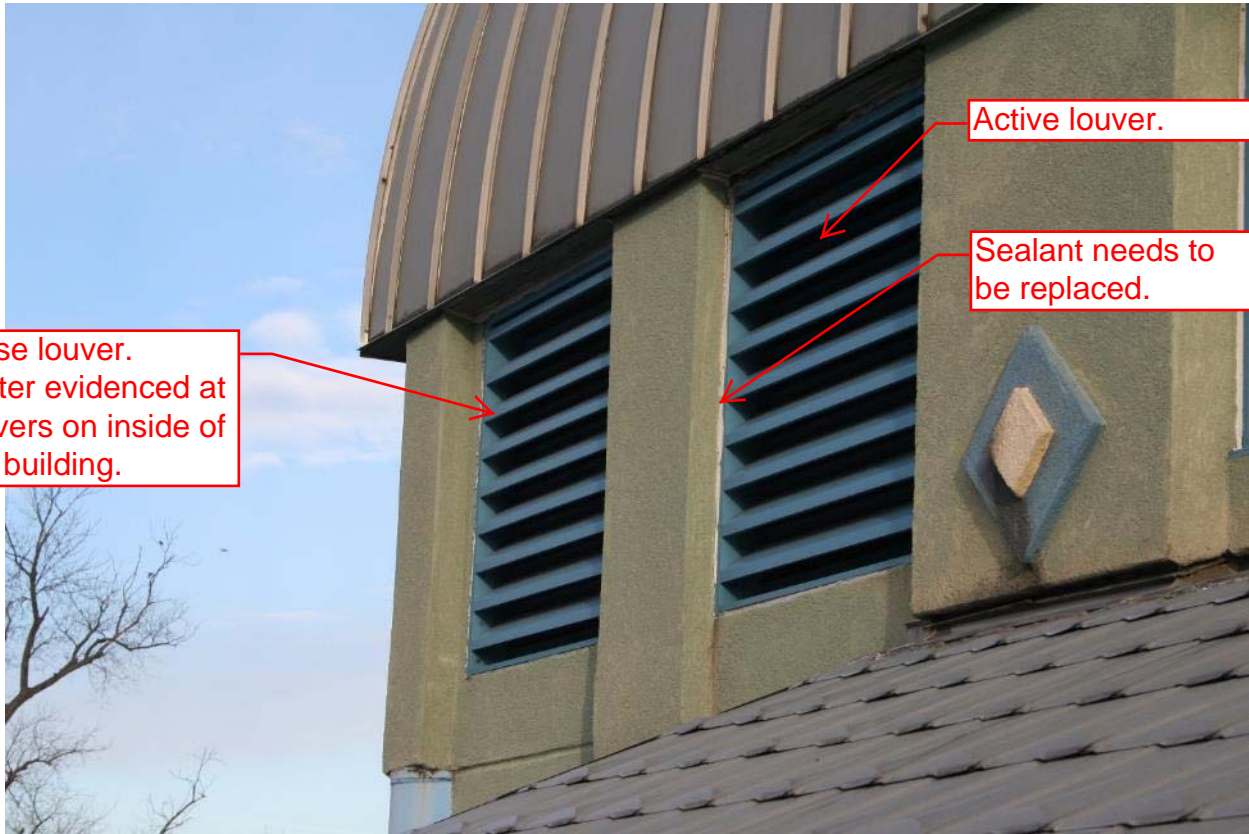
False louver.
Water evidenced at
louvers on inside of
the building.

Southwest upper roof location near the louvers. Note that the furthest louver to the west is a "false" louver. On the inside of the building, we noted some water infiltration at this false louver location which may suggest that the installation may not be fully weather tight.

Sealant needs to
be replaced.

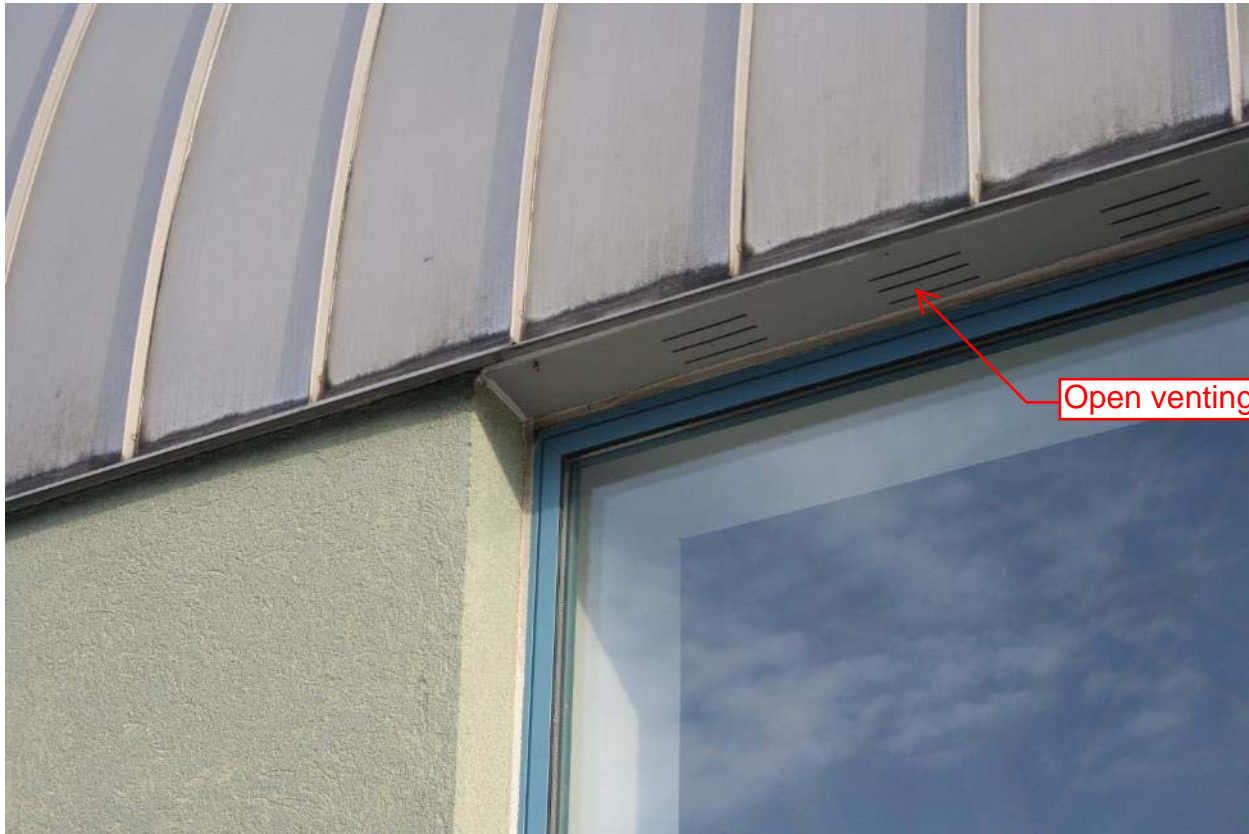
We noted that the clerestory window heads have vented louvers in them. The venting of the underside of the roof decking is common however this condition relies heavily on the proper placement of the inboard insulation materials and a fully occlusive vapor barrier to be installed. A review of the drywall vault from the inside of the building suggests that moisture is present in the roof cavity and may require further investigative testing to determine the installation conditions. This is beyond the scope of this report.

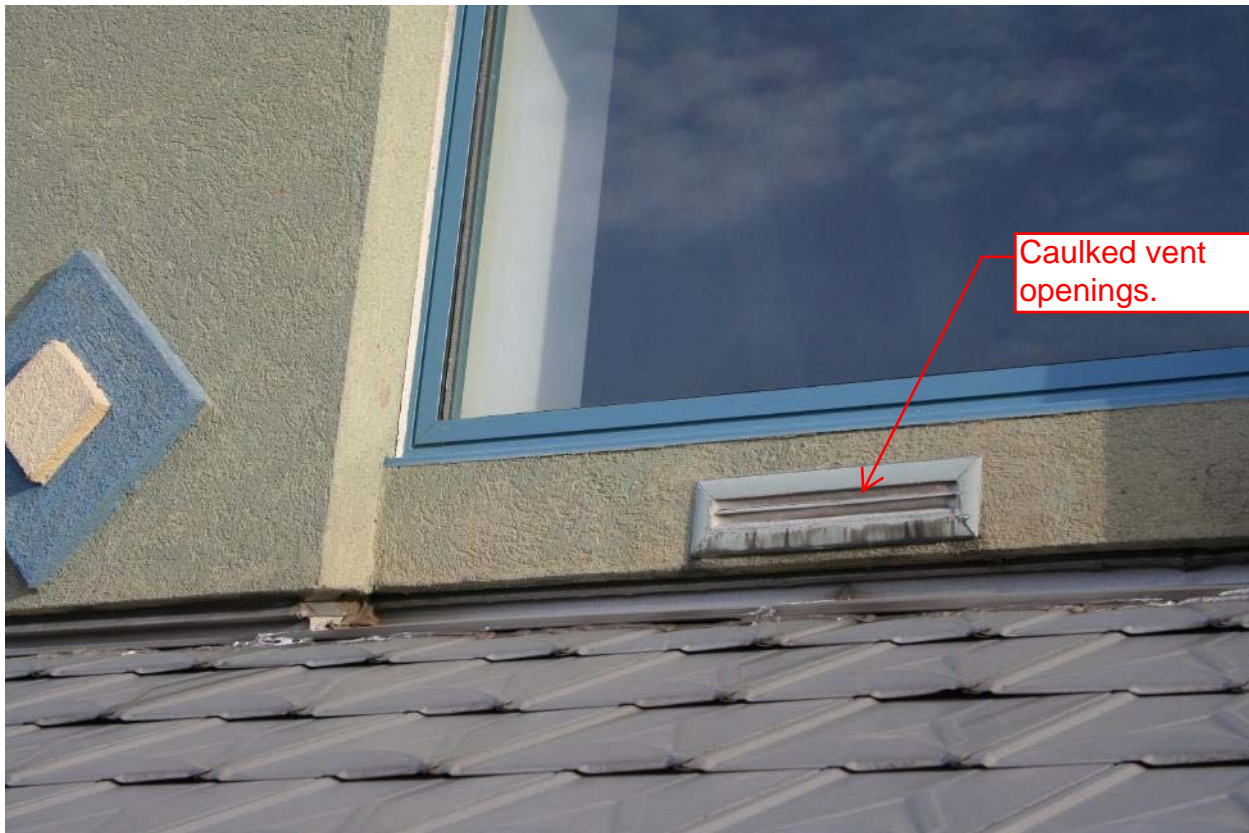
Under window vents at the upper clerestory windows have all been caulked over. We believe the original intent was for this vent to be active venting for the lower shingle roof area however the Owner's existing as-built drawings (detail 1/A5-6) seems to indicate that there is no clear pathway for air flow due to insulation placement. This condition should be further investigated by removing a portion of the interior drywall to determine the air flow pathway. This is beyond the scope of work for this project.

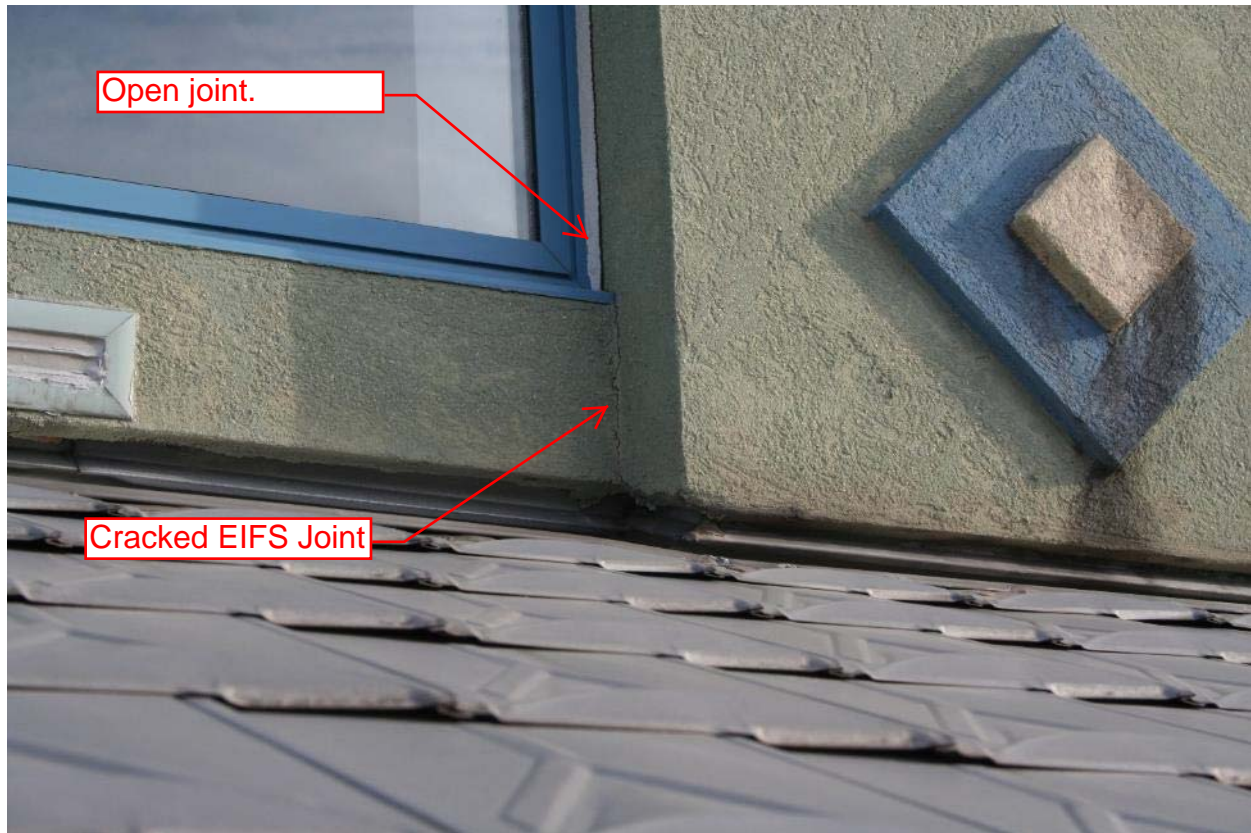
Some cracked open joints are noted at the upper clerestory window, inside corner EIFS locations. Window sealant joints were also observed to have been cracked at several upper window locations.

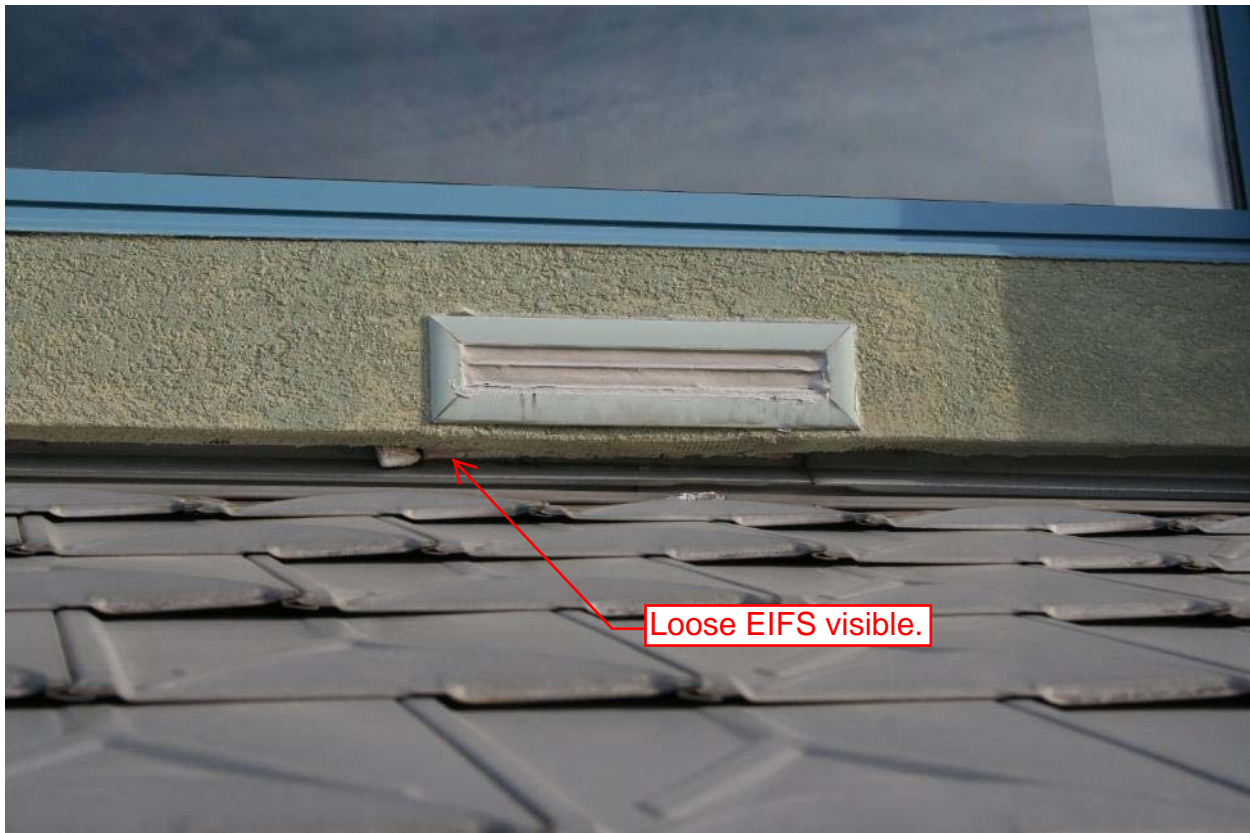
South wall upper clerestory window counterflashing below a window at the sealed in roof vent. Note that some of the EIFS in this location has come loose and did not appear to have been properly back-wrapped with reinforcing mesh.

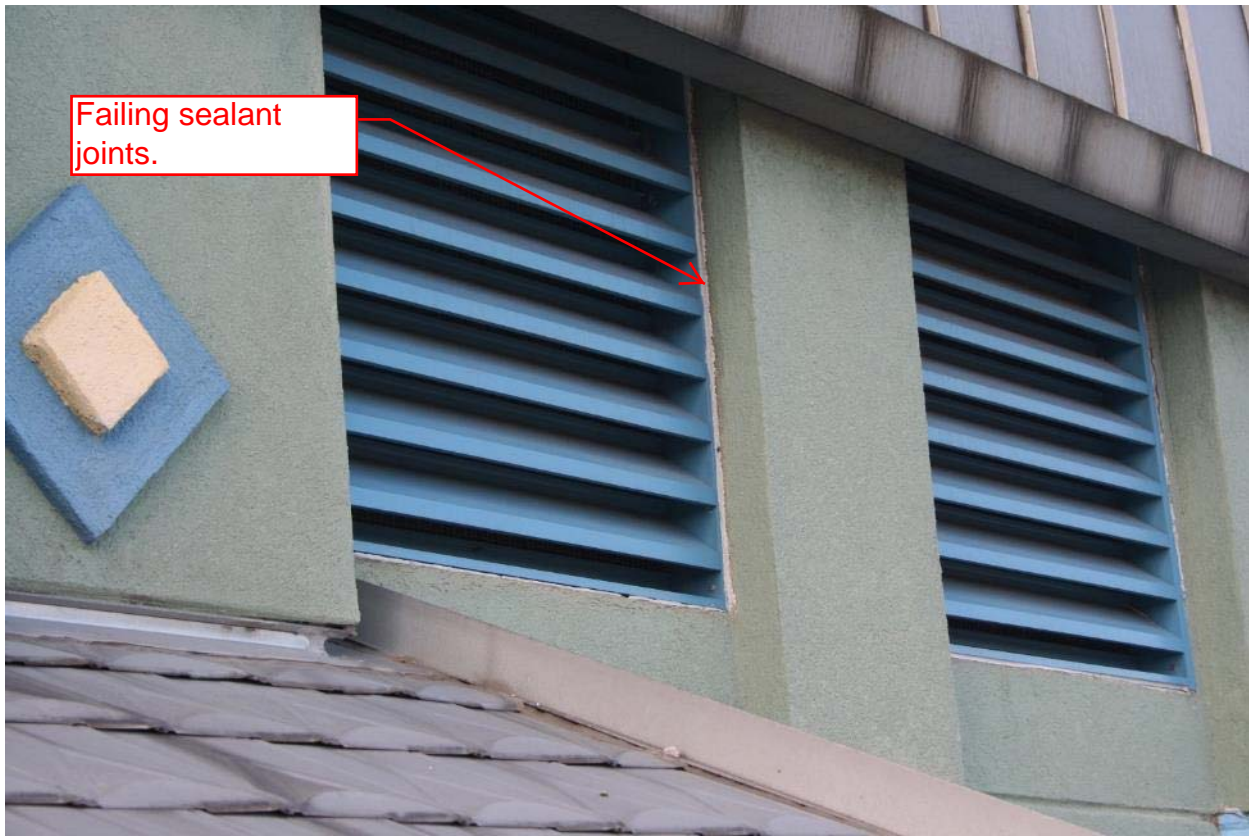
Perimeter sealant joints at the louvers appears dried and cracked and should be replaced. An open joint at the sill of one of the louvers was visible.

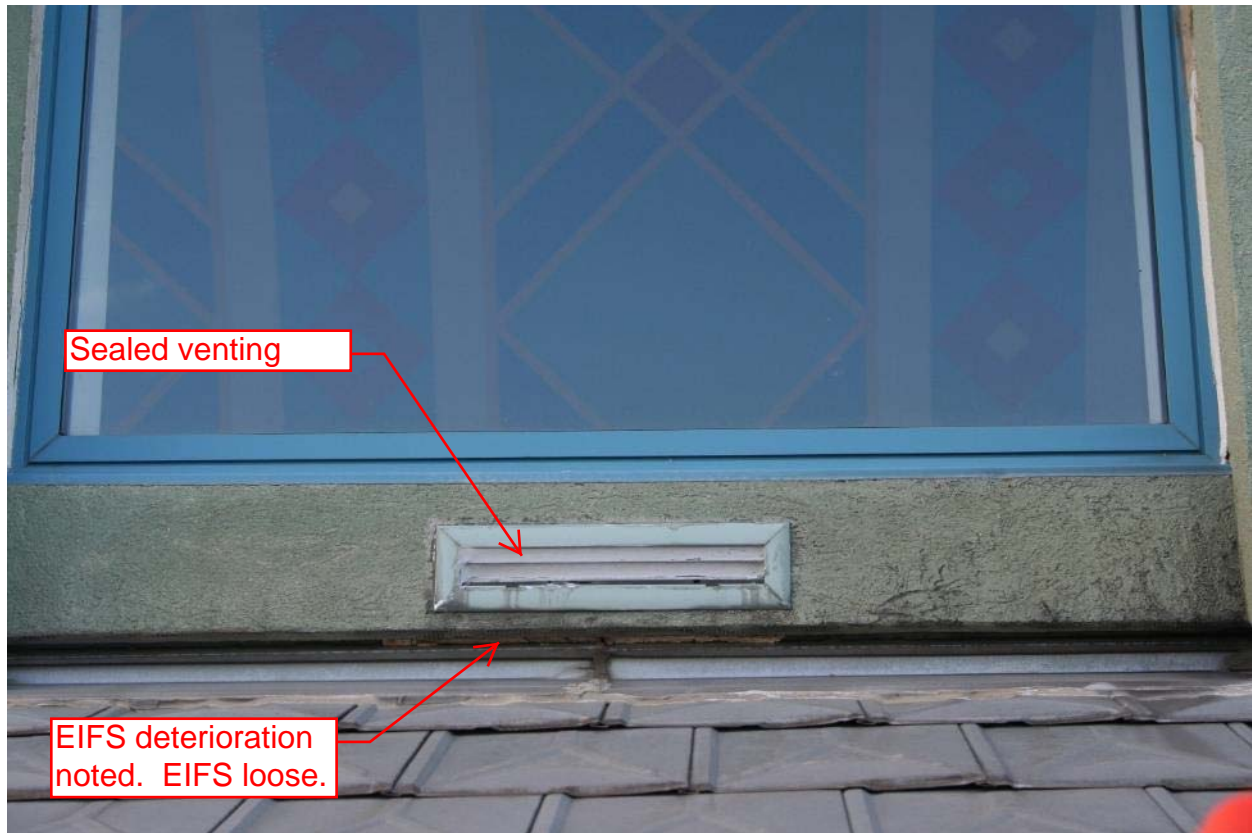
North clerestory window wall venting louver is caulked in similar to all south side louvers. Note the EIFS under the louver appears to have deteriorated as evidenced by the white insulation board that is visible.

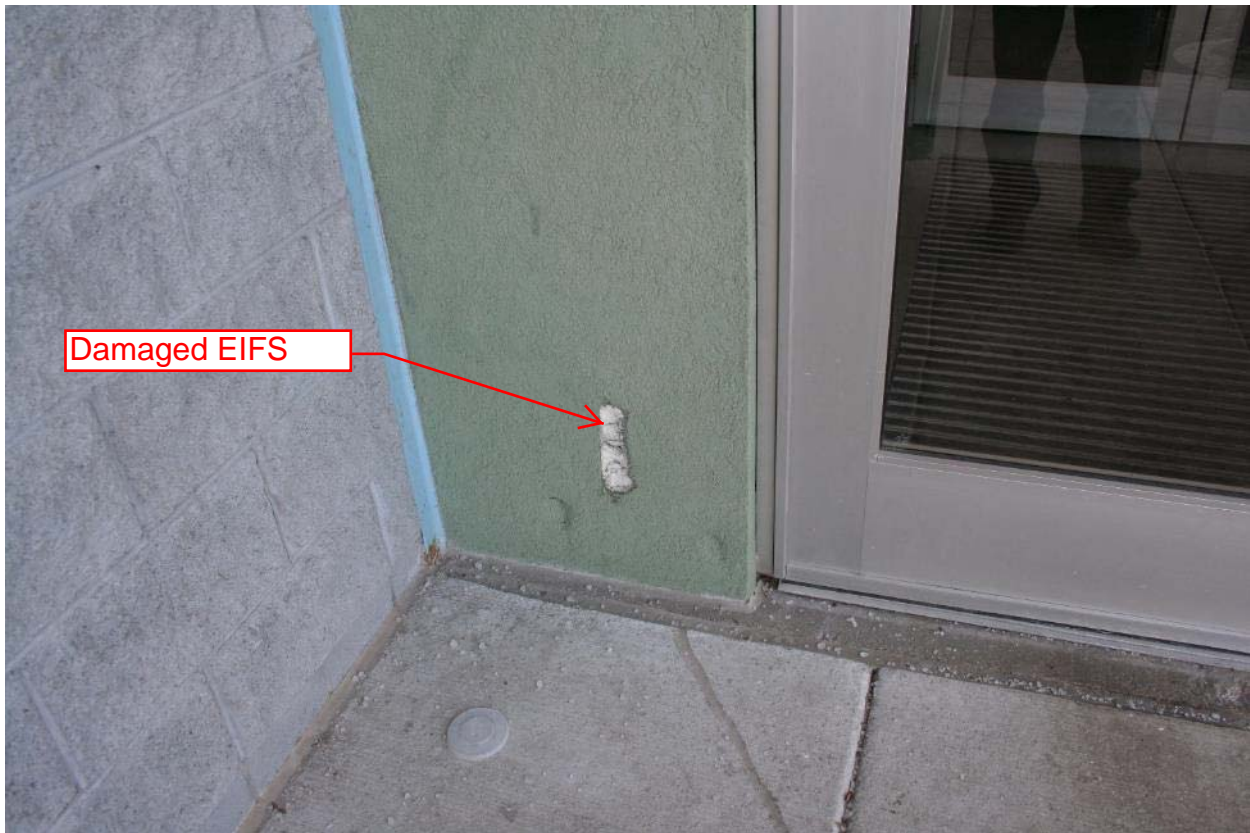
EIFS damage has penetrated the outboard fiberglass mesh. The exterior mesh and synthetic stucco coating must be removed back 2 inches from the damaged locations and patched according to the EIFS manufacturer's recommendations.

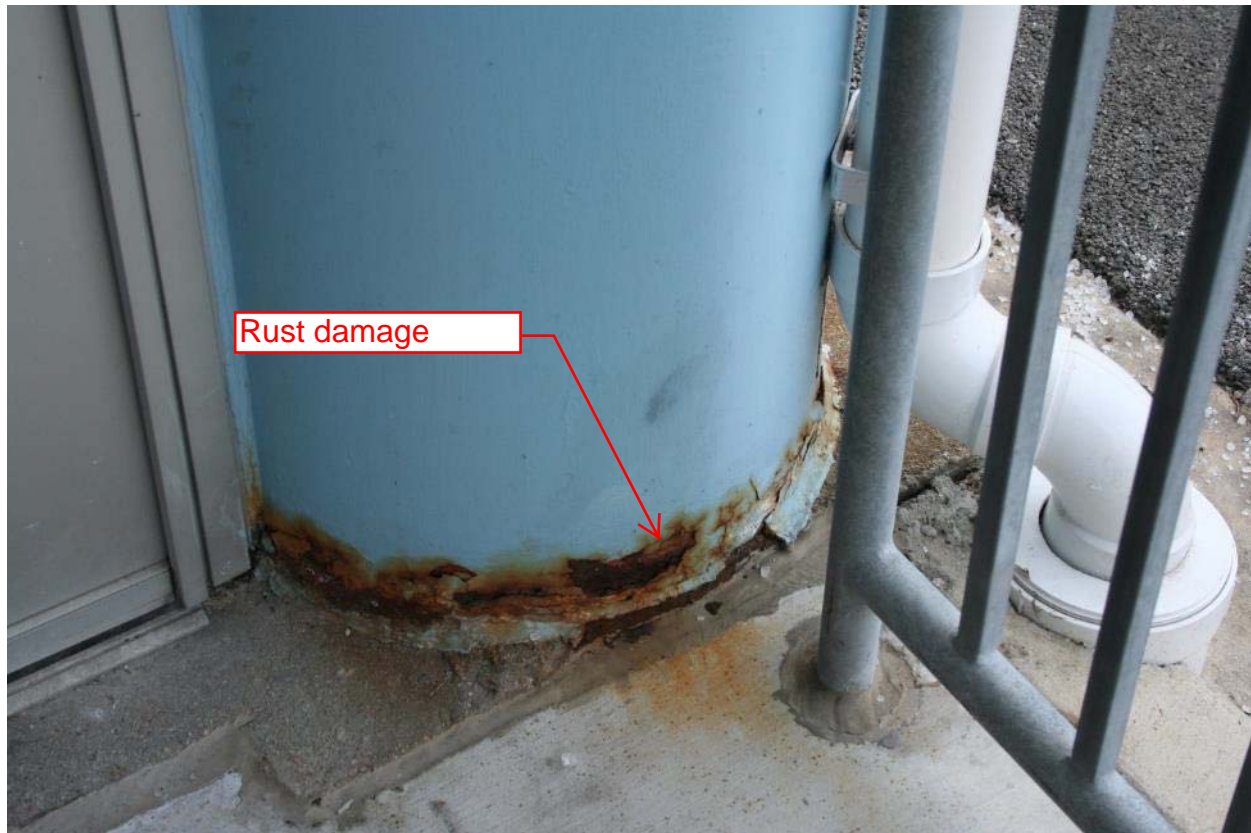
Exposed round steel column at the NW corner of the building. Note the metal plate between the column and the aluminum curtainwall system. This plate is not indicated on the original construction documents.

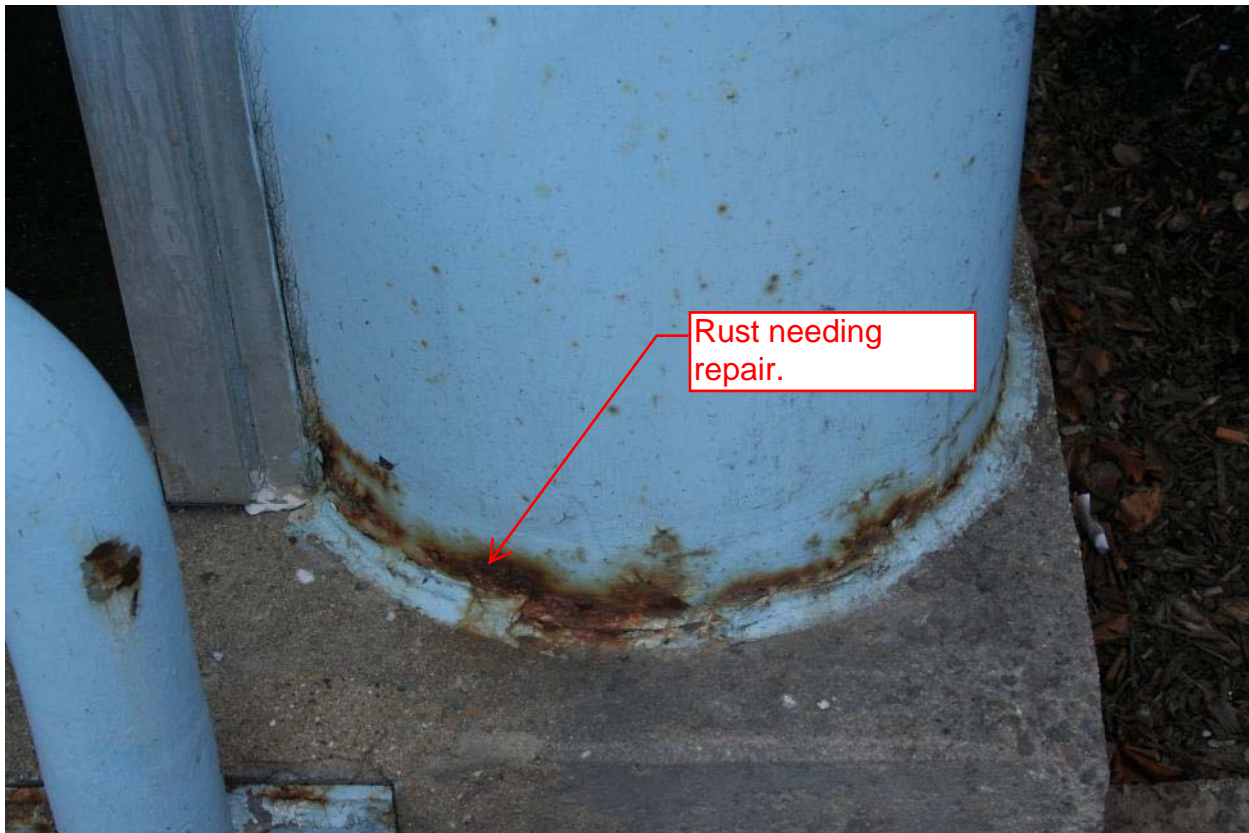
This is the SW entrance column at the base. The same concerns exist at this location as they do at the NW column location.

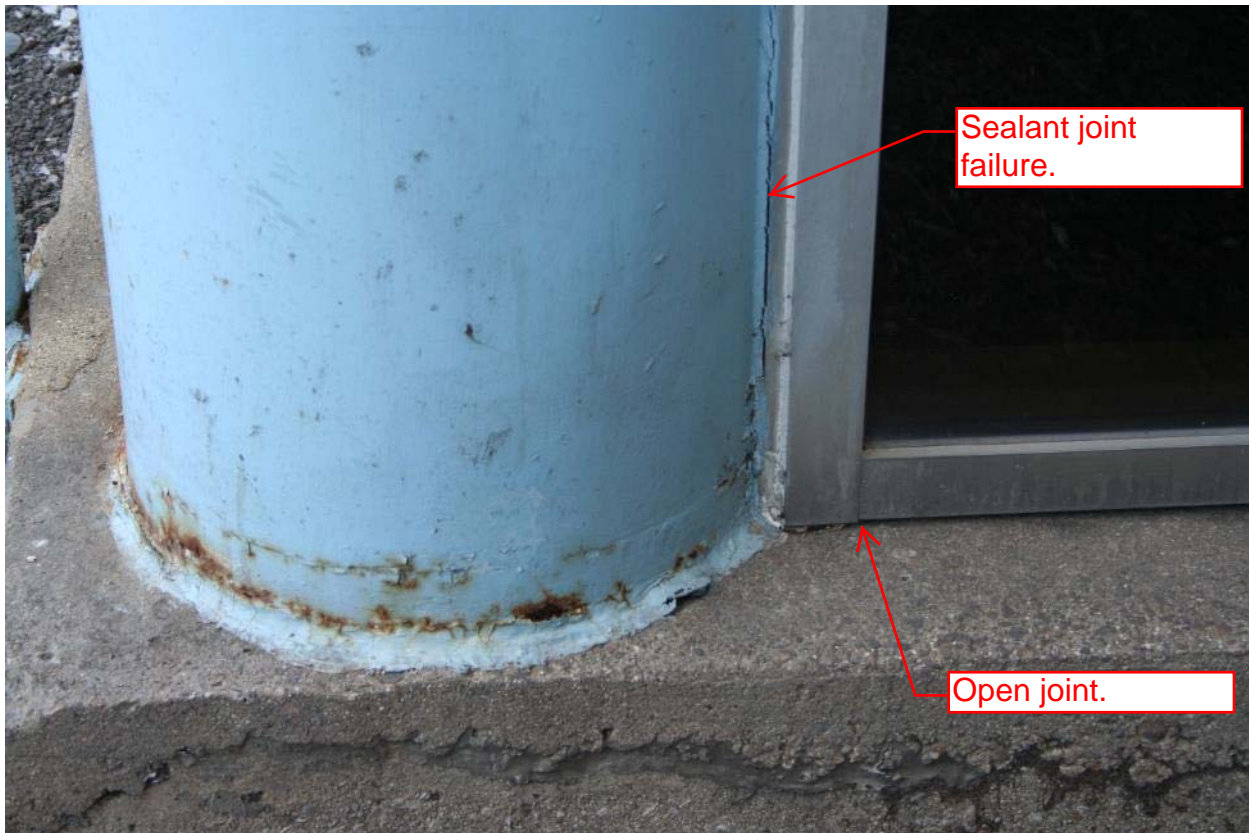
This is the south face of the SW column. Note deterioration is significantly reduced away from the asphalt parking lot and away from de-icing salts. Also note the sealant failure at the steel column to the clerestory window jamb.

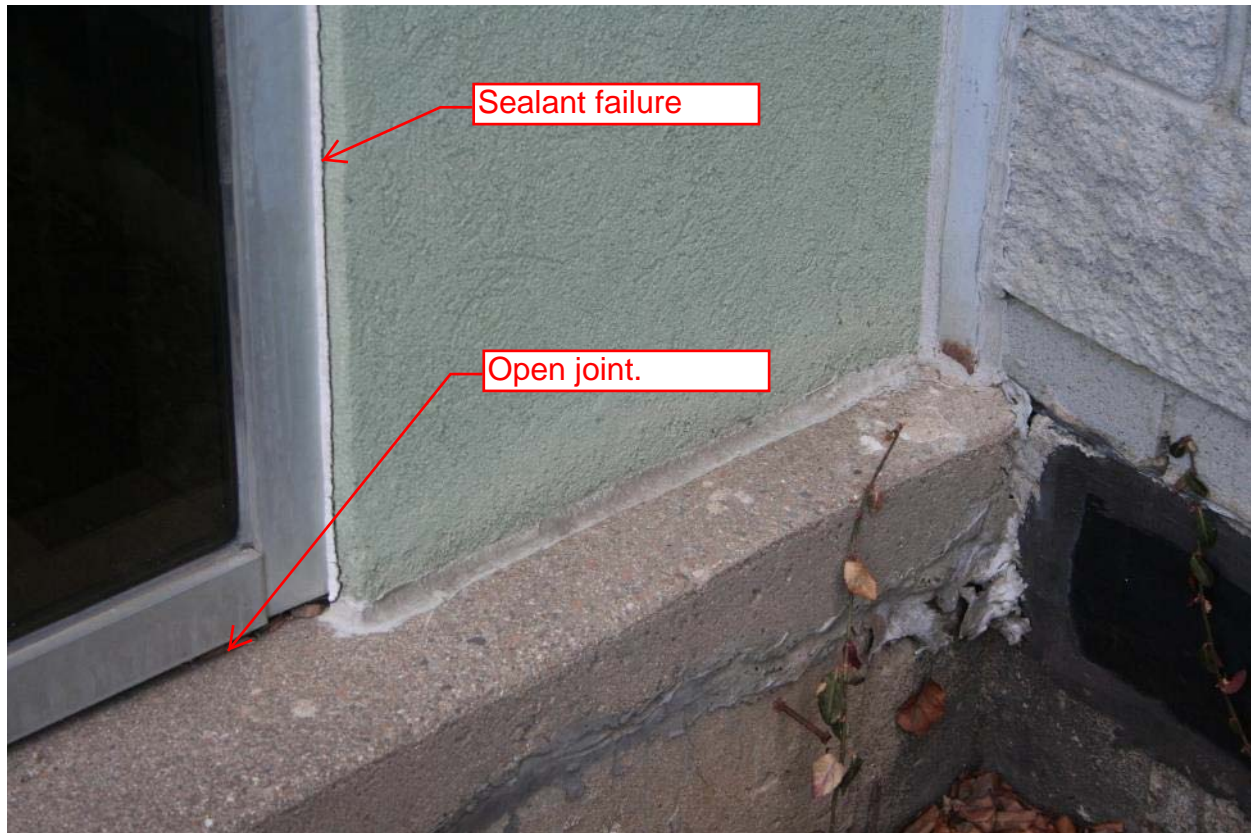
EIFS to curtain wall window framing at the SW corner of the building; just south of the main entrance lobby. Note the sealant failure at the curtain wall window framing system and the open joint at the window base.
