- LaGrange Park Public Library
- Water Infiltration Investigative Study
- April 28, 2015
- Kluber Project No. 15-357-960

Re: Water Infiltration Investigative Study
Kluber, Inc. Project No. 15-357-960

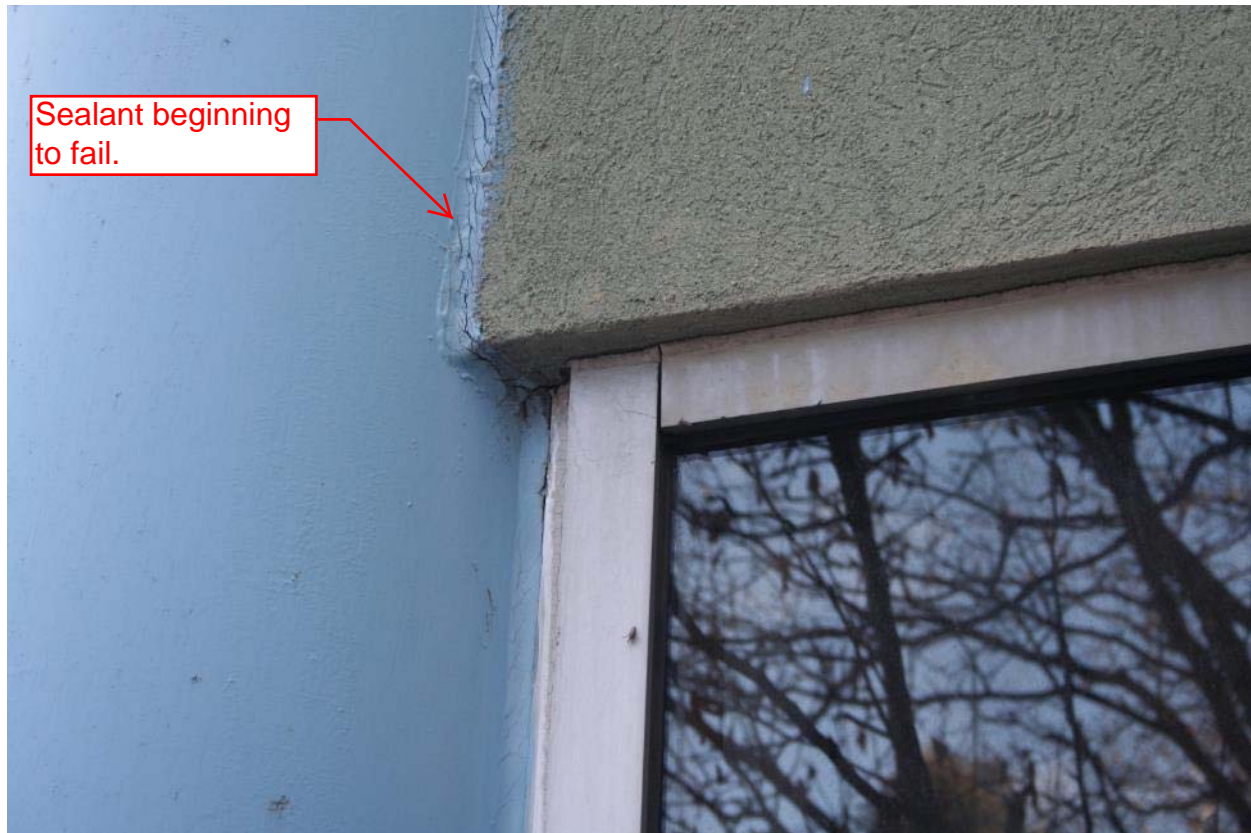
SW entrance curtain wall framing at the window head. Note the failing sealant that is beginning to crack at the joint between dis-similar materials at the EIFS to Blue Steel column location.

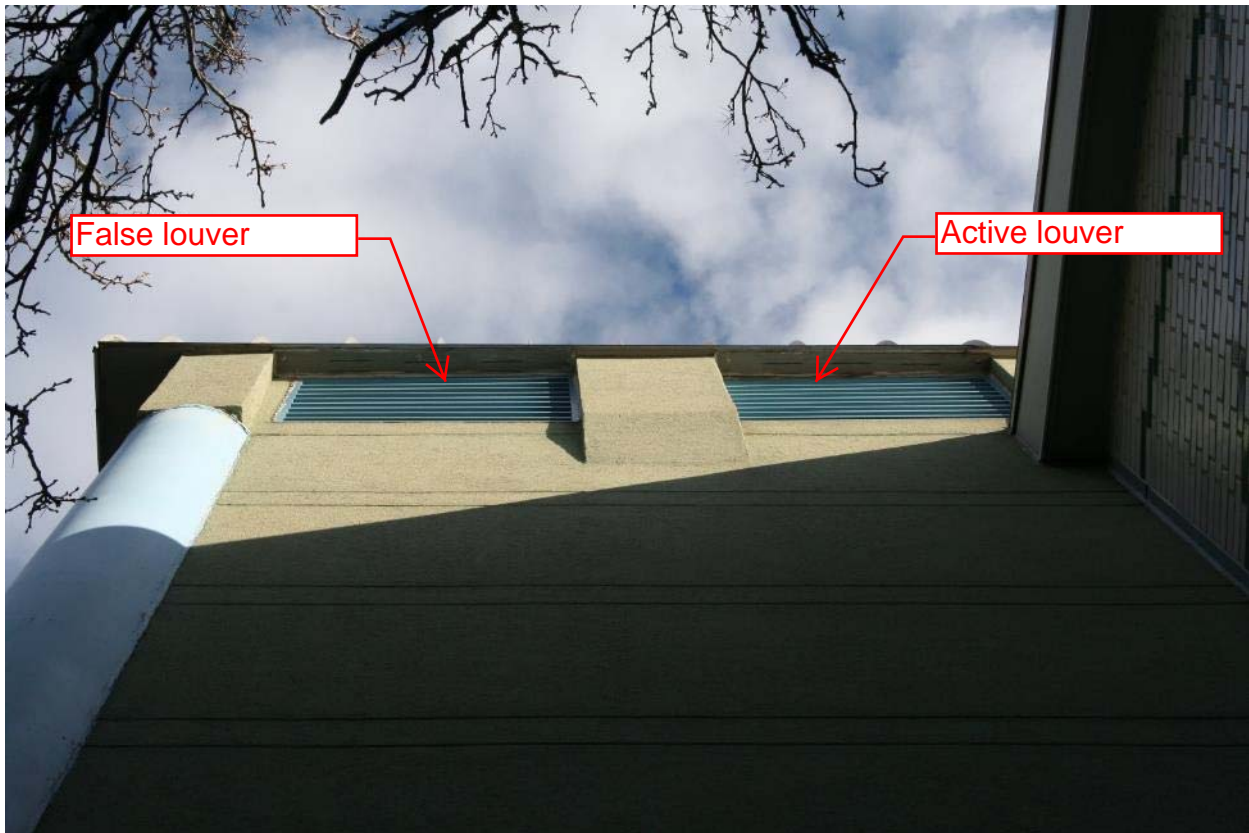
SW entrance column looking up toward the vaulted roof. The left most louver is a "false" louver. All louvers were found to have failed sealant joints at the perimeter and some moisture penetration was noted on the interior surface of the drywall.

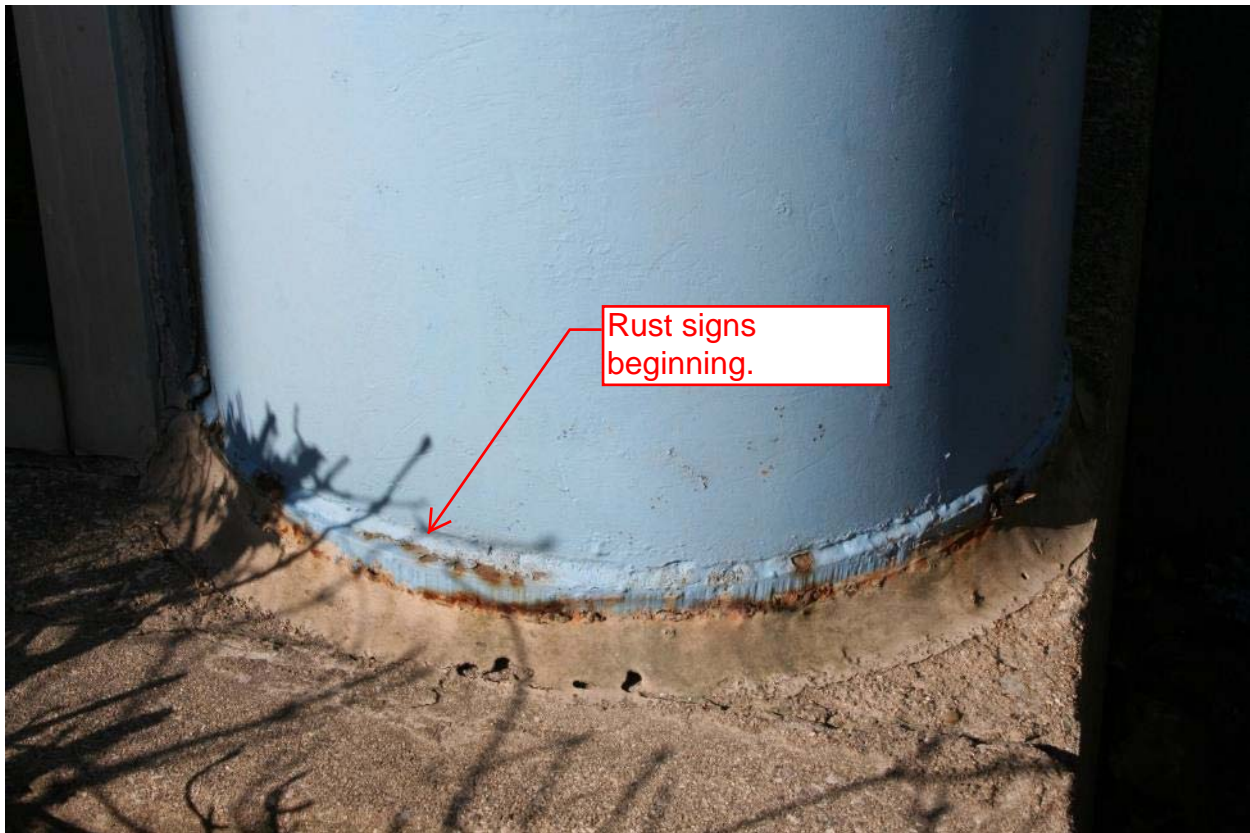
East wall at base of curtain wall window framing system. Note base has been caulked and the sealant joint has failed. Window to steel column sealant joint has also failed and needs to be repaired.

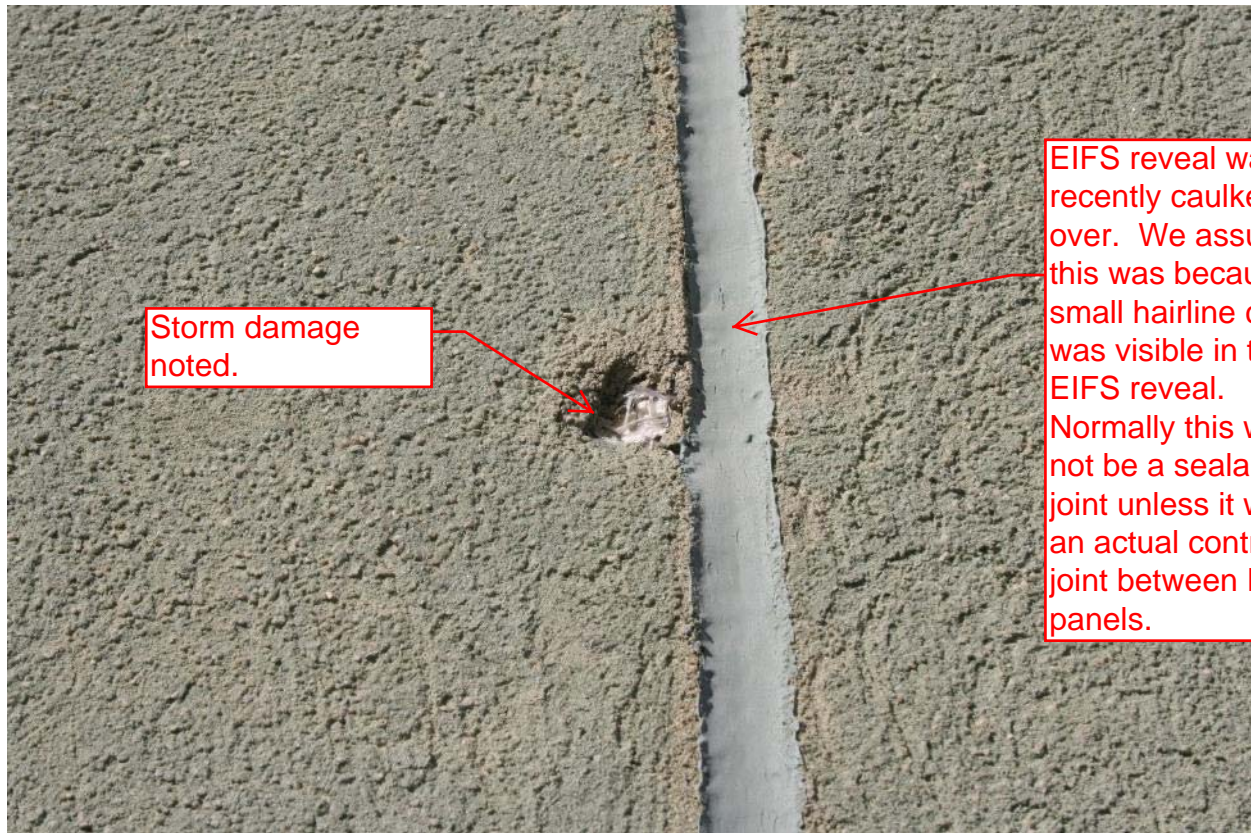
Storm damage
noted.

EIFS damage at a reveal joint in the east façade. Note that the sealant joint is actually supposed to be an EIFS reveal but has been caulked over in an apparent effort to reduce water infiltration.

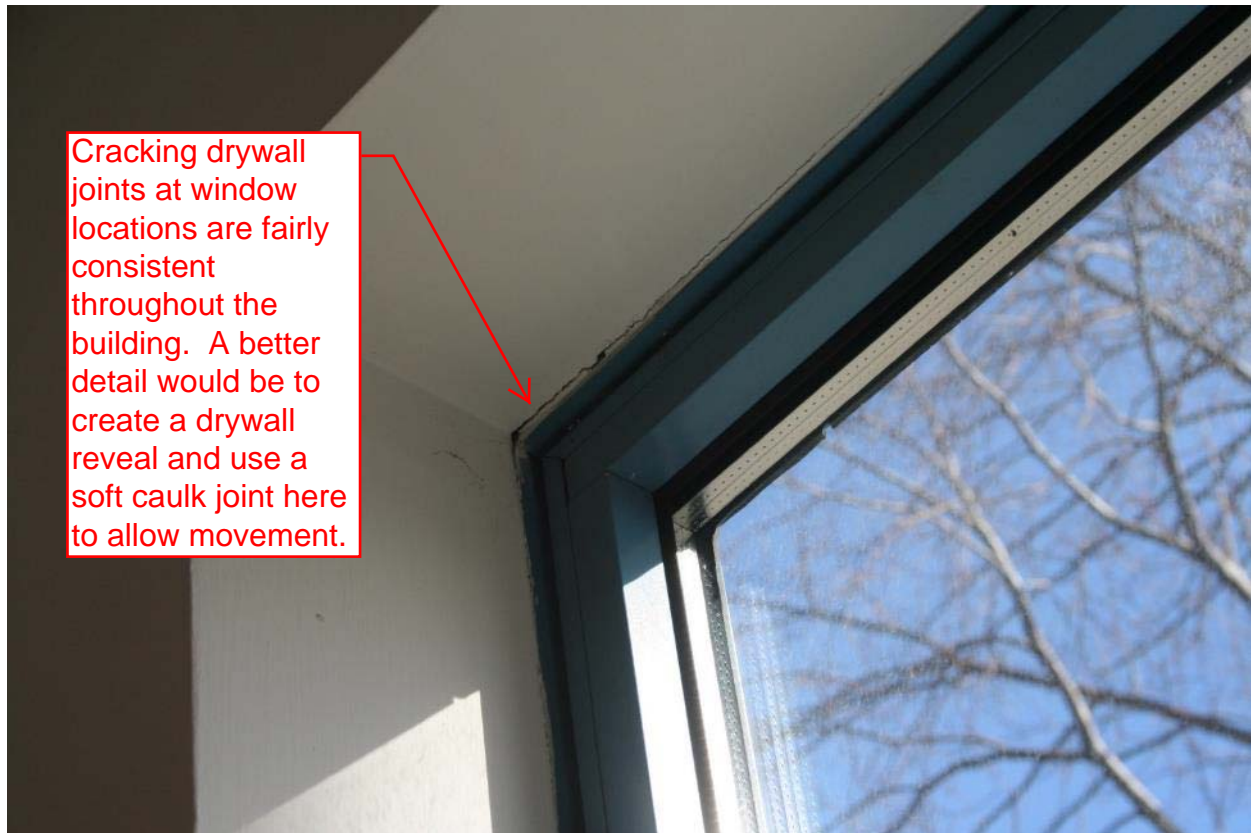
Cracking drywall joints at window locations are fairly consistent throughout the building. A better detail would be to create a drywall reveal and use a soft caulk joint here to allow movement.

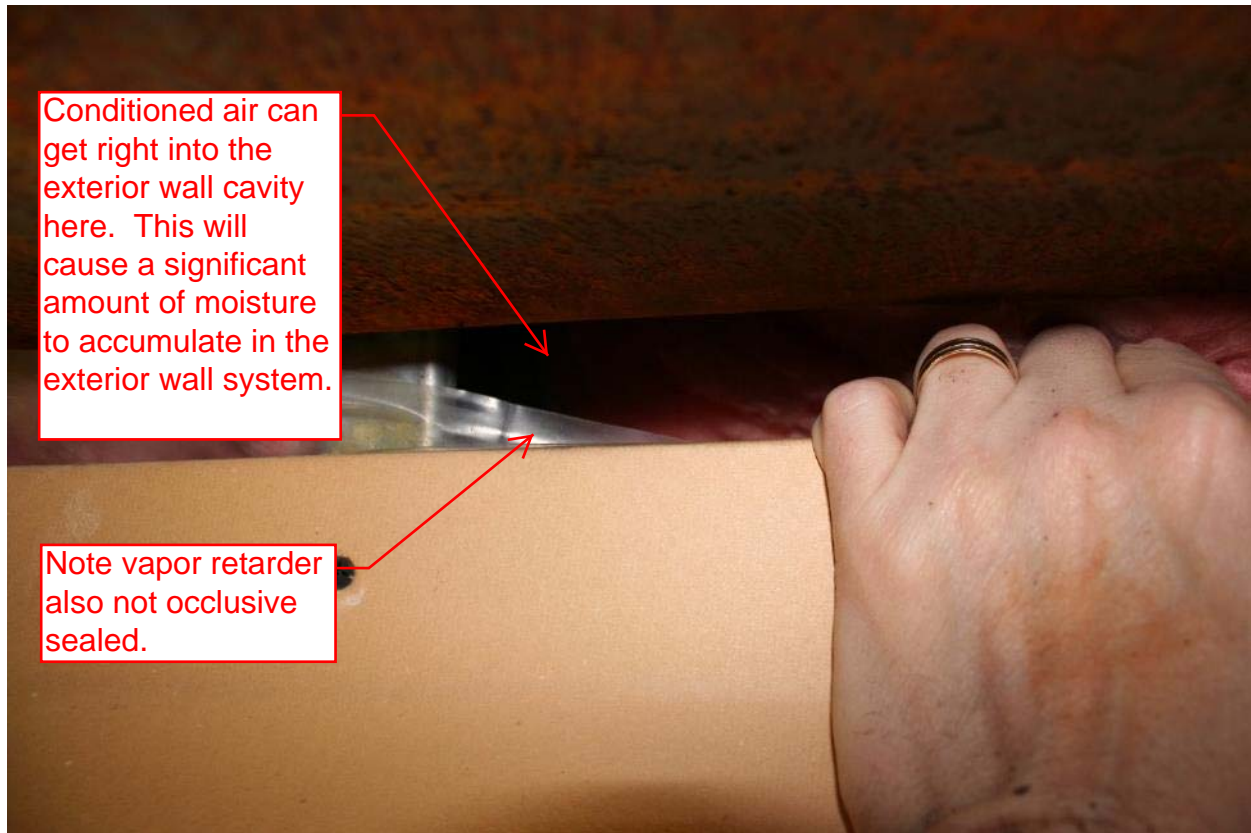
This photo is taken from the first floor NE stacks area near the east, exterior wall above the acoustical ceiling cavity. Note that the drywall does not extend all the way up to the underside of the steel floor beam and the vapor barrier (clear visqueen) does not either. This allows conditioned air to infiltrate into the exterior wall cavity. This gap occurs at all exterior wall conditions at the east and west walls of the building. This need to be corrected immediately.

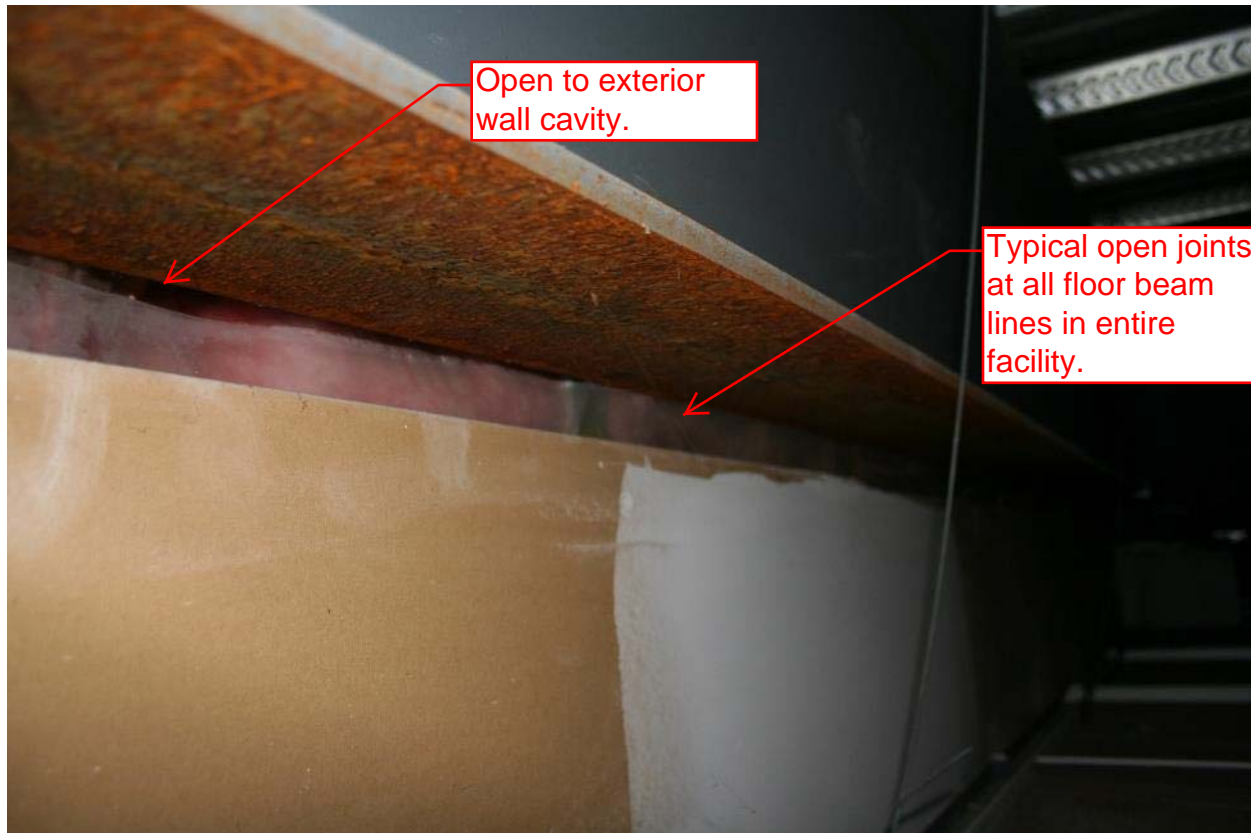
Another picture of the drywall and visqueen vapor barrier not installed correctly.

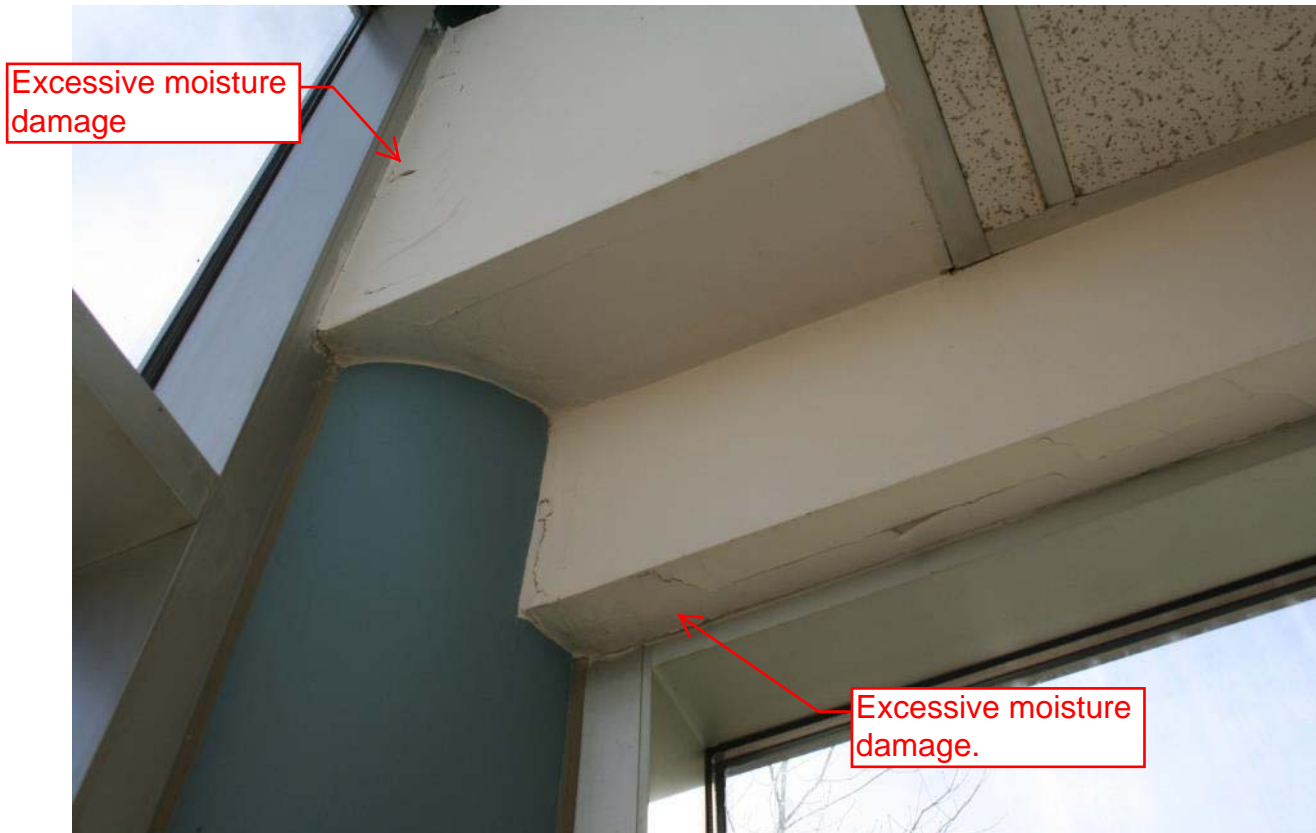
SE round steel column at the first floor beam connection. Note the significant drywall deterioration likely occurring because the dew point is falling inside the wall cavity. The exterior detailing to the EIFS to the steel column is also suspected to be contributing to this water infiltration condition.

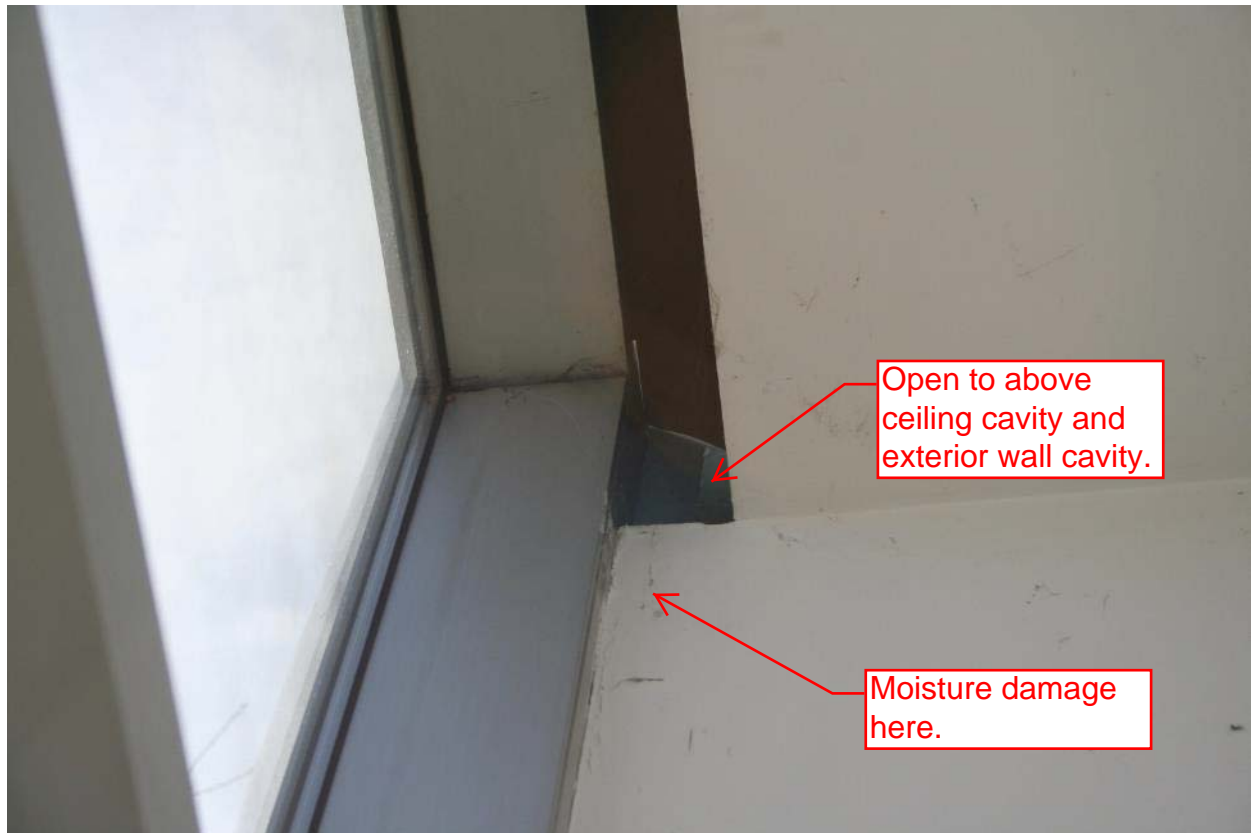
East curtain wall windows looking up from lower level to the first floor. Drywall moisture damage has been noted.

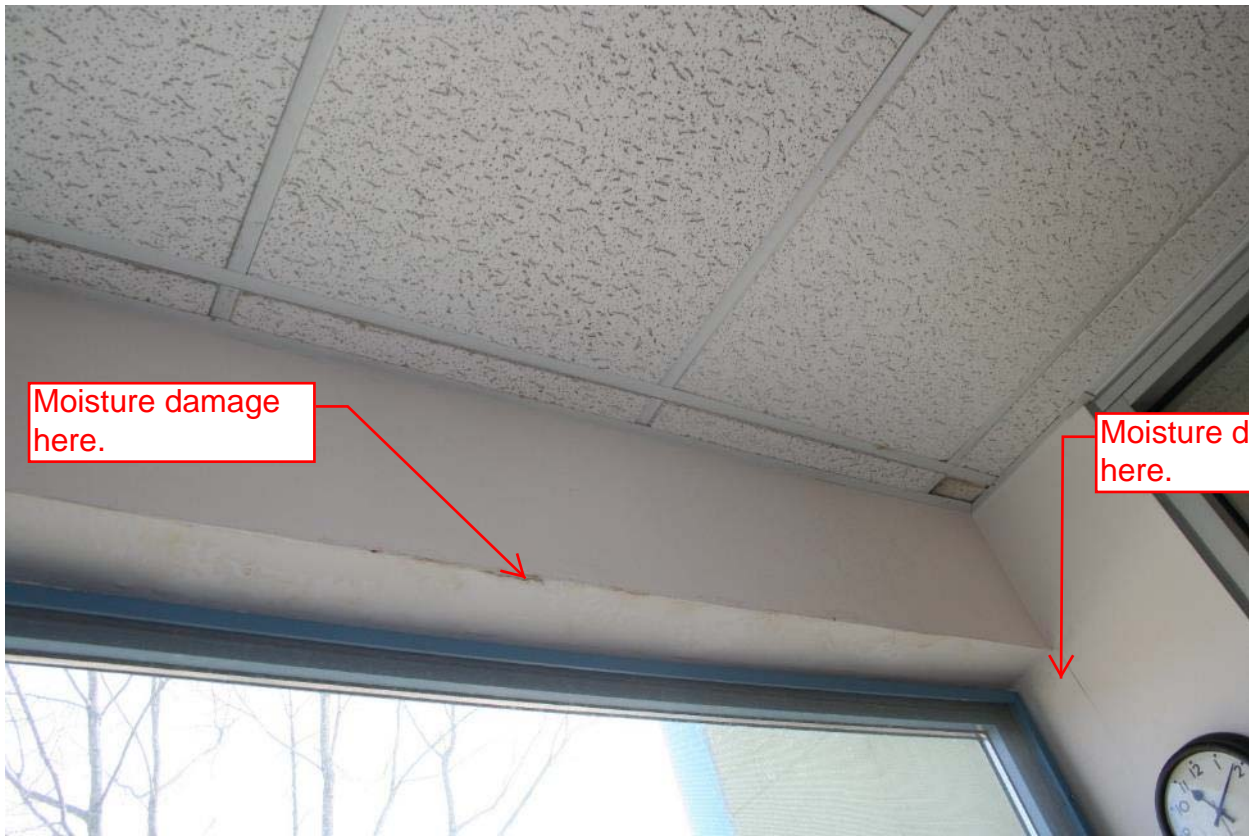
Lower level at the east façade near the SE corner of the Children's Department. Note window head drywall is showing sign of moisture damage.

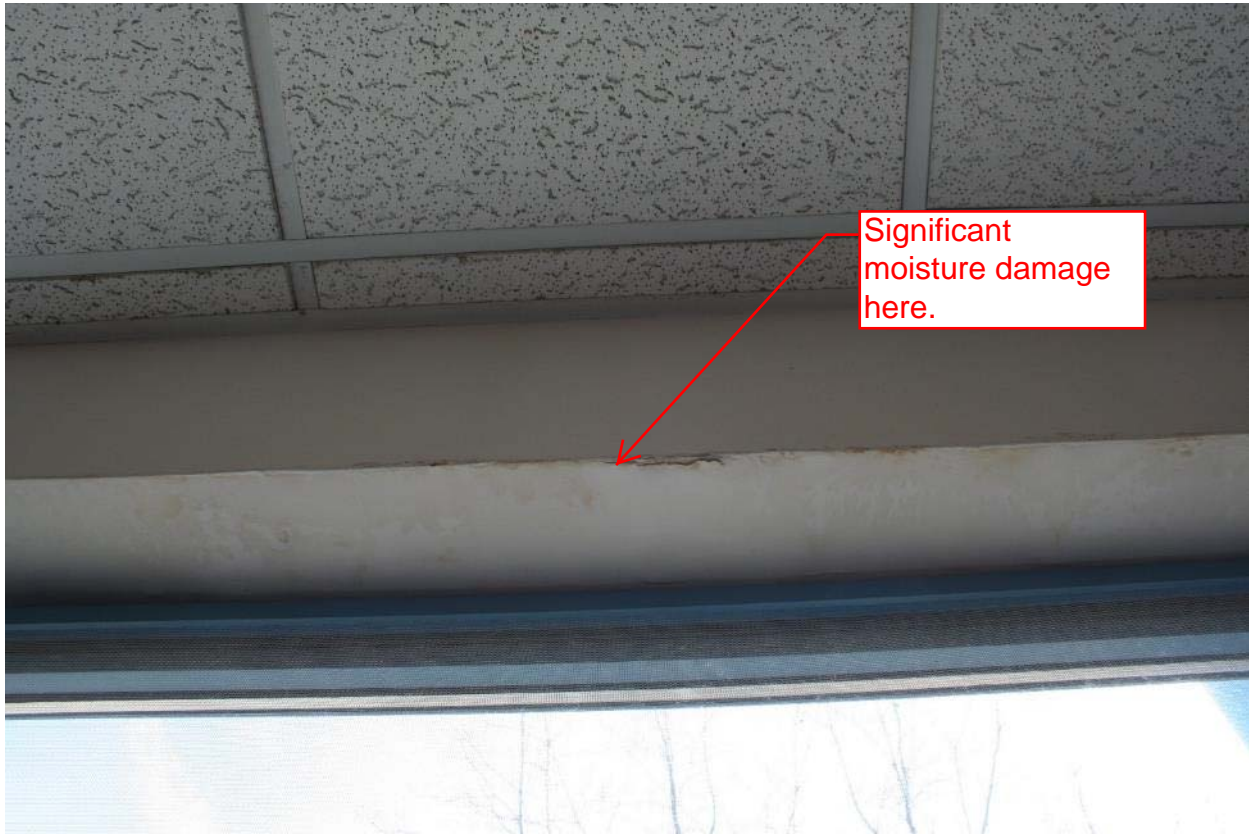
A closer look at the east exterior window at the lower level. This condition is similar at most of the exterior windows at the east elevation.

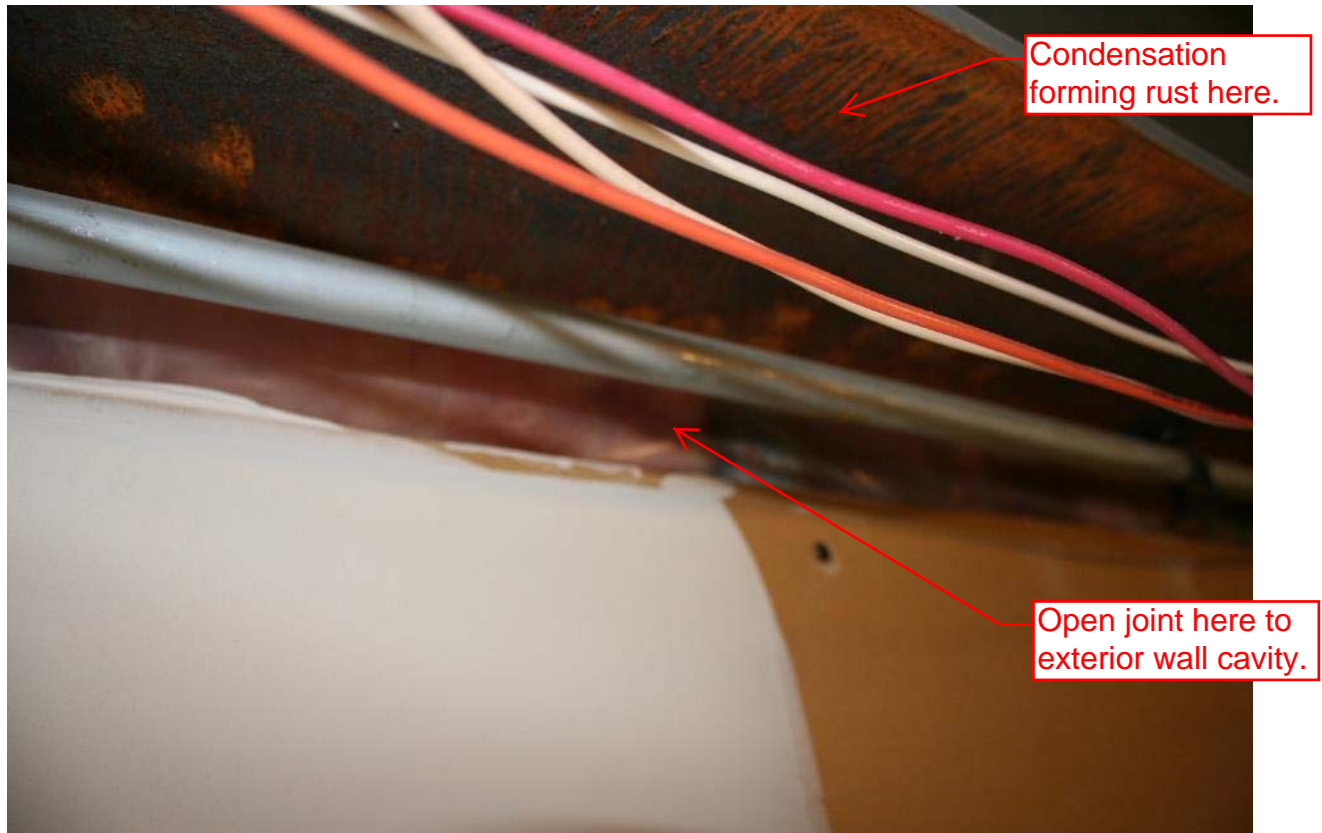
Another gap between the east wall drywall and the bottom of the steel beam. This open joint allows conditioned air to enter into the exterior wall system.

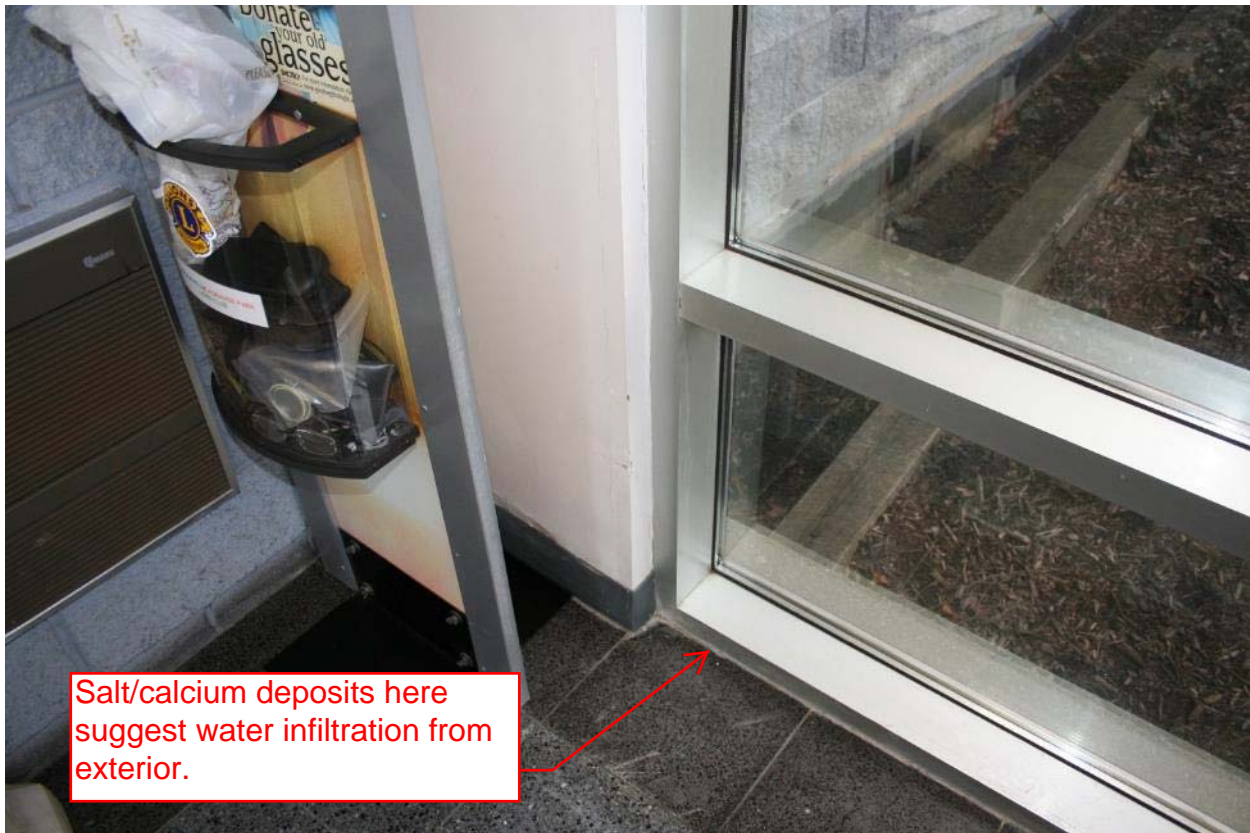
SW corner of the entrance lobby at the west end of the building. Note calcium / salt deposits at the floor line between the tile and window system suggesting water infiltration from the exterior.

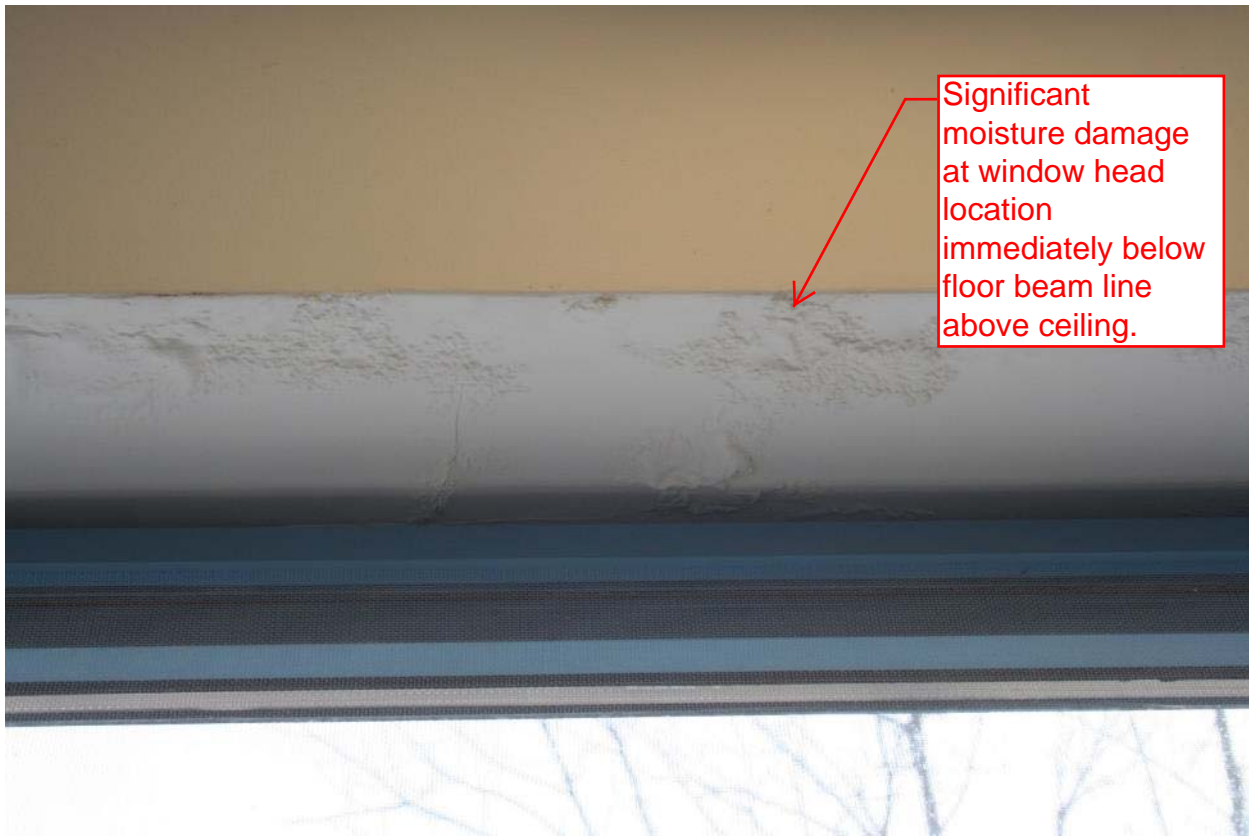
Significant moisture damage at window head location immediately below floor beam line above ceiling.

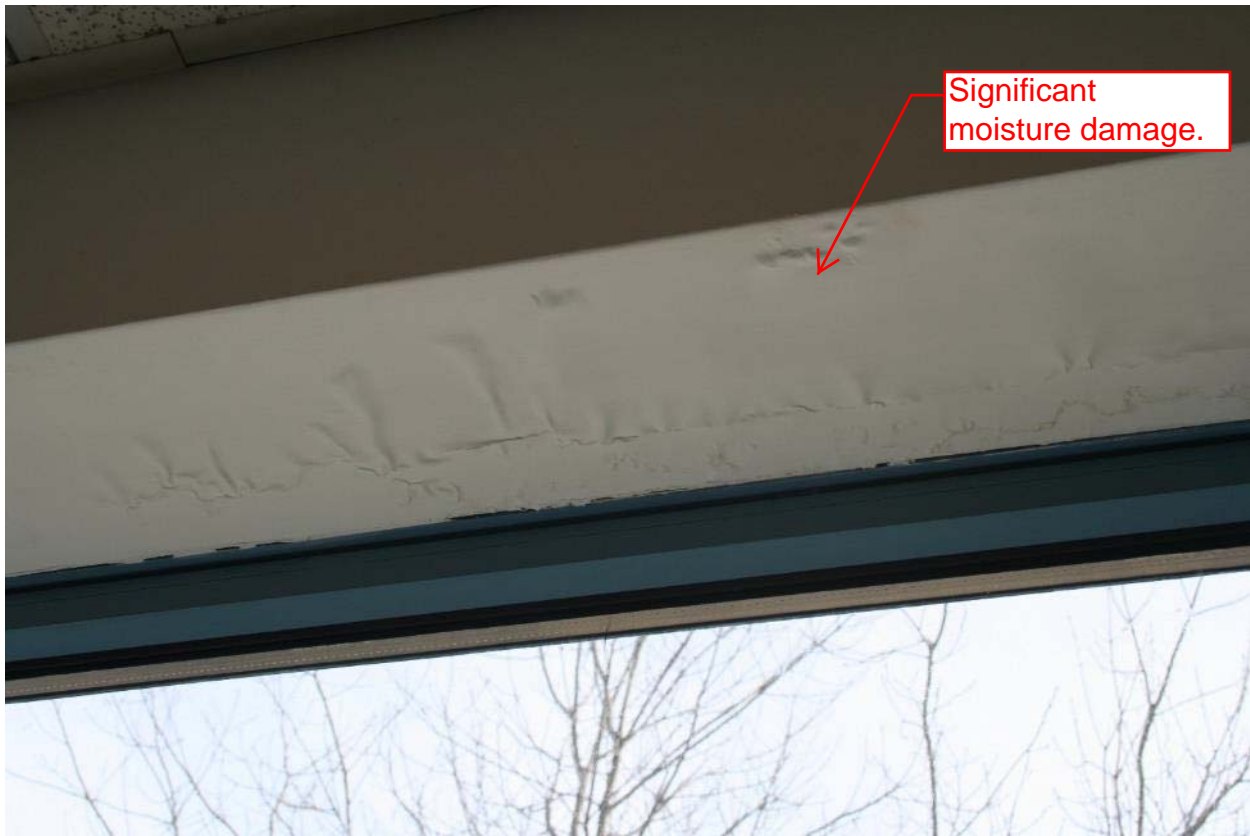
Significant
moisture damage.

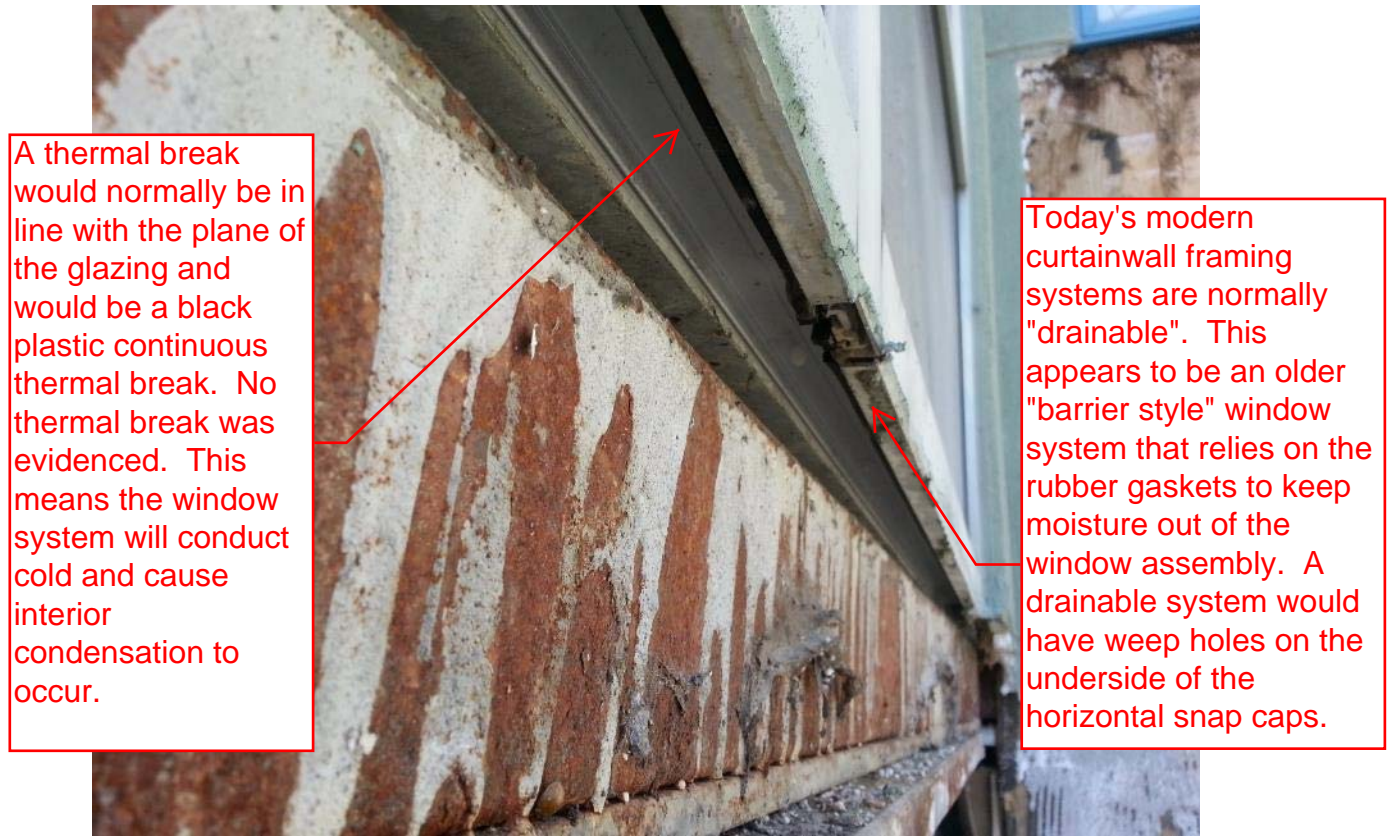
A thermal break would normally be in line with the plane of the glazing and would be a black plastic continuous thermal break. No thermal break was evidenced. This means the window system will conduct cold and cause interior condensation to occur.
