- LaGrange Park Public Library
- Water Infiltration Investigative Study
- April 28, 2015
- July 18, 2015 - Updated
- Kluber Project No. 15-357-960

EXPANDED INVESTIGATIVE STUDY: North & South Facades

Re: Water Infiltration Investigative Study
Additional Services - Report Addendum
North & South Building Façade Review
Kluber, Inc. Project No. 15-357-960

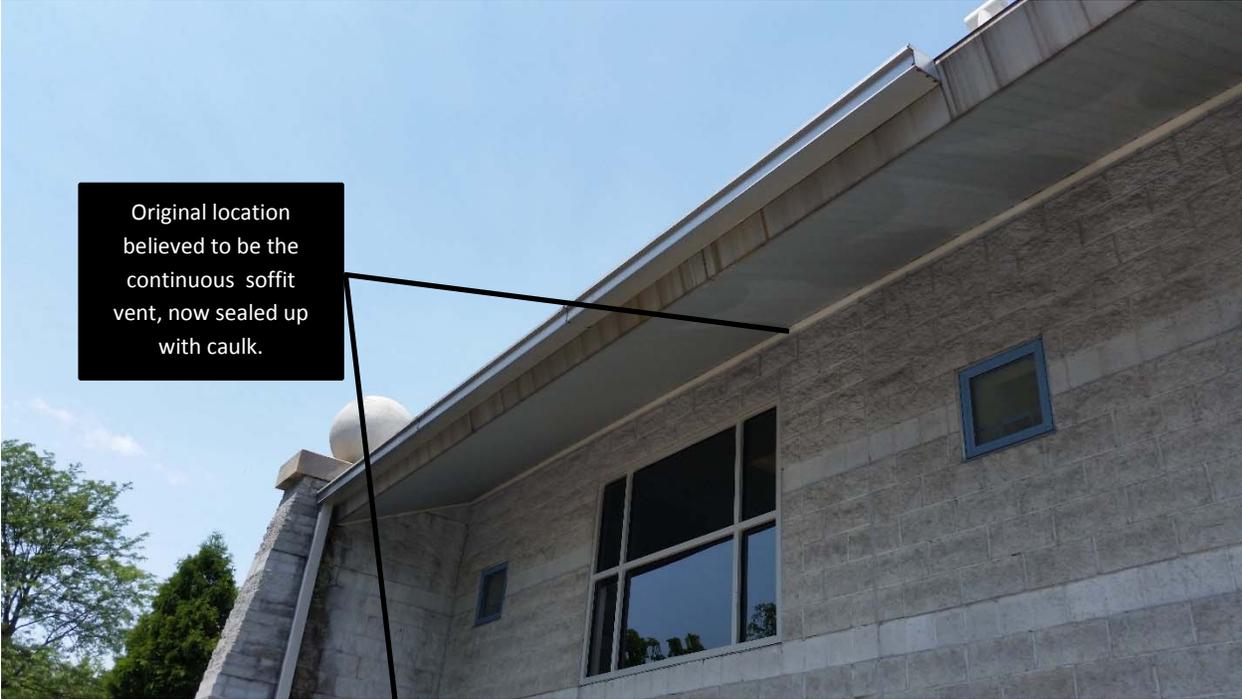
Original location believed to be the continuous soffit vent, now sealed up with caulk.

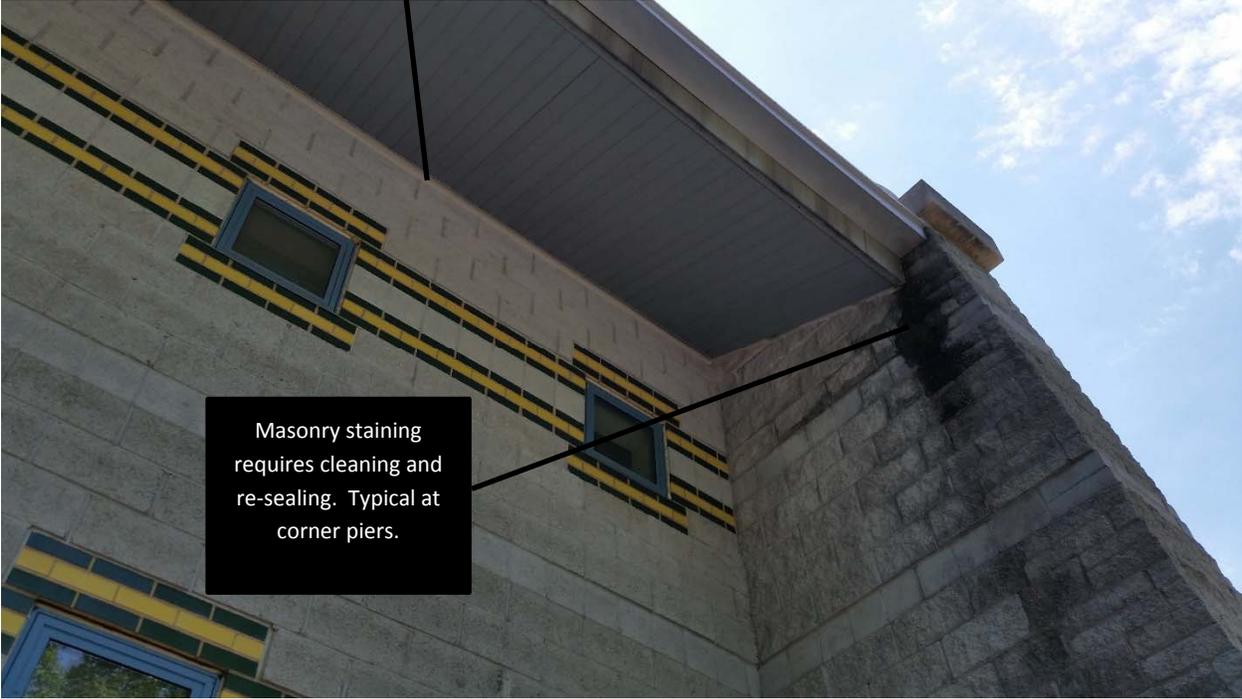
Masonry staining requires cleaning and re-sealing. Typical at corner piers.

At the locations of the buttress walls, excessive organic staining was evident. This is a typical condition at all four corners of the building but more severe at the northern elevations not exposed to direct sunlight as often.

All existing masonry surfaces at the exterior of the building require detergent or chemical cleaning to remove observed organic staining. After masonry surfaces are cleaned. They require the installation of a "breathable sealer" to retard moisture penetration into the wall surfaces. These sealers can be either clear, to maintain the original design appearance or opaque, which would allow the library to change the color of the masonry surfaces. Brick masonry "banding" would not require sealing.

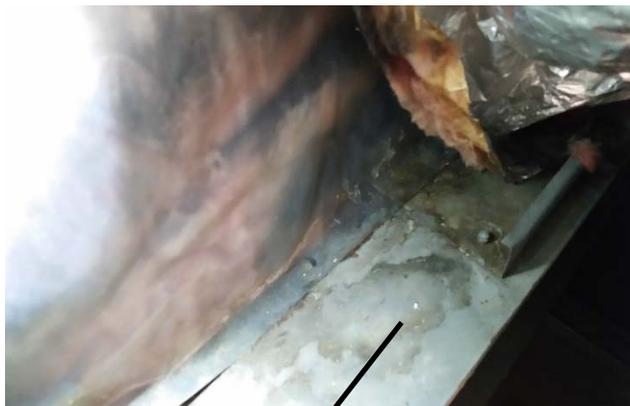
Moisture staining

The photo at the left was taken in the same ceiling cavity at the Library Director's office. Note the moisture stain on the top of the steel beam. This indicates that some moisture build-up is occurring in the wall cavity behind the drywall surfaces. We believe this residual moisture can be reduced by simply making sure the vapor barrier is taped and sealed fully to the steel beams and at all transition points.

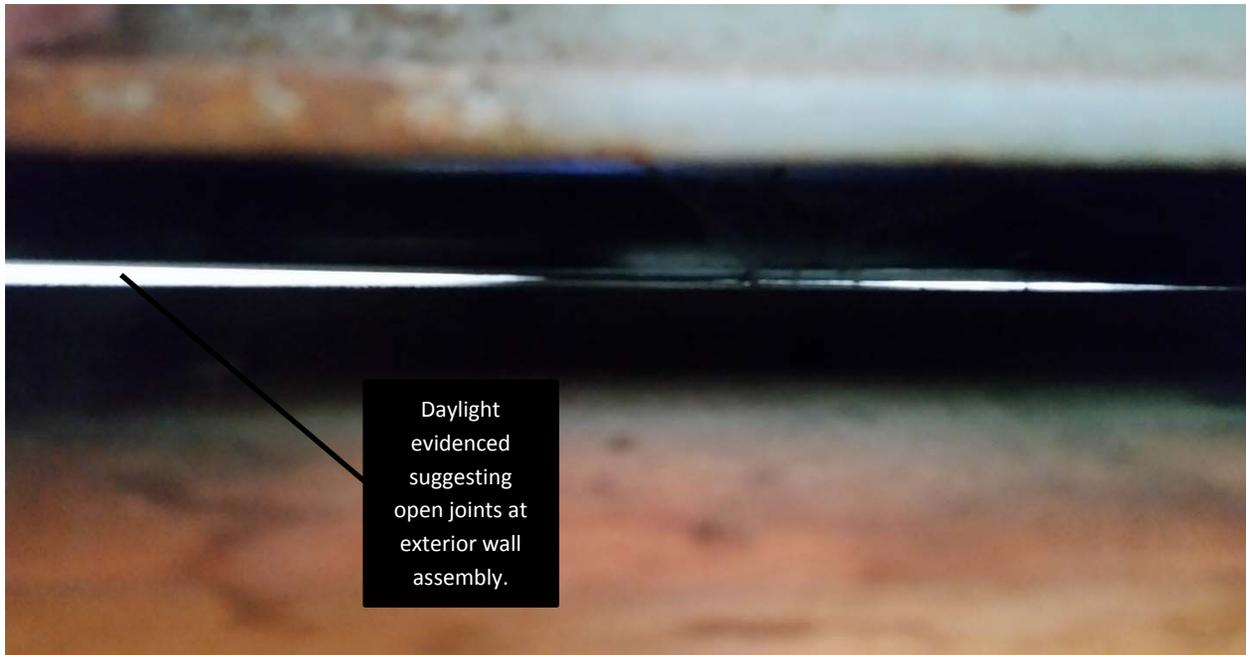
Daylight evidenced suggesting open joints at exterior wall assembly.

This photo was taken at an opening west of the Southeast wall louver that was opened up for inspection. As you can see, we were able to see daylight to the exterior in this photo. This means there is an open joint between the roof line and the sloping shingles that needs to be corrected. The photo below is looking towards the SE active wall louver. Note the significant cracks in the drywall surfaces due to the lack of control joints.

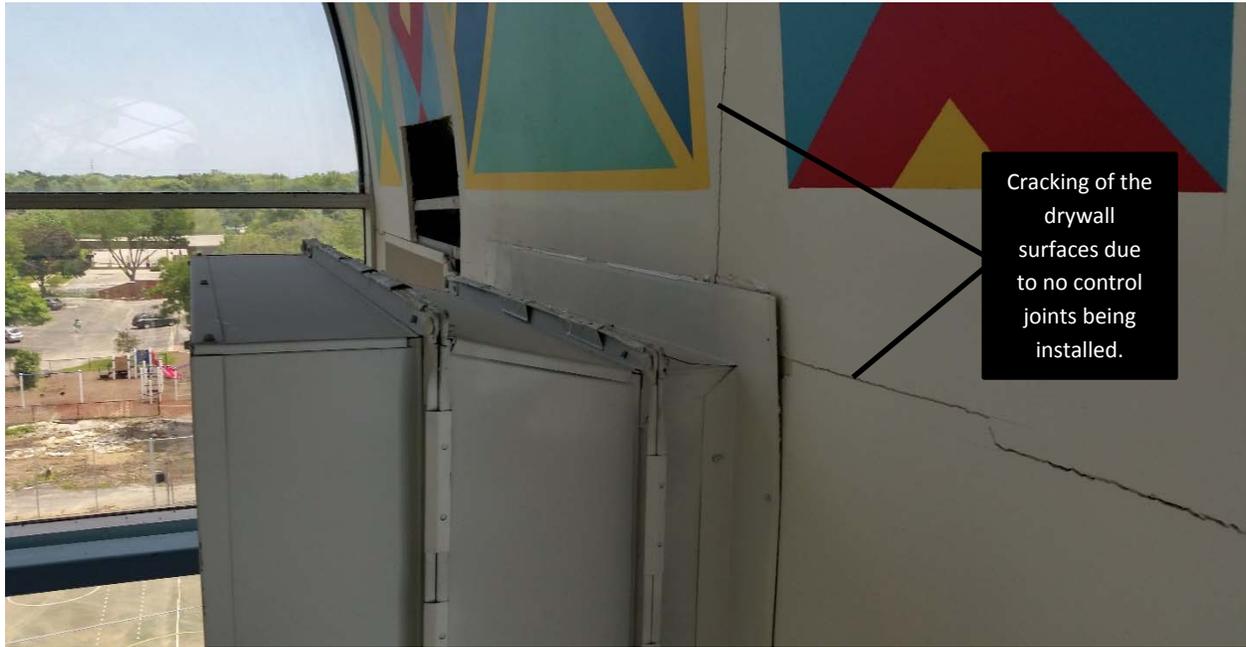
Cracking of the drywall surfaces due to no control joints being installed.

It should be noted that we are recommending additional drywall surfaces be repaired throughout the barrel vault location. Although outside the scope for this report, we have observed that the barrel vault, gypsum board ceiling assembly does not incorporate appropriately spaced control joints as recommended by the national gypsum construction handbook to retard drywall cracking. Normally control joints in this application would be placed at +/- 20 foot intervals following the curvature of the ceiling assembly.

The installation of new control joints in the vaulted ceiling assembly can be accomplished without the need to remove the existing suspended drywall surfaces assuming the metal sub framing was installed parallel to the length of the barrel vault as shown on the original contract documents. The proposed control joints would simply be "cut into" and taped into the existing ceiling assembly. After installation, the entire ceiling would require repainting including the ceiling mural if desired by the library board. Costs for these alternative repairs have been identified separately in Section 10 of this updated report.

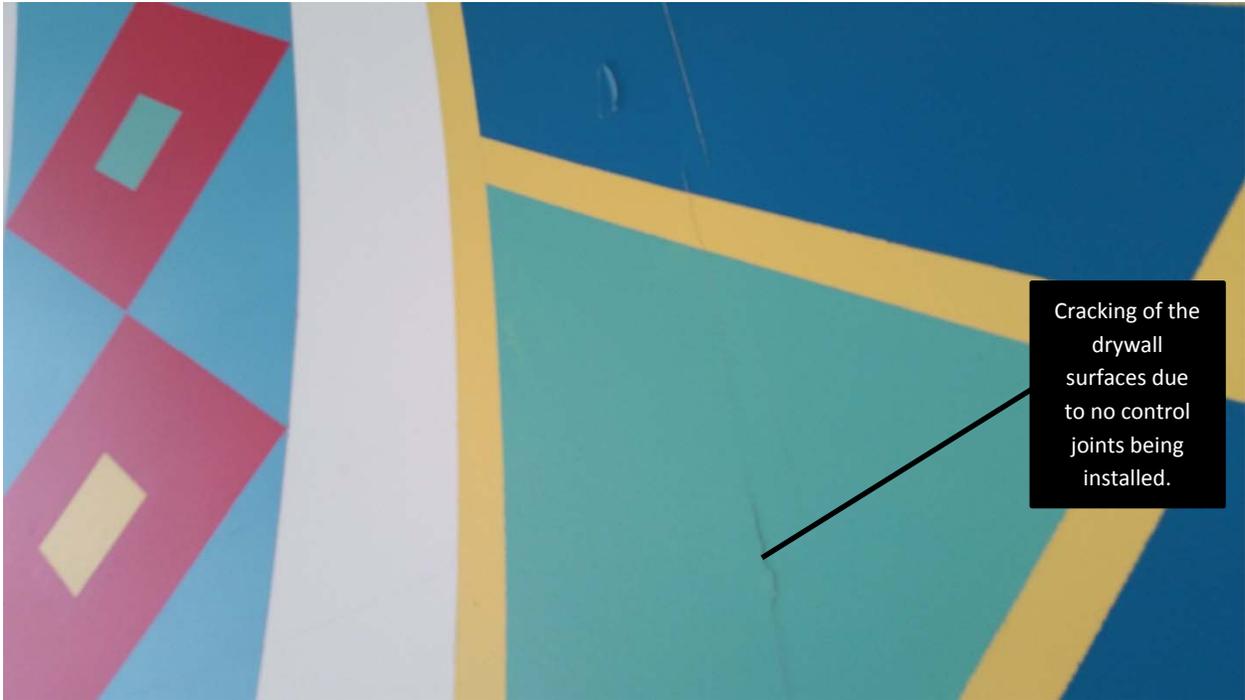
Note additional drywall cracking is forming at additional areas of the vaulted ceiling due to the lack of control joints being placed. Owner should consider correcting this issue. We do not feel this is a result of water infiltration but normal building movement of the materials.

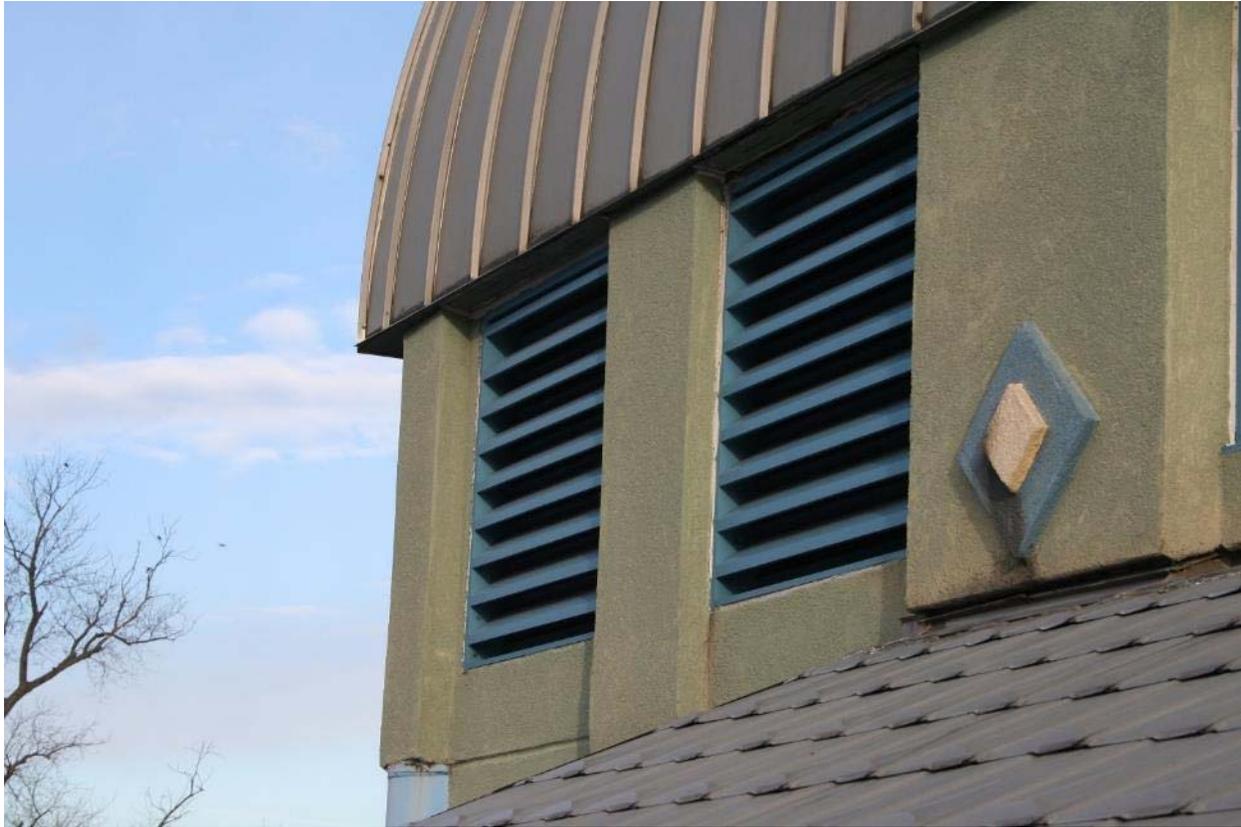
Southwest upper roof location near the louvers. Note that the furthest louver to the west is a "false" louver. On the inside of the building, we confirmed some water infiltration at this false louver location which may suggest that the installation may not be fully weather tight.

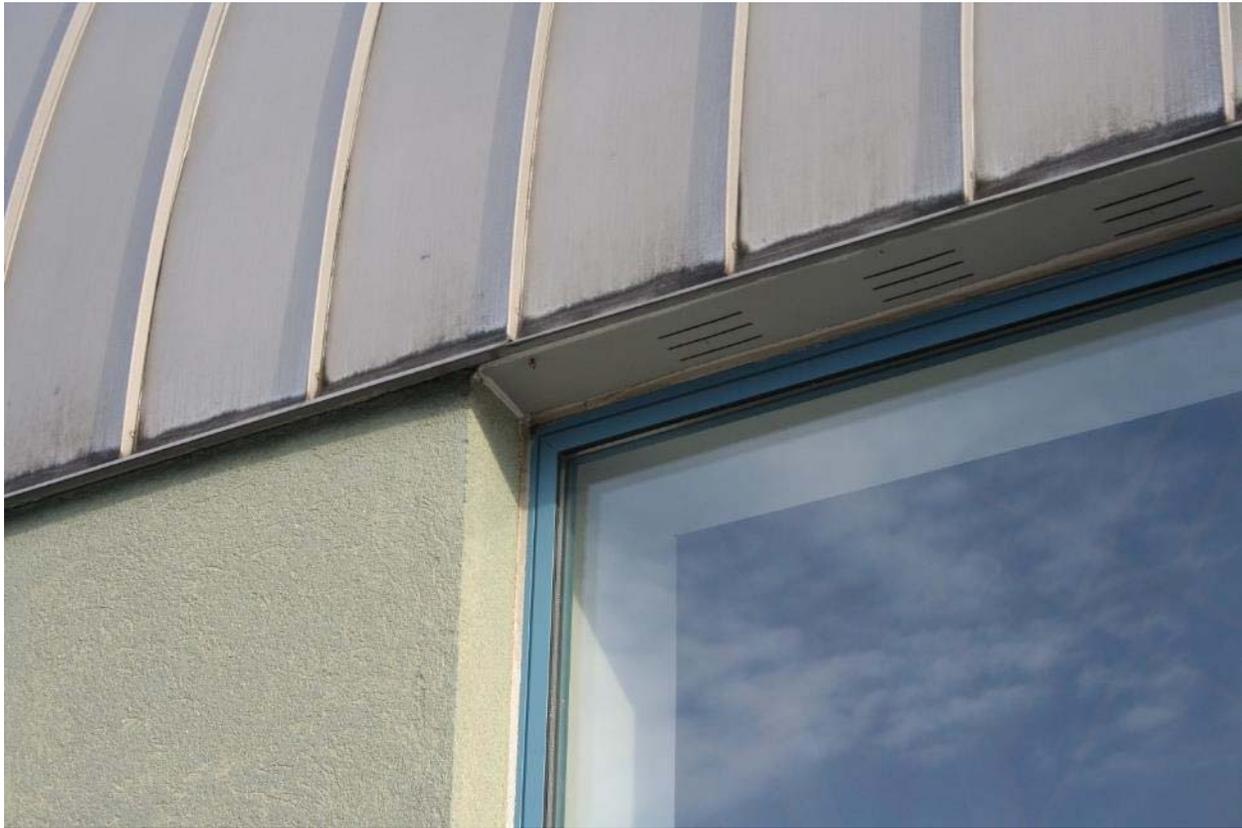
We noted that the clerestory window heads have vented louvers in them. The venting of the underside of the roof decking is common however this condition relies heavily on the proper placement of the inboard insulation materials and a fully occlusive vapor barrier to be installed. Invasive testing noted the interior bat insulation is "inboard" of the venting area and appears to be operating as designed.

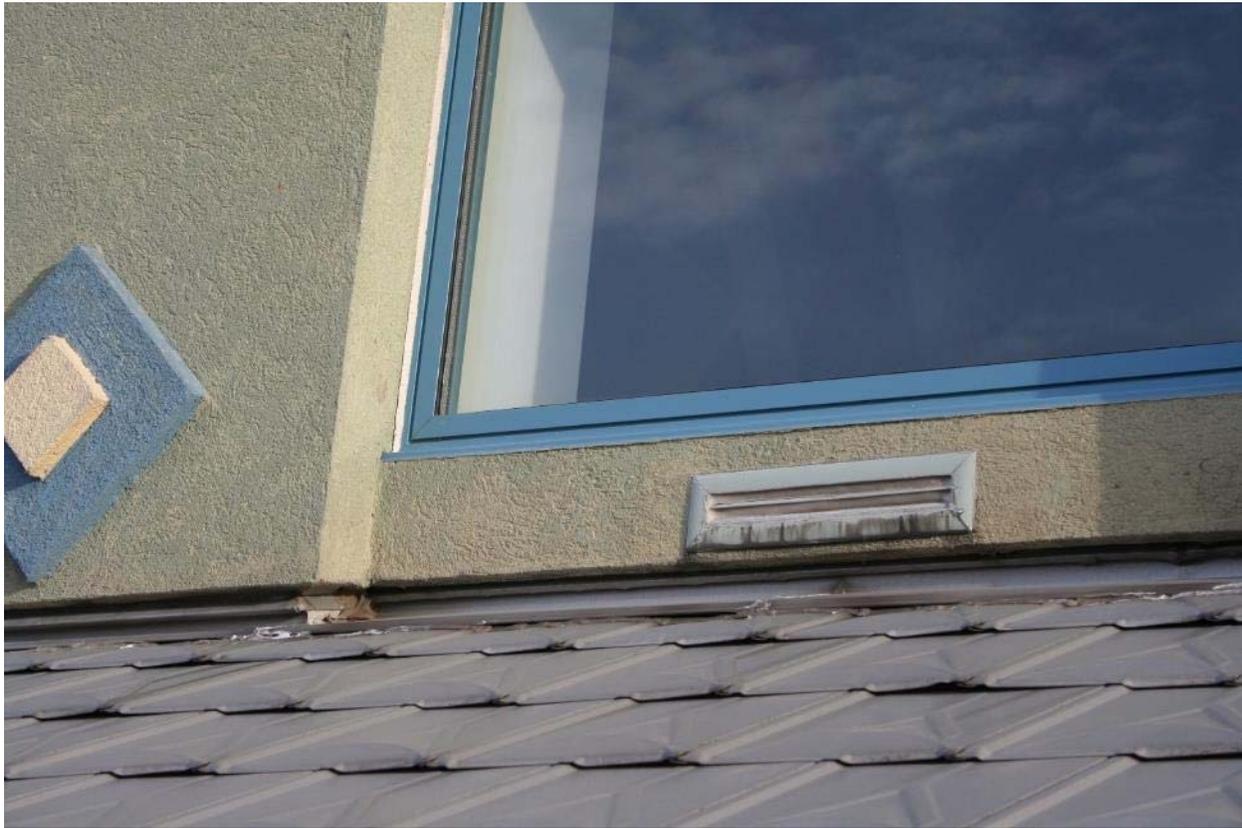
Under window vents at the upper clerestory windows have all been caulked over. We believe the original intent was for this vent to be active venting for the lower shingle roof area. After invasive inspection, we are recommending that these vents be removed and additional roof venting added in the shingle roof sections.

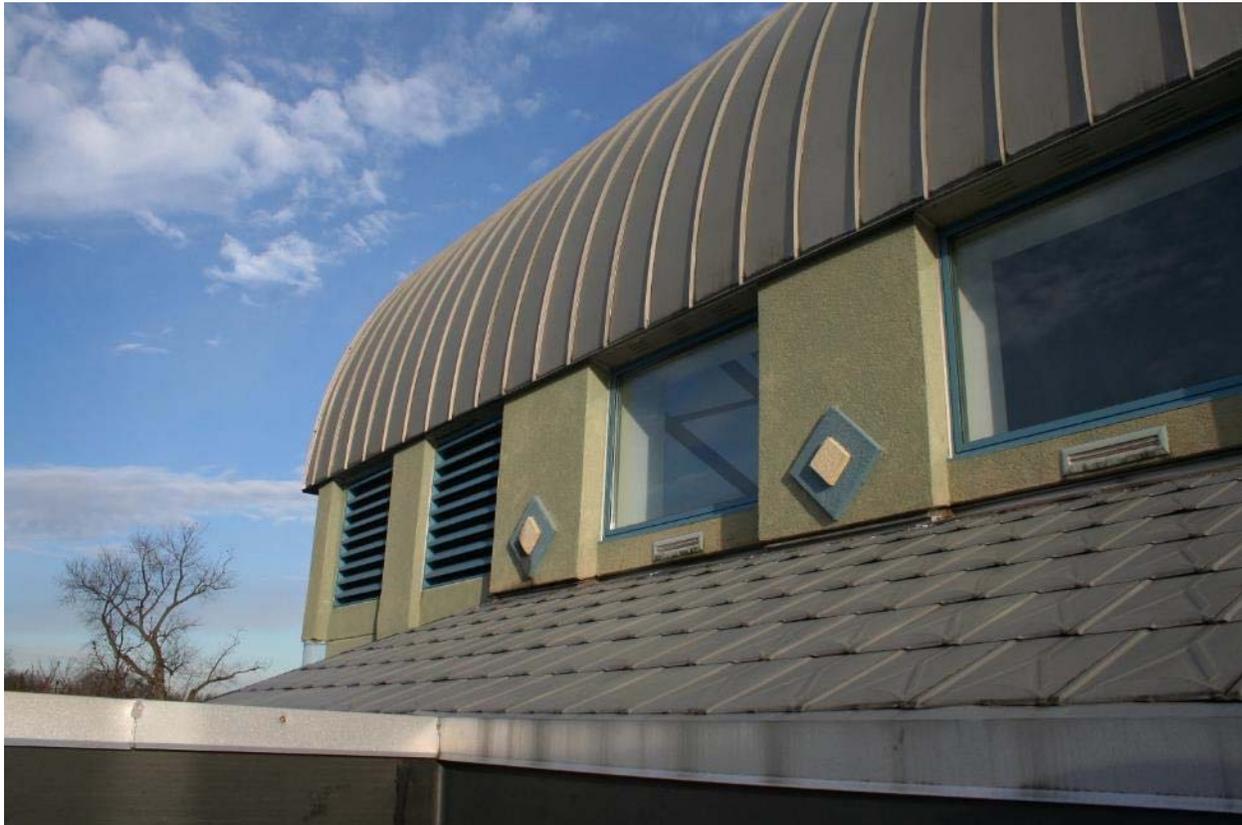
View looking from the SW mechanical roof platform to the SW corner of the building.

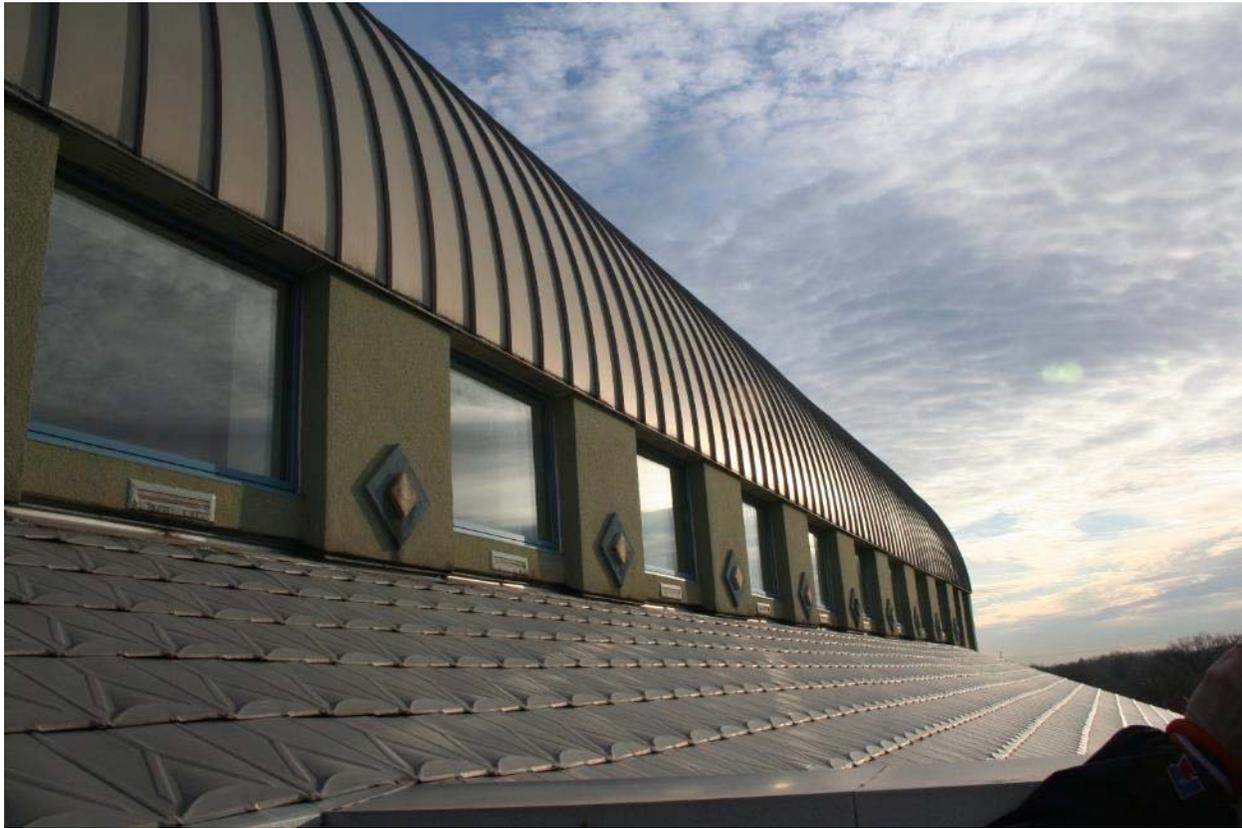
View from the SW mechanical roof area looking to the east. We noted a slight undulation in the roof decking near the east end of the building.

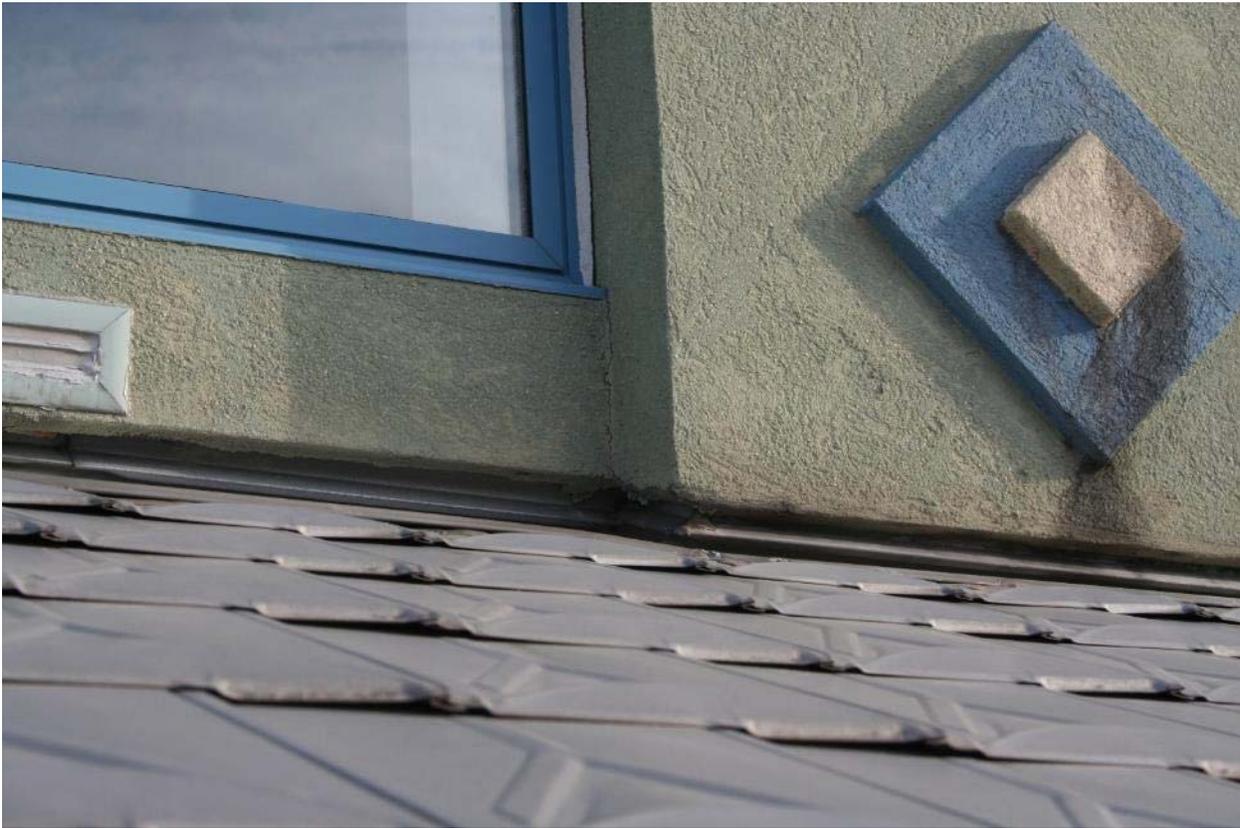
Some cracked open joints are noted at the upper clerestory window, inside corner EIFS locations. Window sealant joints were also observed to have been cracked at several upper window locations.

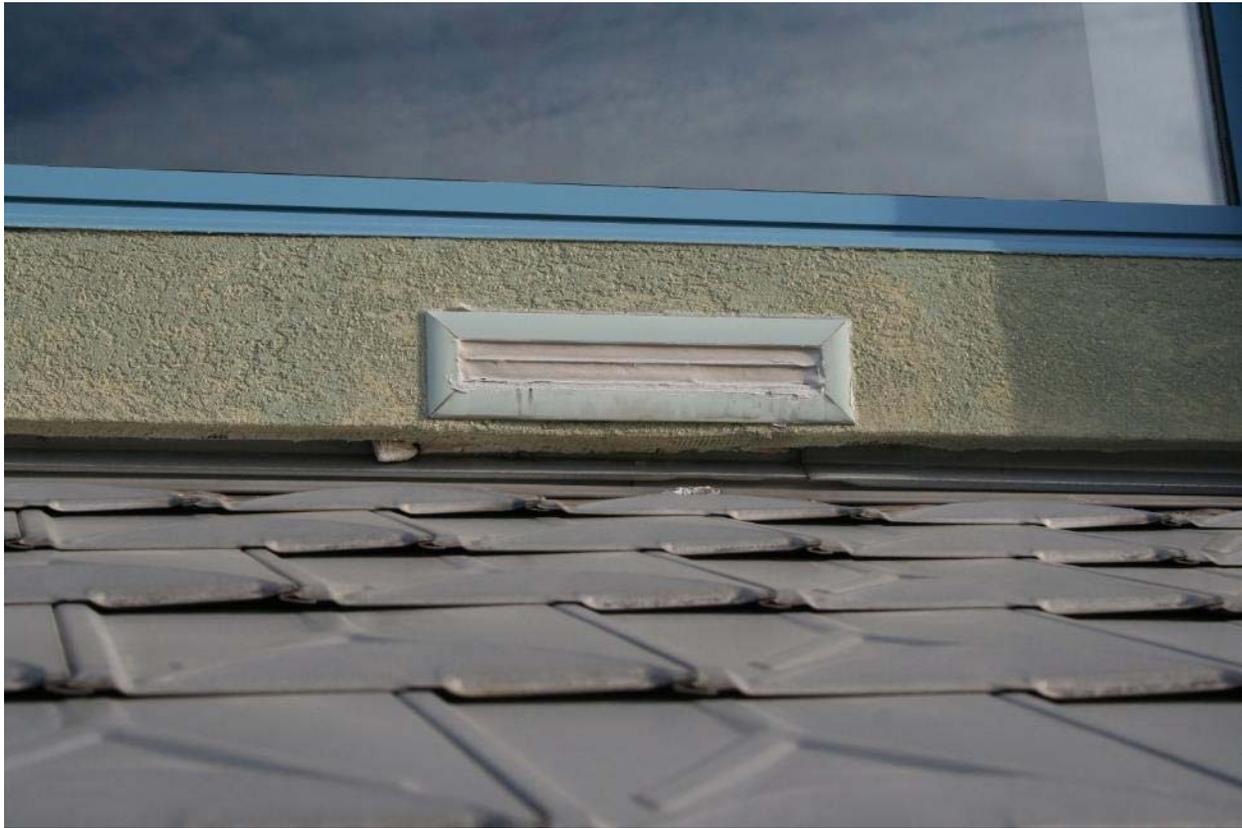
South wall upper clerestory window counterflashing below a window at the sealed in roof vent. Note that some of the EIFS in this location has come loose and did not appear to have been properly back-wrapped with reinforcing mesh.

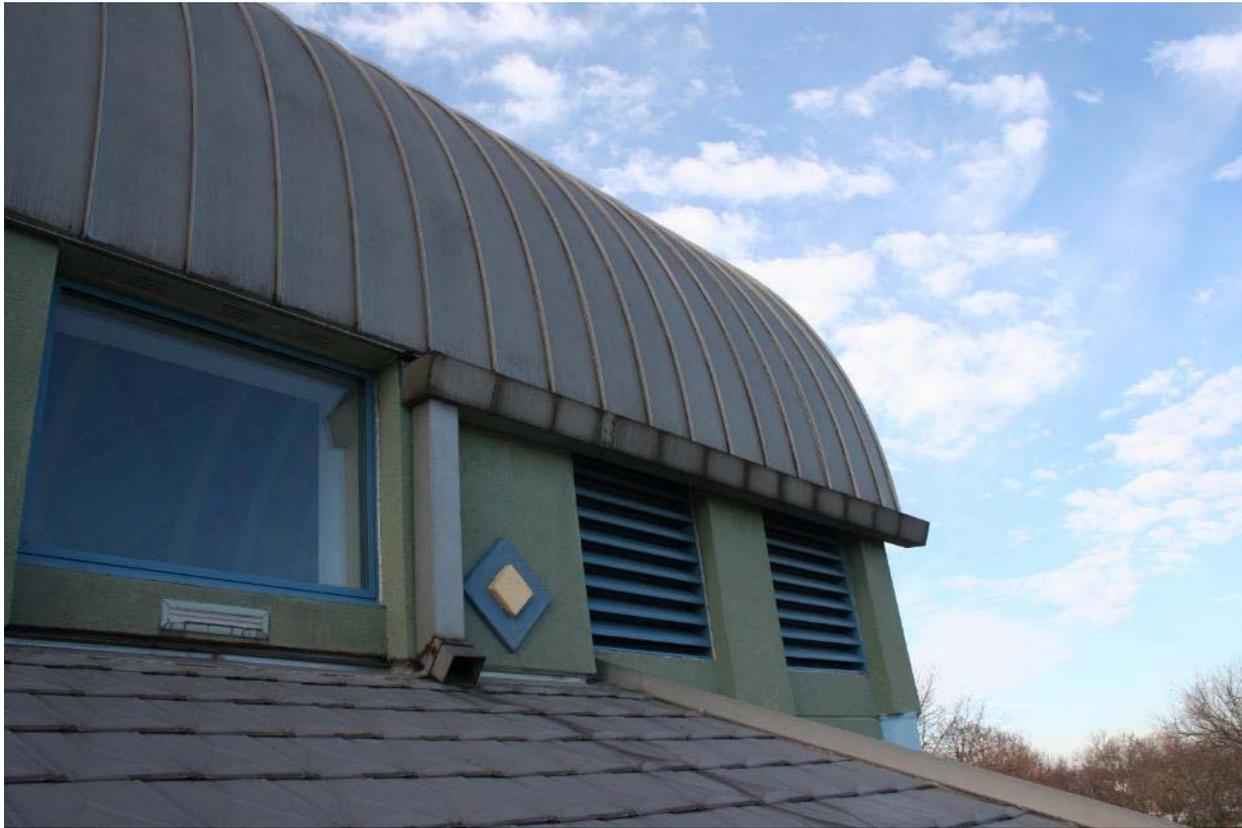
NW mechanical roof platform looking towards the NW louvers. Note the western most wall louver is a false louver that is inactive. Interior moisture near this locations suggests that the wall louver may have been improperly installed.

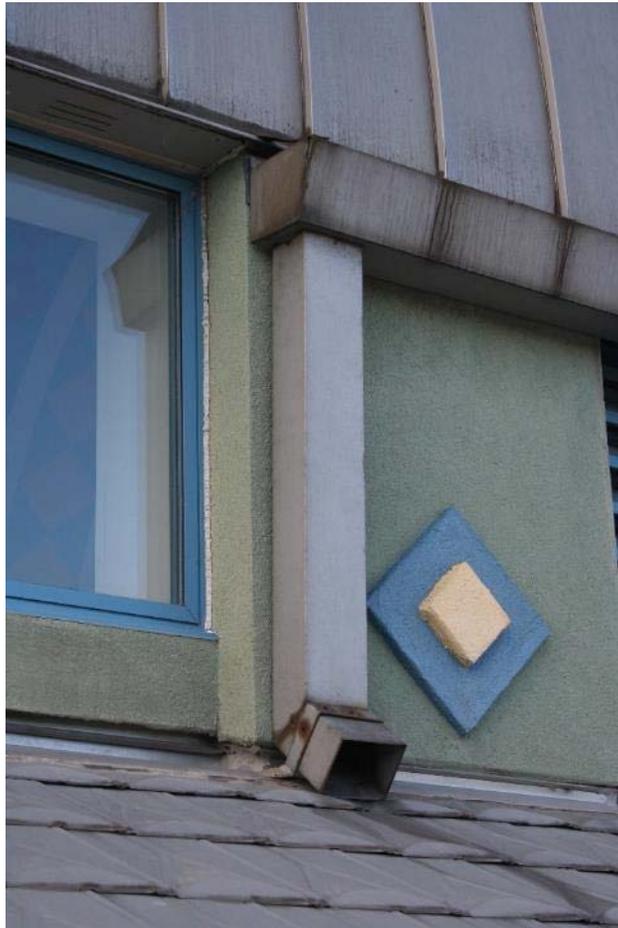
Downspout from upper gutter over main entrance doorway appears in good condition for a building of this age.

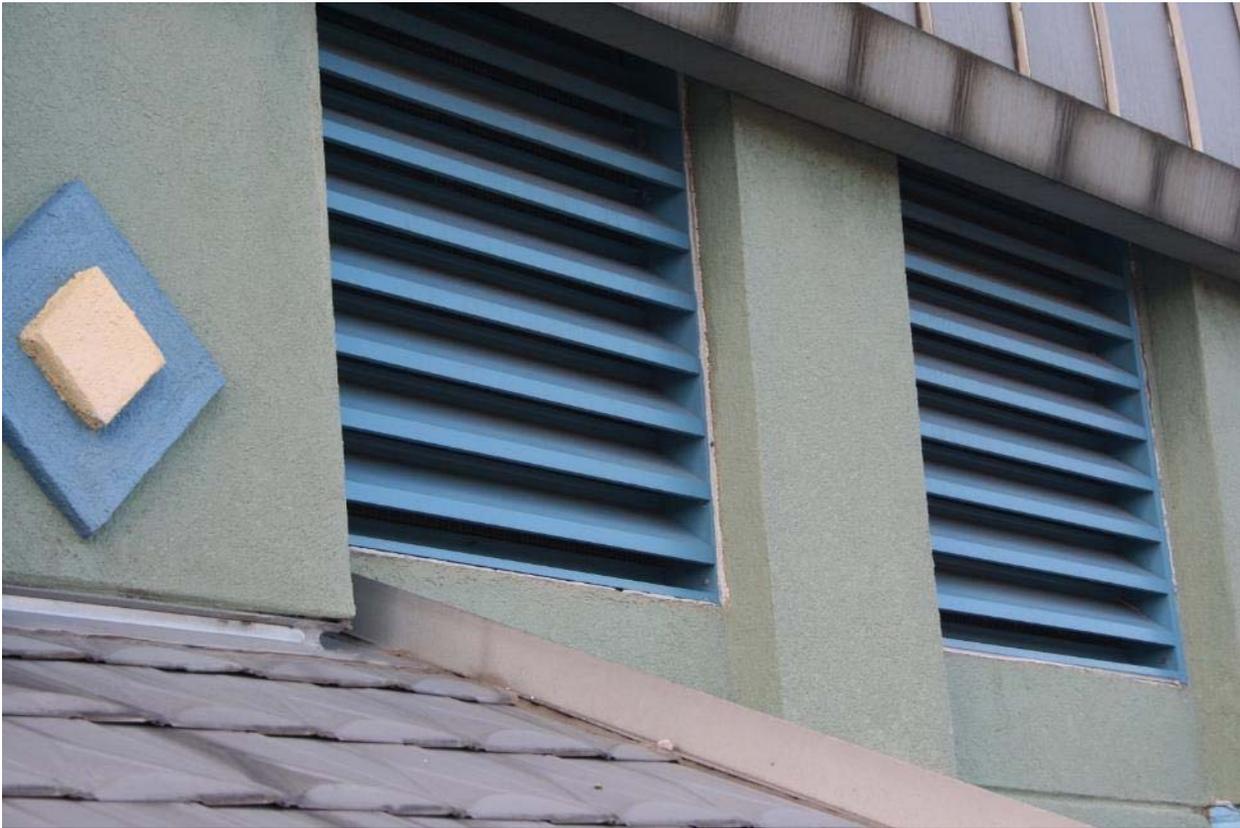
Perimeter sealant joints at the louvers appears dried and cracked and should be replaced. An open joint at the sill of one of the louvers was visible. Invasive testing indicates that the louvers should all be removed and new counterflashings installed to properly drain to the exterior of the building.

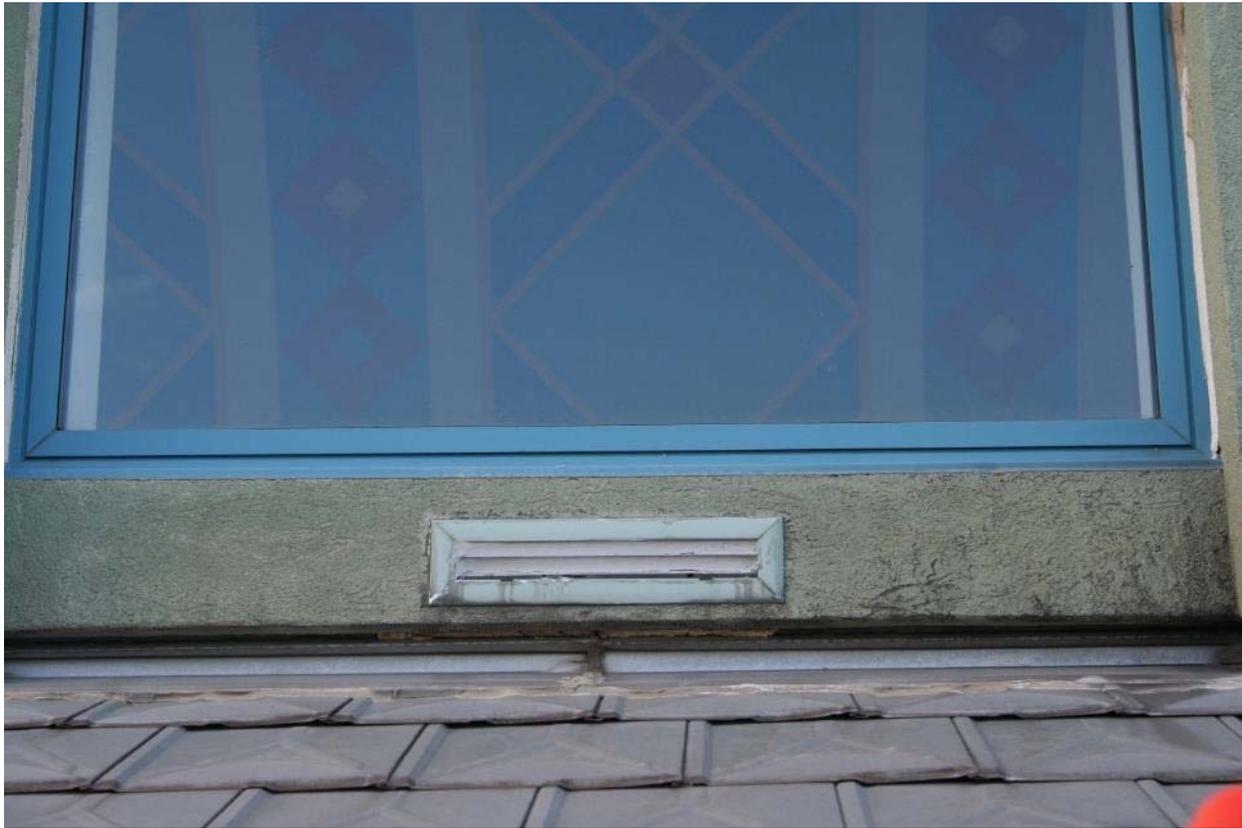
North clerestory window wall venting louver is caulked in similar to all south side louvers. Note the EIFS under the louver appears to have deteriorated as evidenced by the white insulation board that is visible.

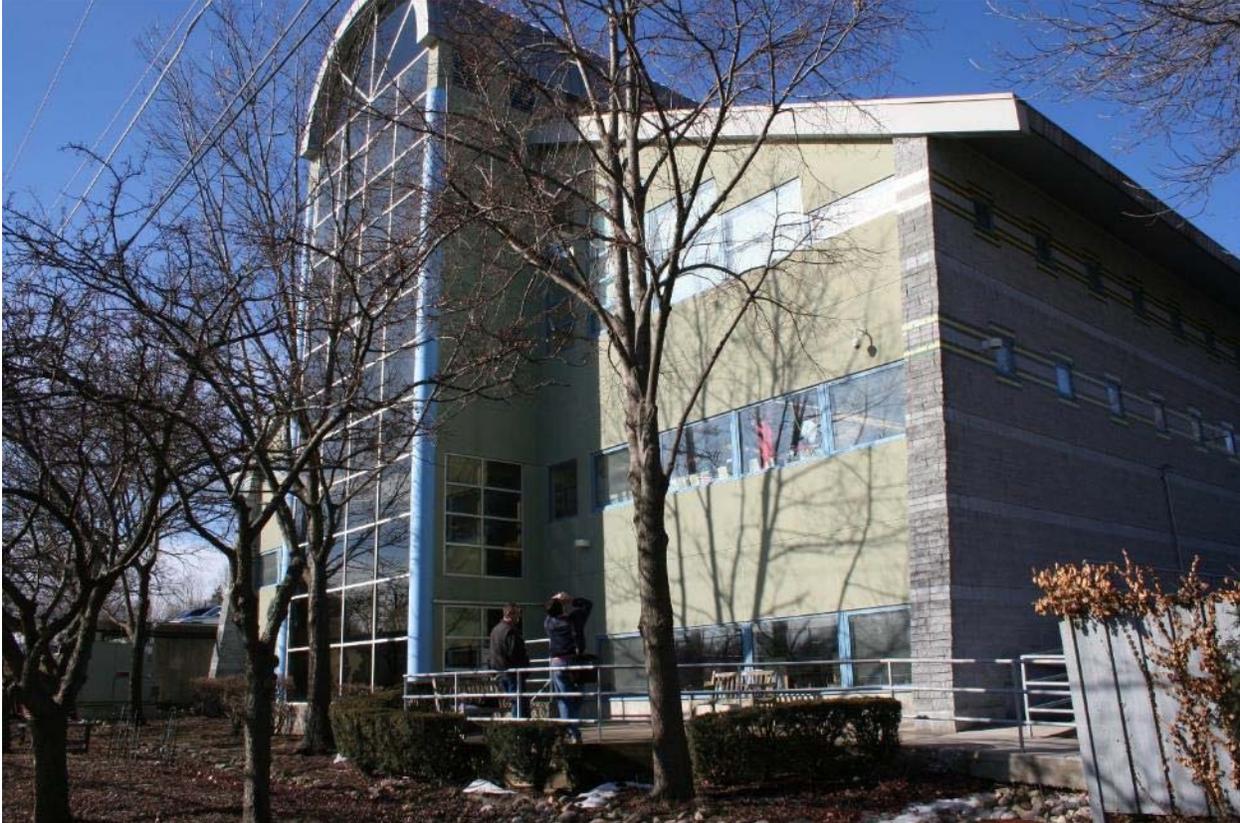
Northeast corner of the building looking towards the split face CMU and clay unit masonry accent bands. Masonry units in this location were found to be soiled and appear to need to be cleaned and re-sealed to prevent moisture penetration.

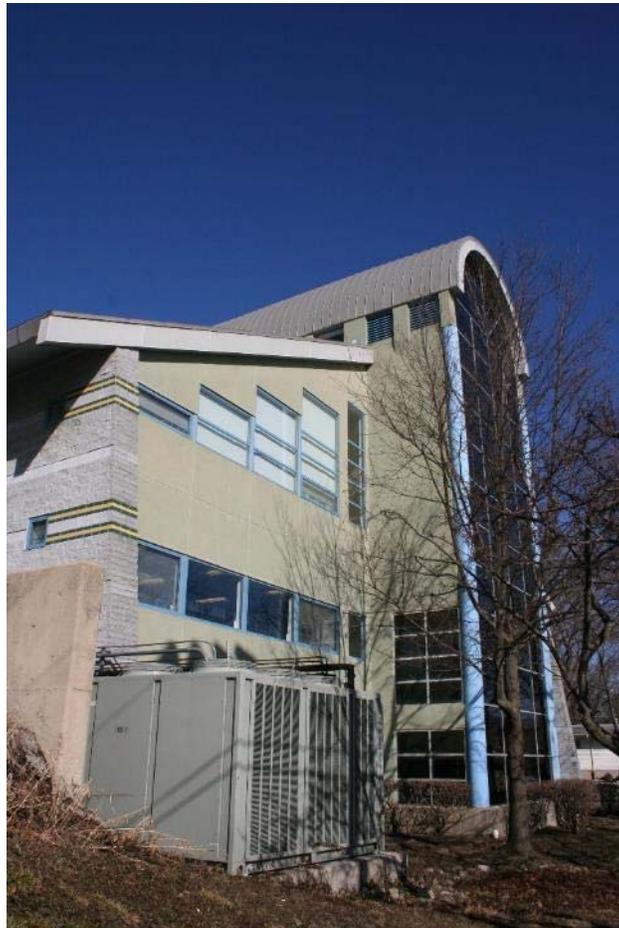
East façade looking towards the SE corner of the building. Note the split face and clay unit masonry is beginning to discolor at this location as well and will require cleaning and sealing to prevent water moisture penetration.

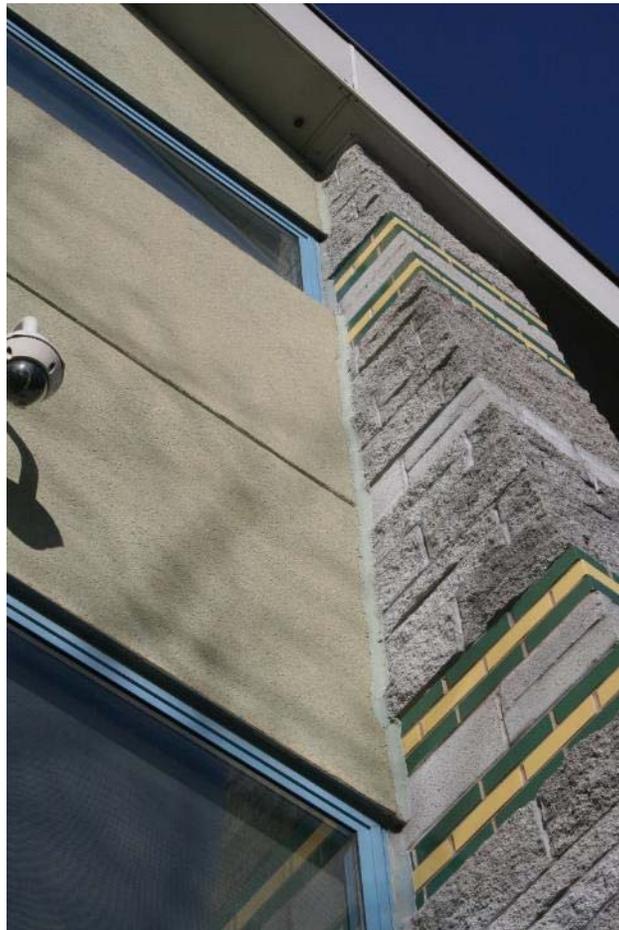
NE corner of building EIFS / Windows to masonry condition for reference. Note staining on the split face block that needs to be cleaned.

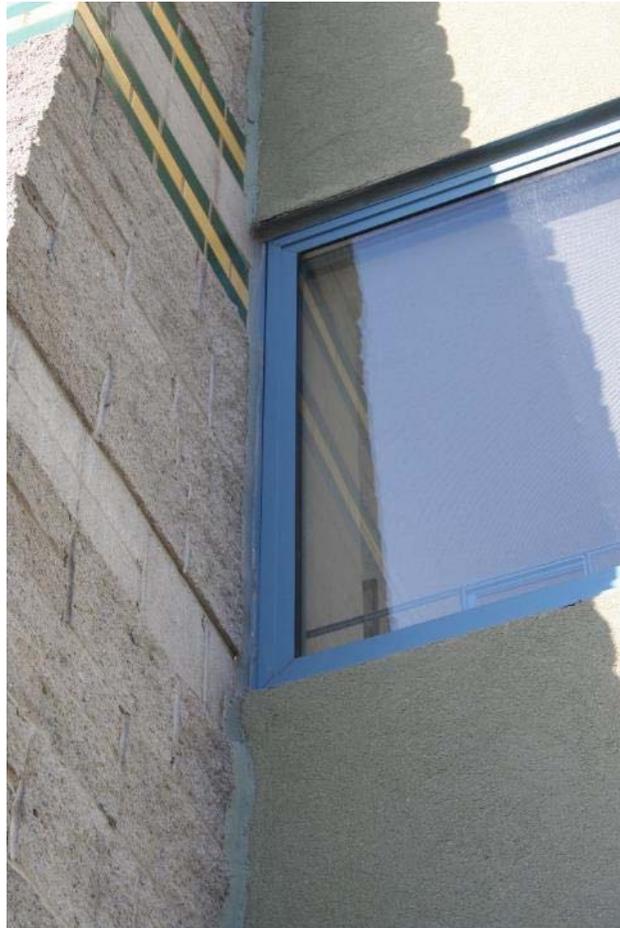
SW corner at first floor operable windows. Note combinations of split face block, smooth face block and clay unit masonry.

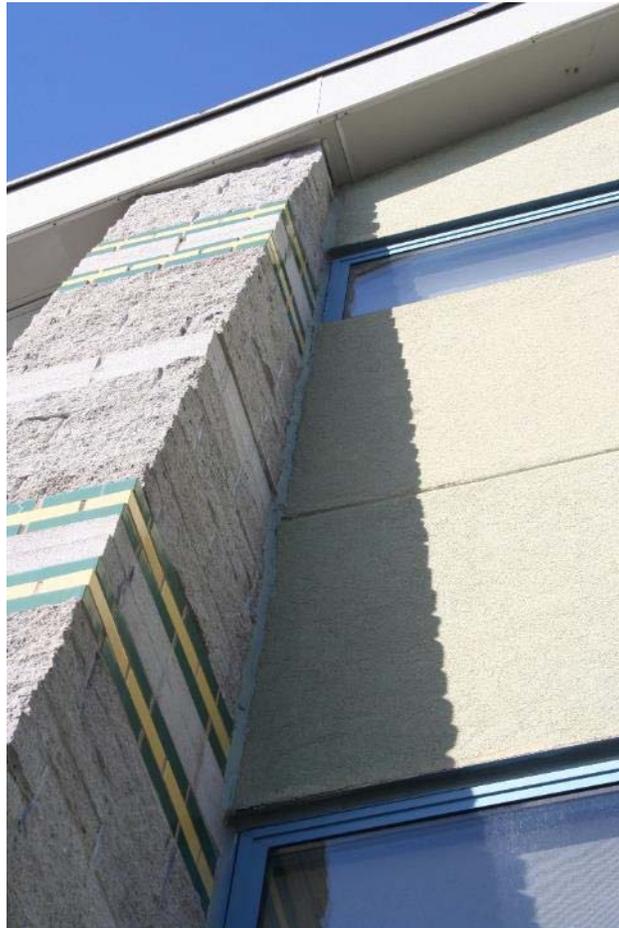
SW corner of building looking up at second floor windows. A few masonry cracks were observed in the smooth face concrete masonry units.

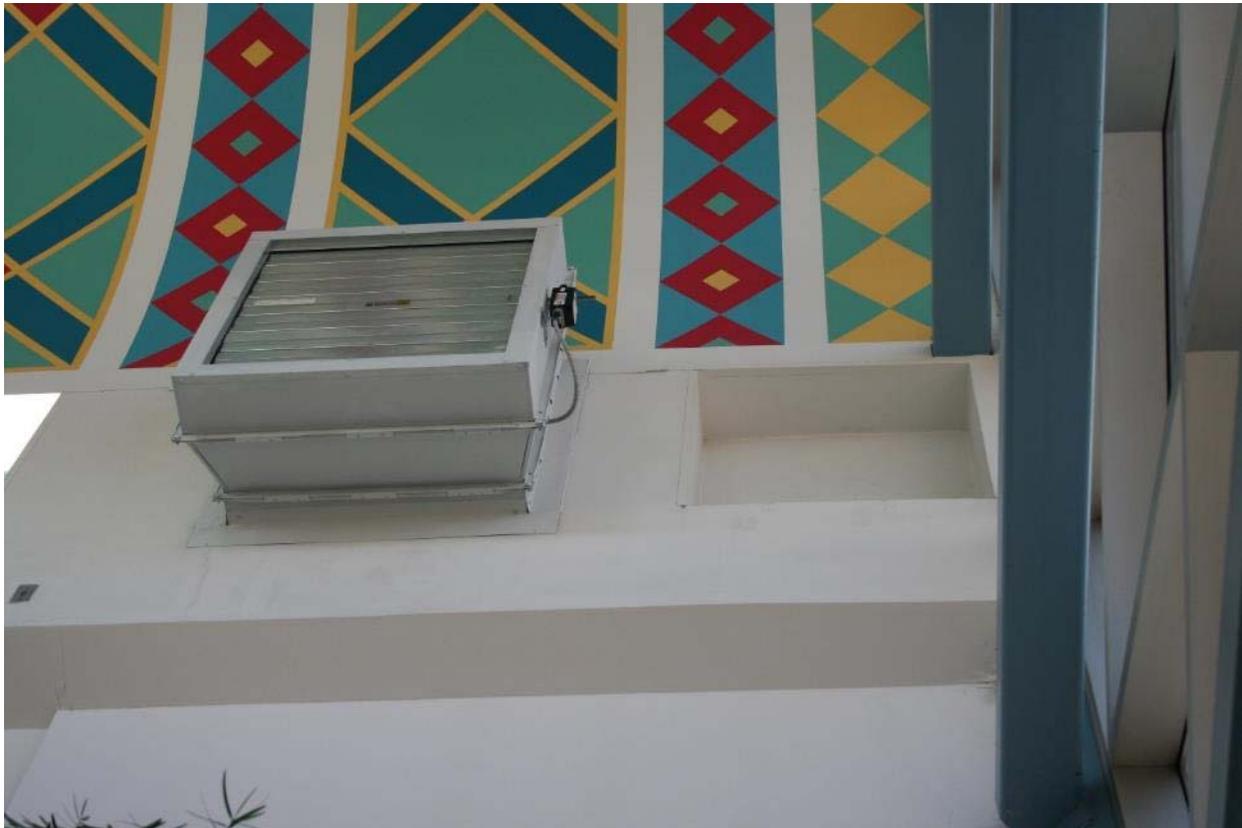
SW barrel vault condition near the louver location. The "false" louver is on the outside of the building at the location of the recessed drywall box-out. Note the water infiltration occurring at this location and drywall cracking occurring at various locations. Invasive inspection at the SE false louver suggests some water infiltration at this location.

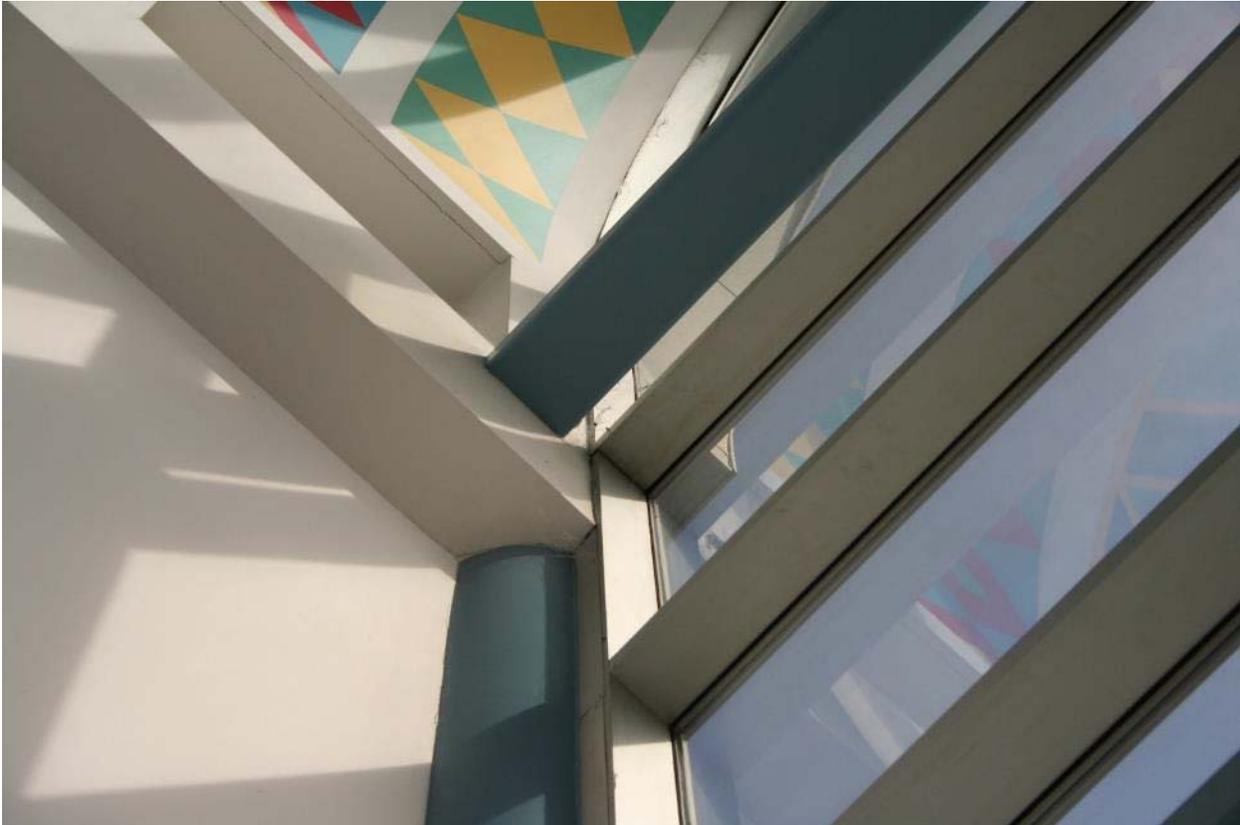
A view looking up from the second floor towards the SW round steel column. Note the cracked corner bead at the recess leading to the false louver at the exterior and some moisture damage to the drywall near the column to beam location. Excessive drywall cracking at the length of the barrel vault was evident and needs to be repaired.
