- LaGrange Park Public Library
- Water Infiltration Investigative Study
- April 28, 2015
- July 18, 2015 - Updated
- Kluber Project No. 15-357-960

EXPANDED INVESTIGATIVE STUDY: North & South Facades

Re: Water Infiltration Investigative Study
Additional Services - Report Addendum
North & South Building Façade Review
Kluber, Inc. Project No. 15-357-960

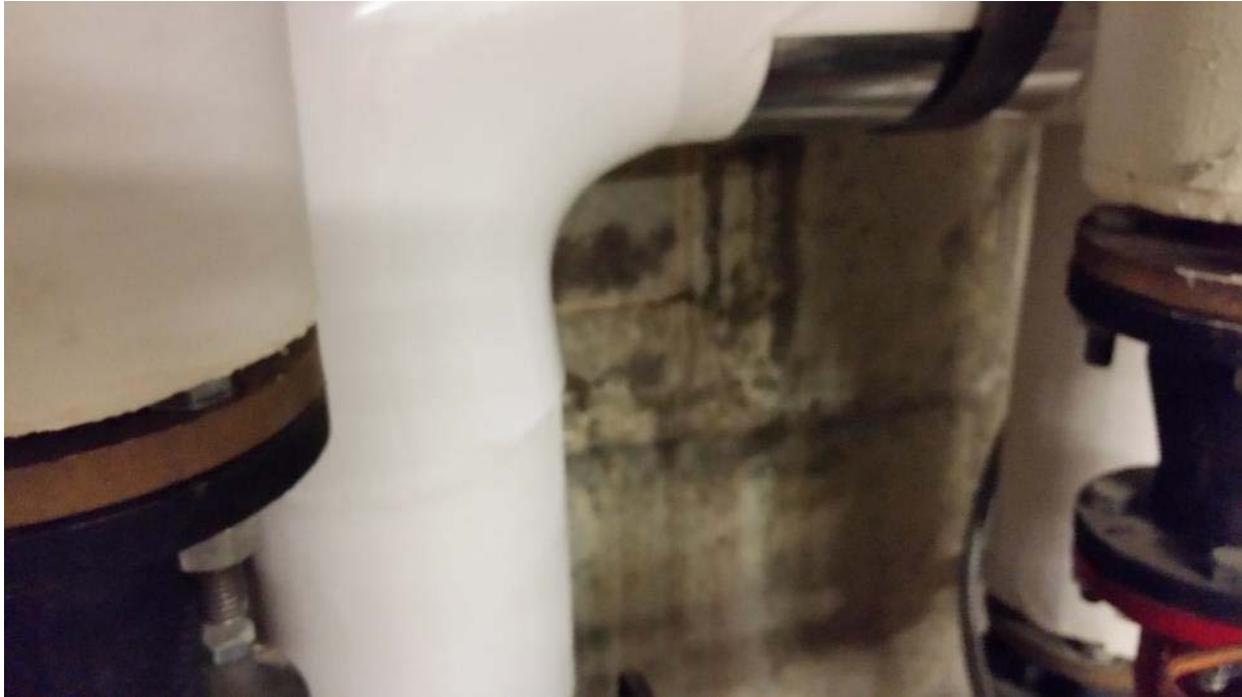
A view at the basement mechanical room near the fresh air intake louver system. Note some moisture evident at the area well leaching in from the exterior.

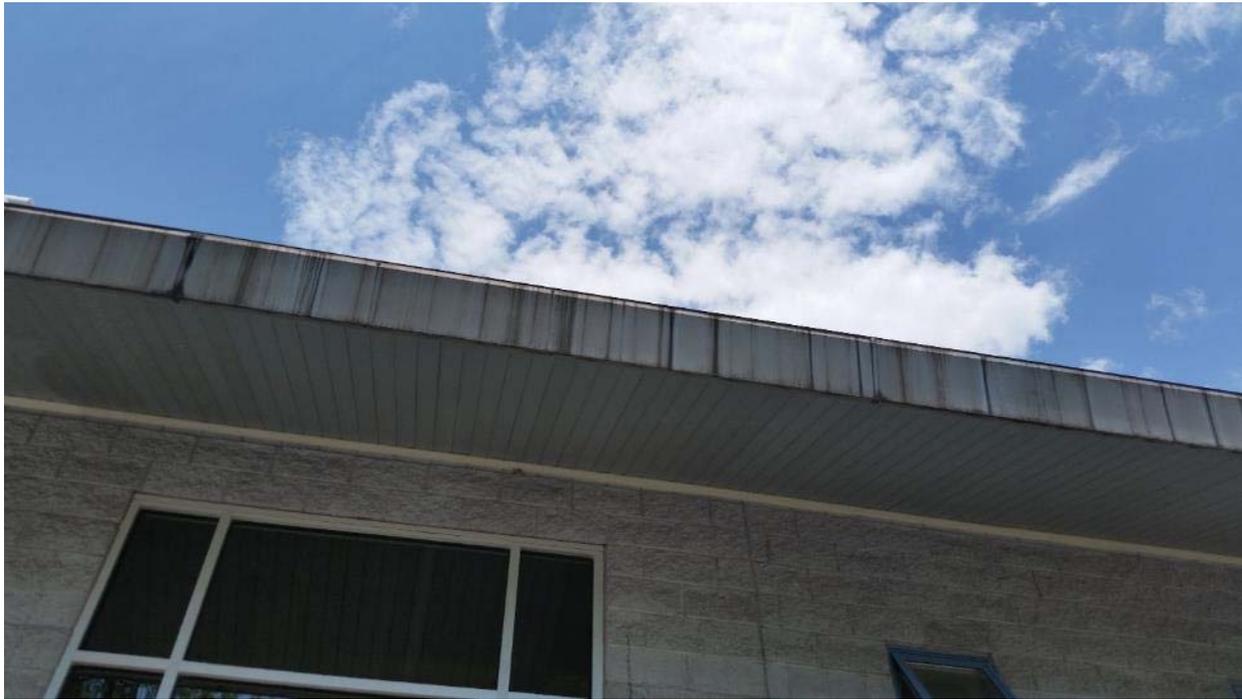
A view of the south elevation looking up towards the roof overhang. Note some staining of the fascia's is common for this building material. Also note the large sealant joint at the top of masonry wall condition. This joint may have been the location of the original soffit venting however the original drawings are vague if soffit vents were called out at this location.

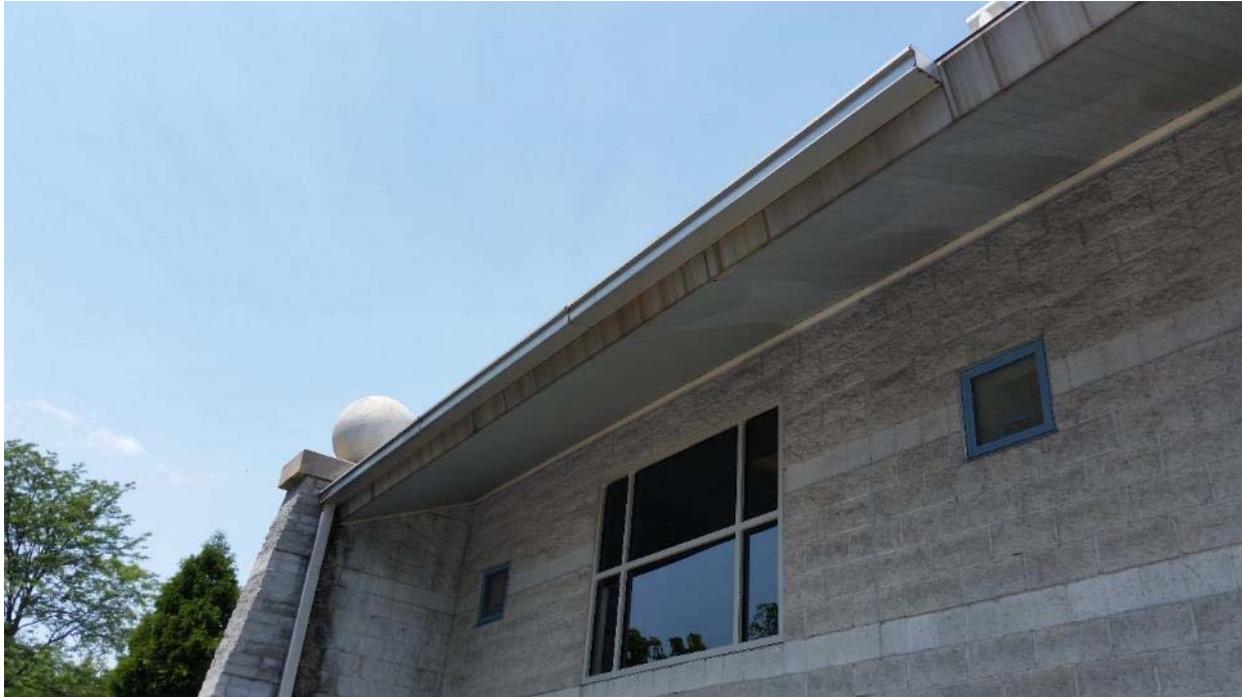
View looking towards southwest corner of the building. Note the excessive staining at the masonry pier locations near the downspout connection. This staining is believed to be organic deposits that should be easily cleaned with detergent based cleaning solutions.

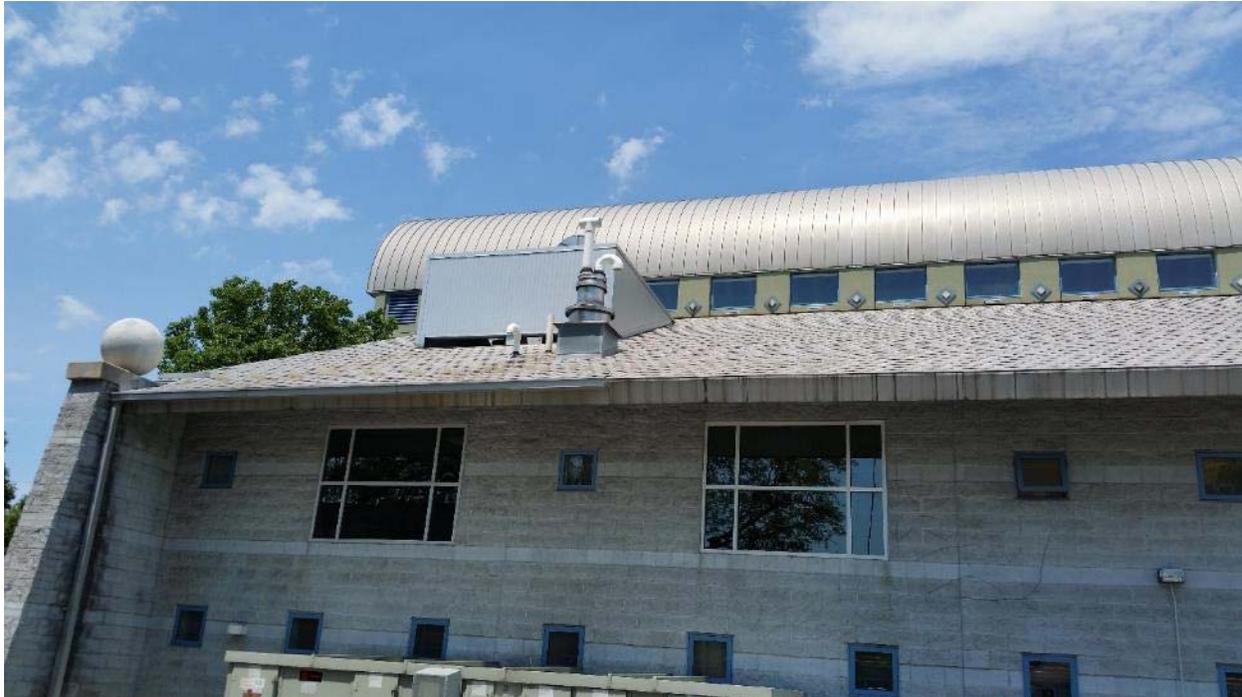
South elevation looking towards the roof areas and the south mechanical well. Note the staining of the split face concrete masonry units.

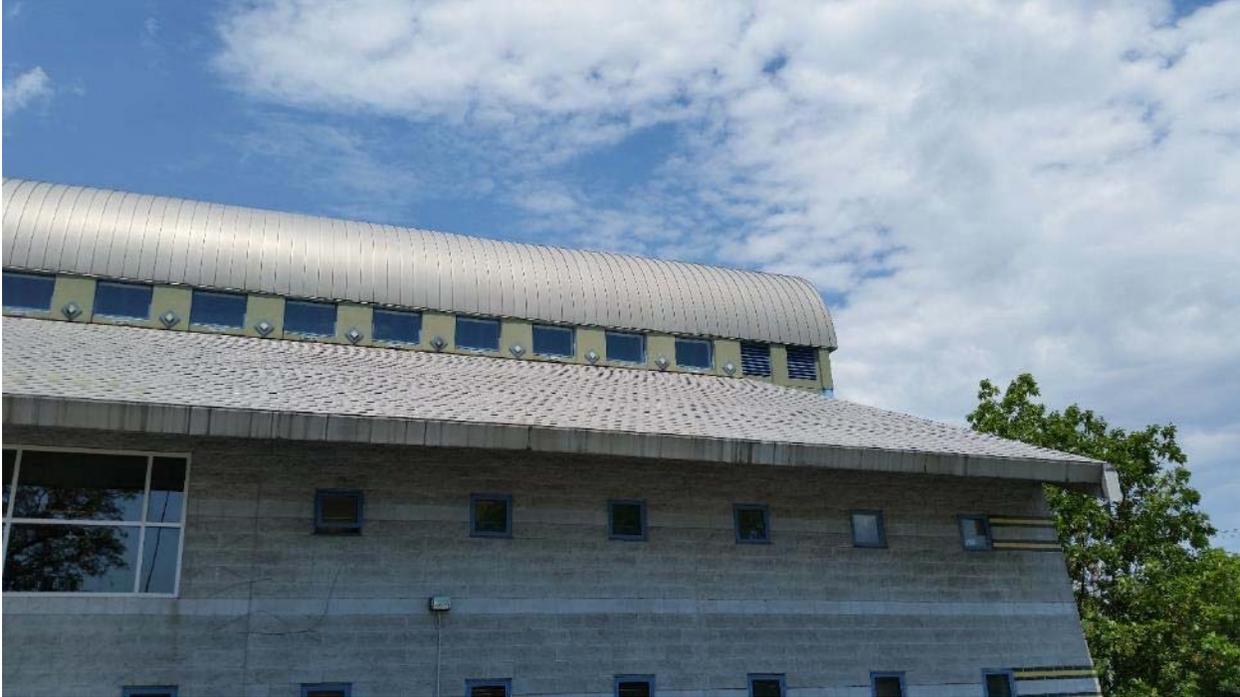
A view of the south elevation looking towards the southeast corner of the building. Less masonry staining evident at this location.

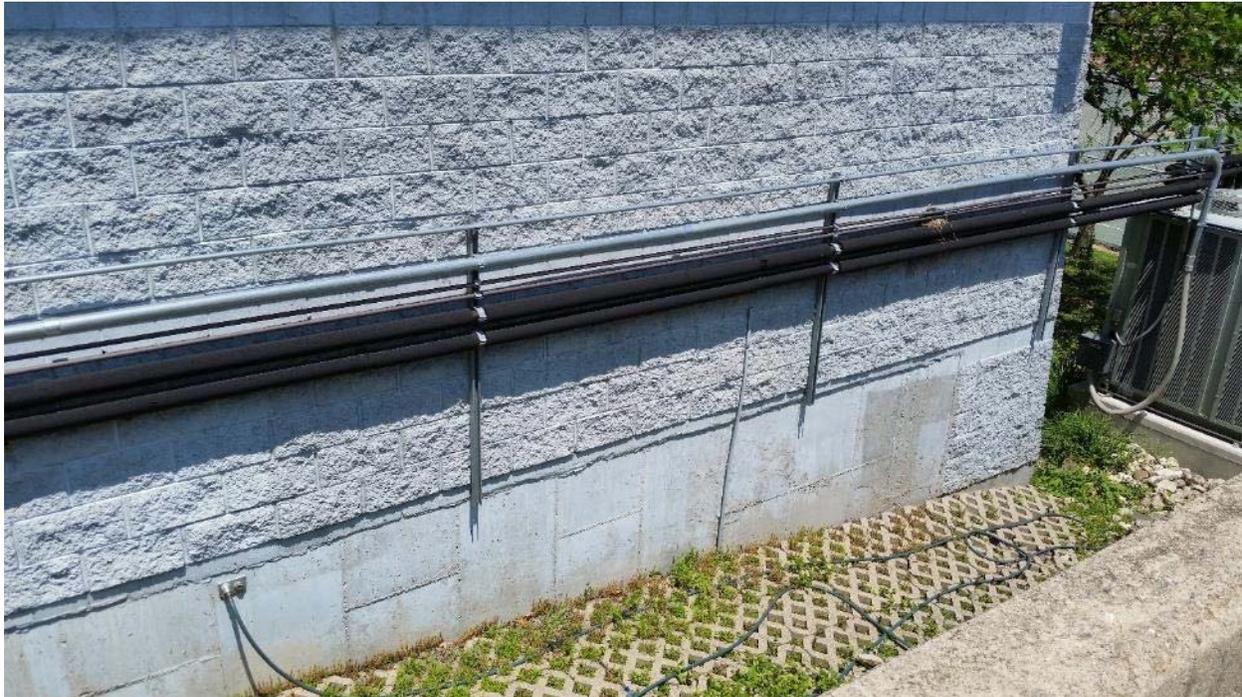
South wall at southeast corner foundation. It appears that masonry thru wall flashing or weep vents have not been installed as commonly found at the lower level of the masonry wall systems at the north and south elevations. This is an unusual condition for masonry cavity wall construction.

The larger masonry concern is the current installation at the base of the masonry wall surfaces placed immediately on top of existing concrete foundation wall systems. No visible thru wall flashing was observed nor were weep holes. These two products are designed to shed water out of the masonry wall cavity and away from the building. Although water infiltration at the base of the masonry wall systems was only observed at the basement mechanical room exterior wall louver, the Library board may wish to consider installing the recommended flashing and weep holes to further protect the building asset from water infiltration. Costs to perform this work have been identified separately as an alternate on our cost estimate noted in section 10 of this report.

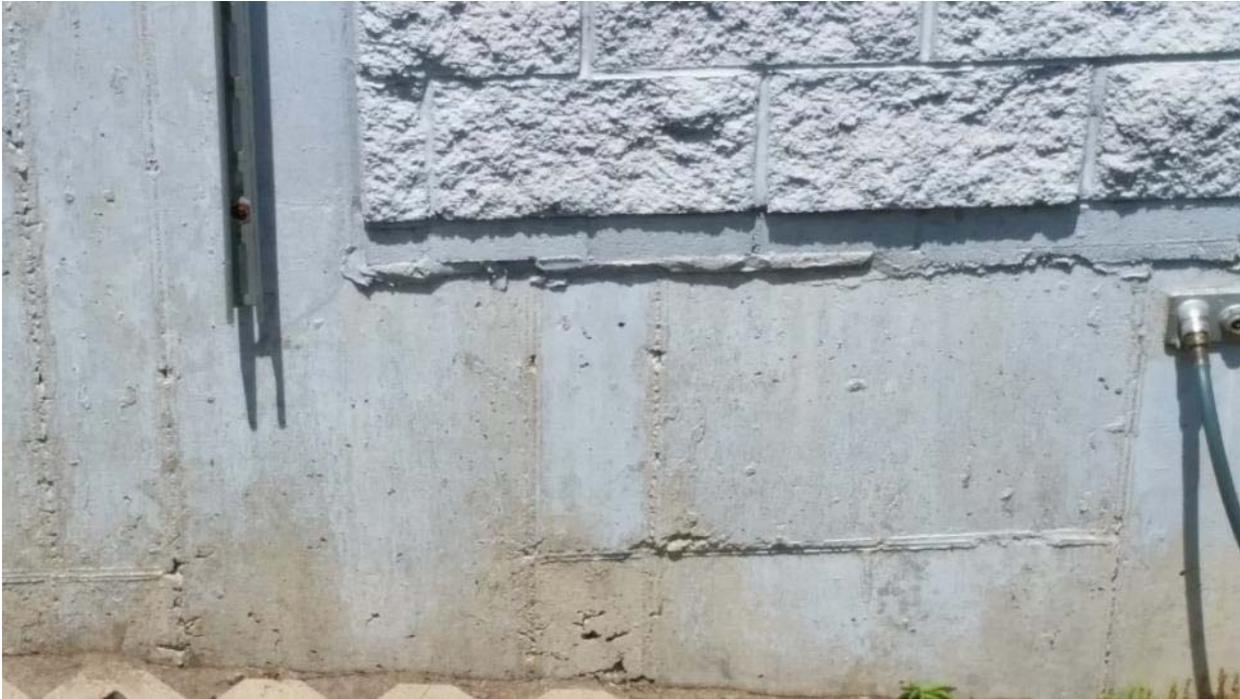
A closer view of the top of foundation wall condition. No weep vents are visible.

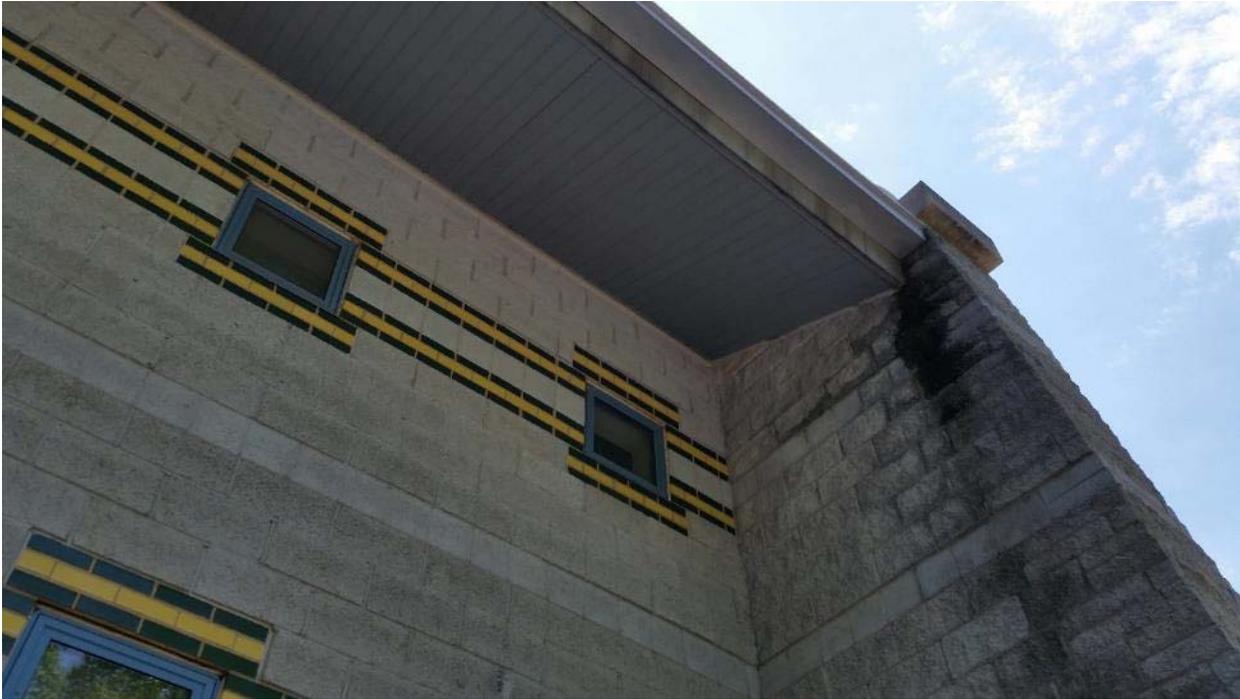
Looking at the Northwest masonry pier on the North side of the building. Noticeable staining is occurring on the split face concrete masonry units. This staining is believed to be organic material that should be easy to clean with detergent based cleaning materials.

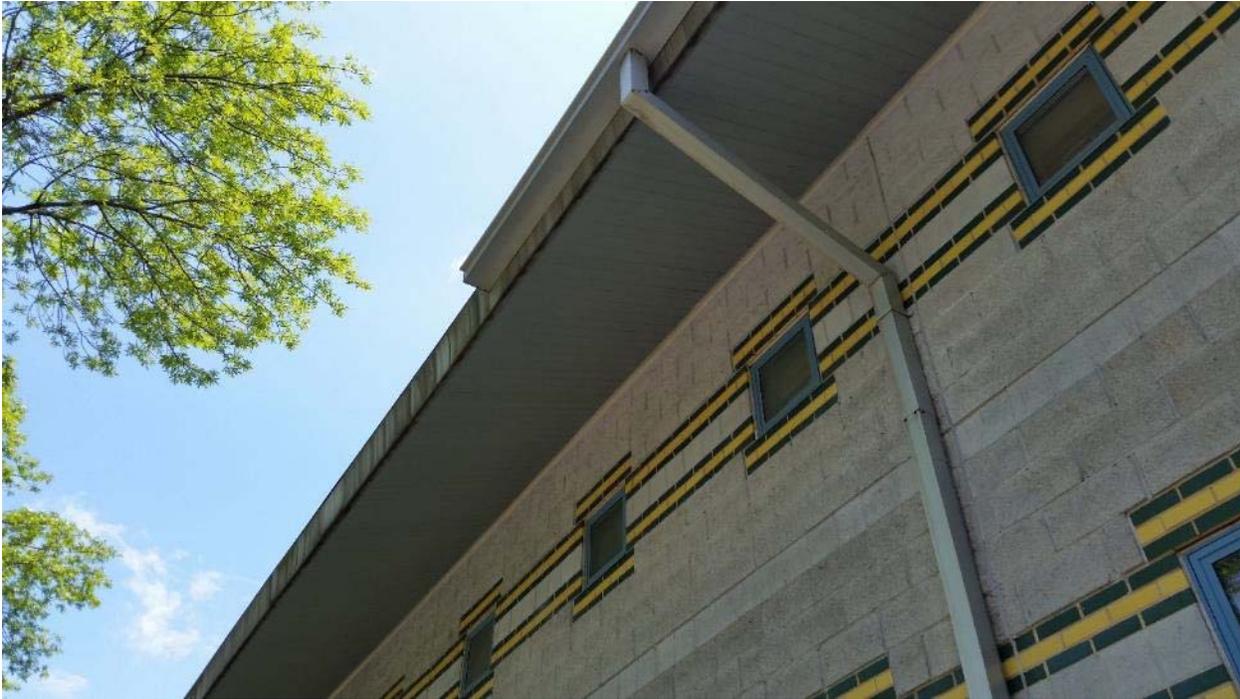
North elevation looking up at large sealant joint at the top of masonry wall condition. This may be the former location of the soffit venting.

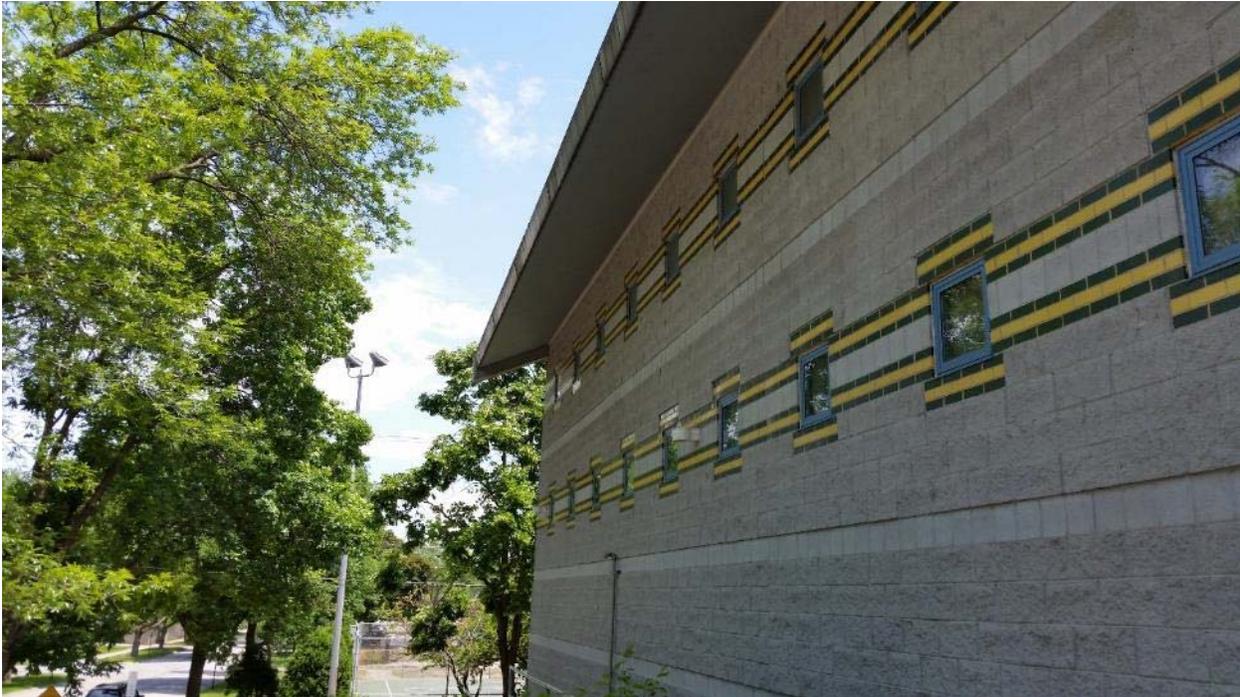
Looking east on the north side of the building towards the park. Block masonry appears to have some water "wicking". Split face block is a porous material and requires a clear or opaque sealer to be installed to retard moisture infiltration.

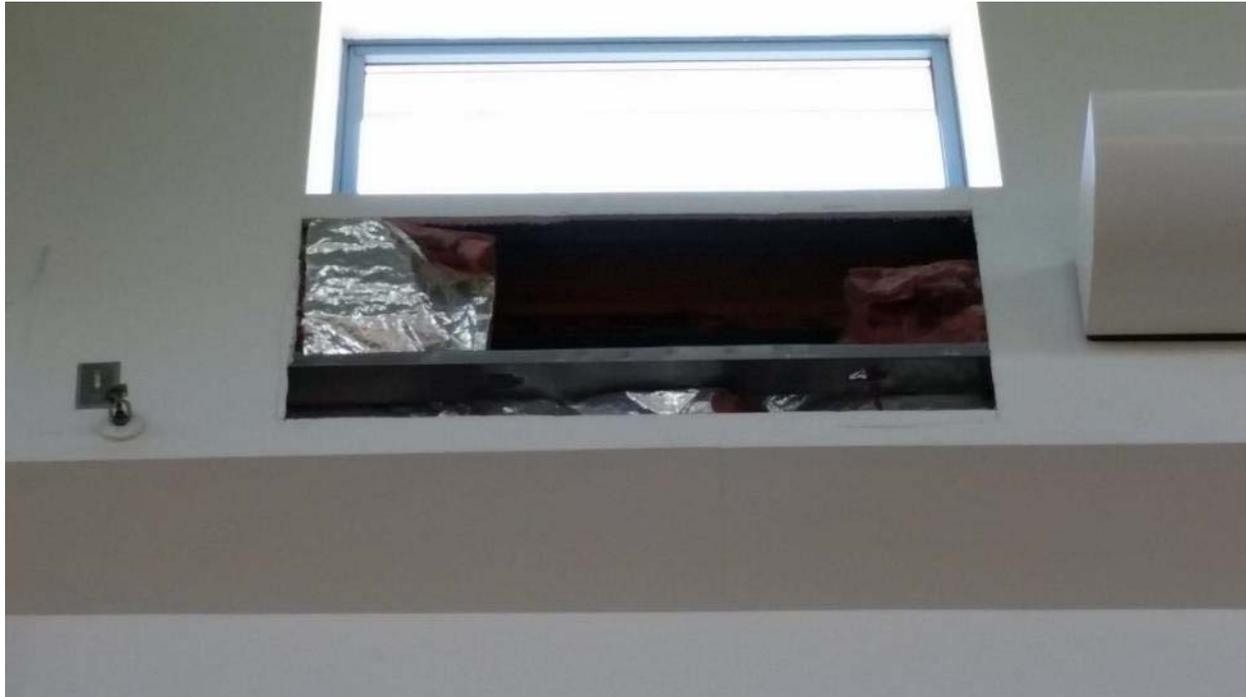
Invasive location just below the far southeast clerestory window location that was opened up for review.

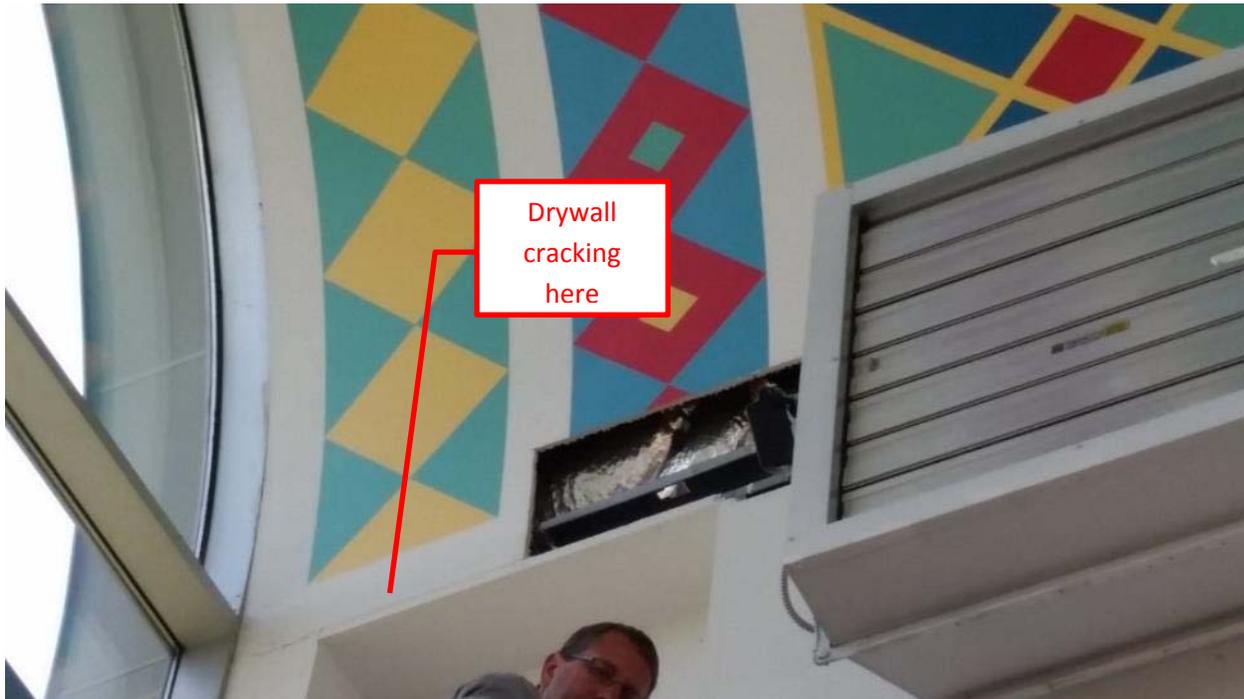
Moisture
stains
observed
