# Community Forum

La Grange Park Public Library  
Facility Discussion

# Our Findings: Structural Damage

Project: LaGrange Park Public Library Water  
Infiltration Investigative Study

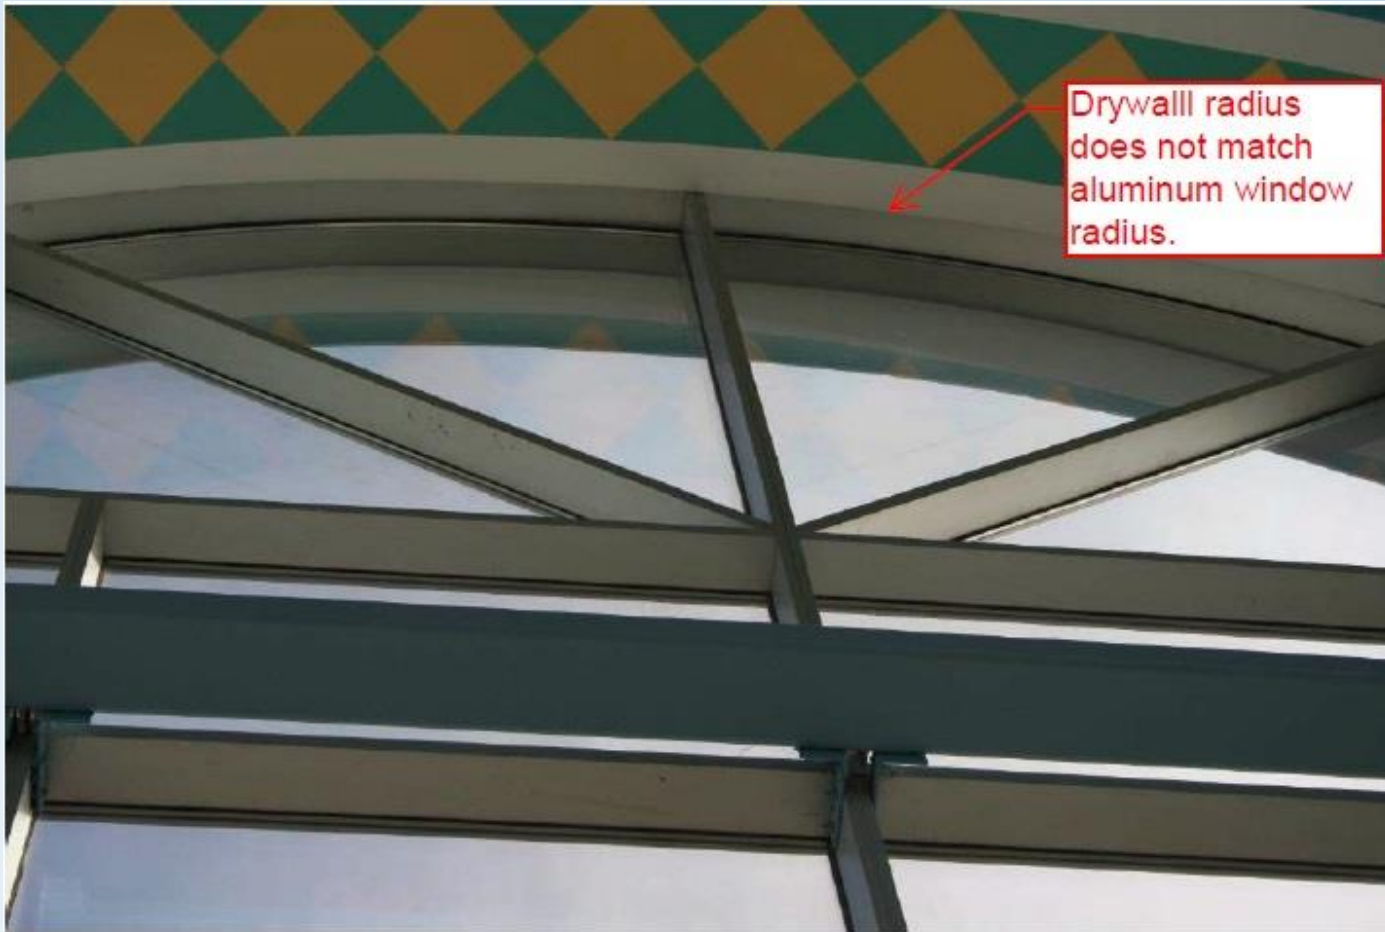
Photo Number: A9844

Description:  
A view looking up towards the East barrel vault glass curtainwall window framing system. Note that the radius of the barrel vault drywall does not match the radius of the aluminum glass curtain wall circumference.

Water is entering the building due to errors in construction & installation of original building features.

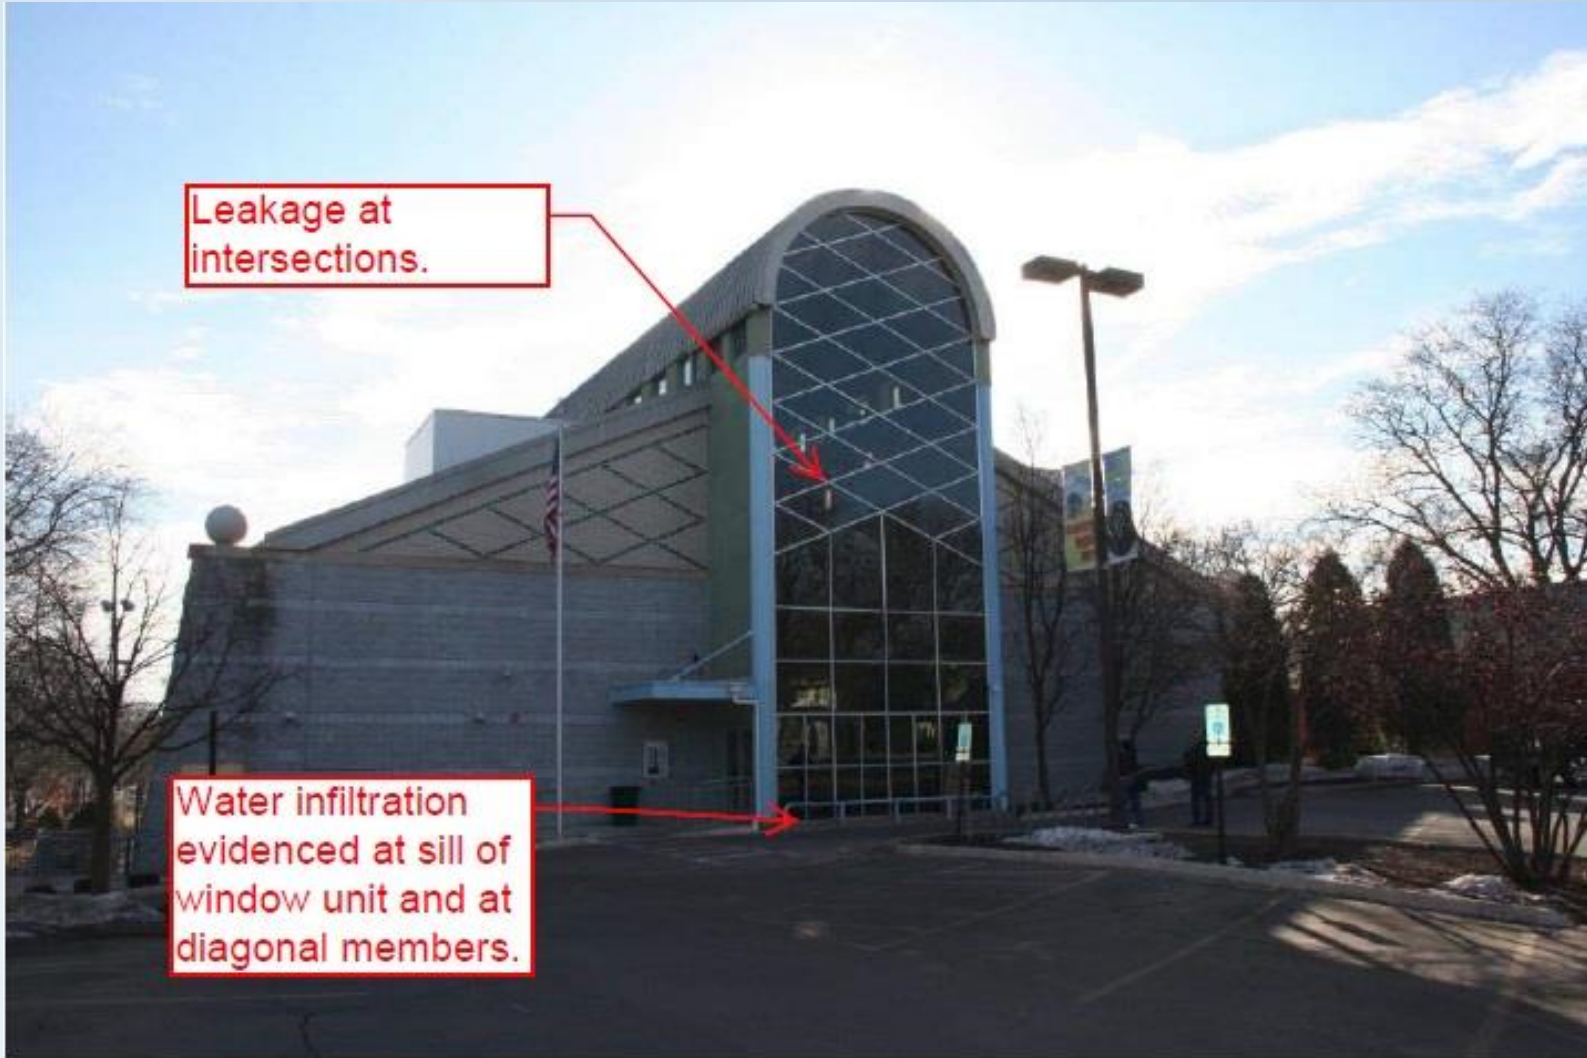
Leakage at intersections.

Water infiltration evidenced at sill of window unit and at diagonal members.

- There was no secondary counterflashing at the curtainwall window heads or sill installations to divert water to the exterior.
- Both window installations do not incorporate thermal breaks which are found in modern day aluminum window systems in this area of the country. This causes the window system to conduct cold temperatures into the interior face of the window system and condense into water droplets, affecting the interior surfaces it comes in contact with.

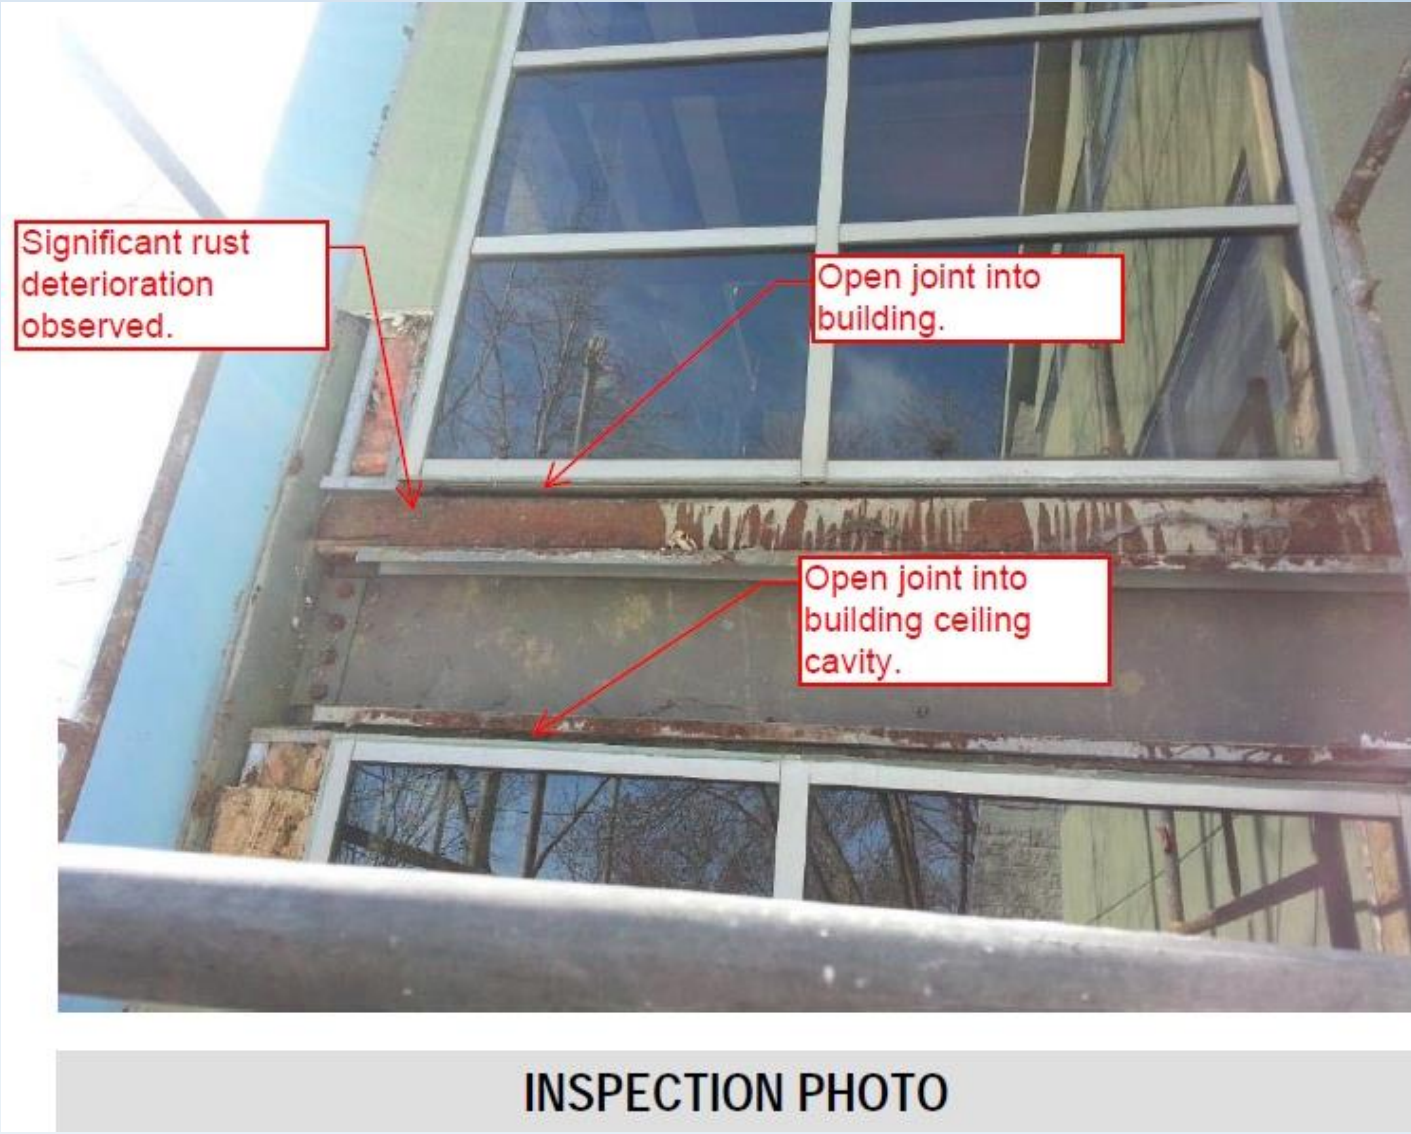
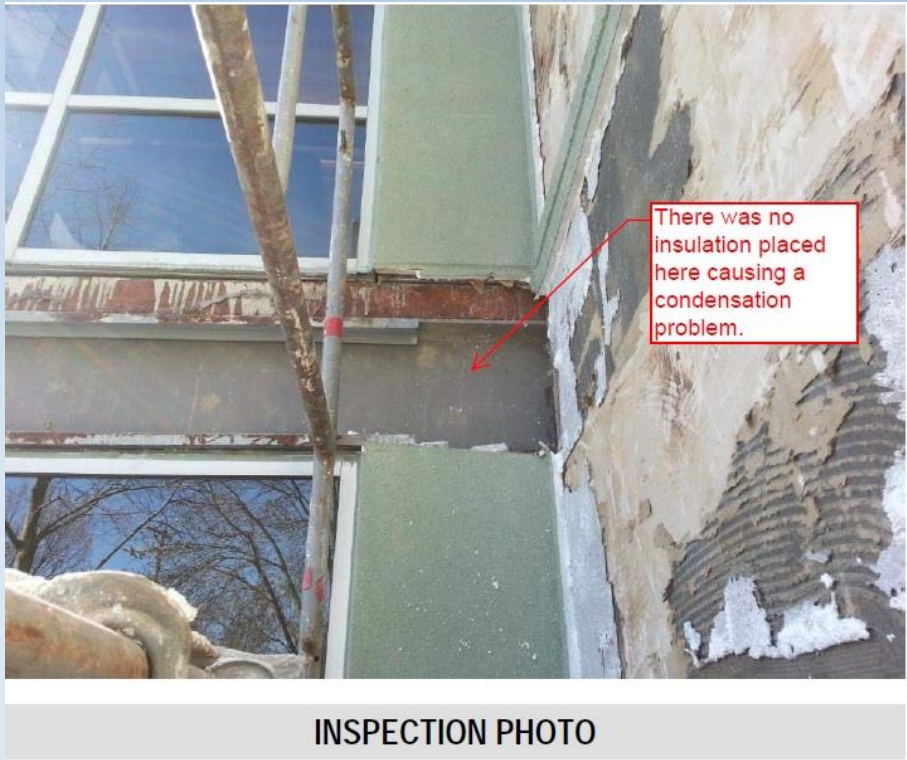
Joint failures and lack of insulation have caused water infiltration, rust, and deterioration, along primarily the east wall.

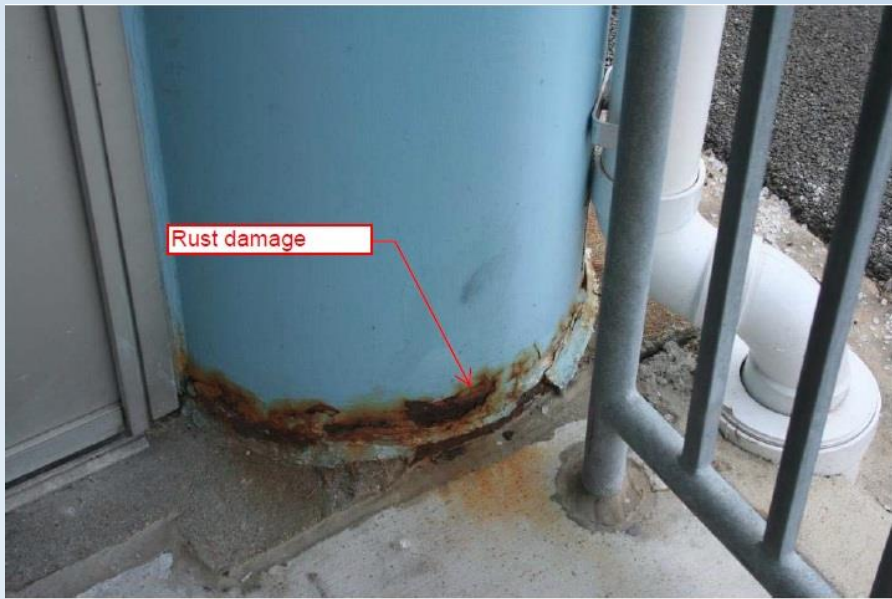
Rust damage

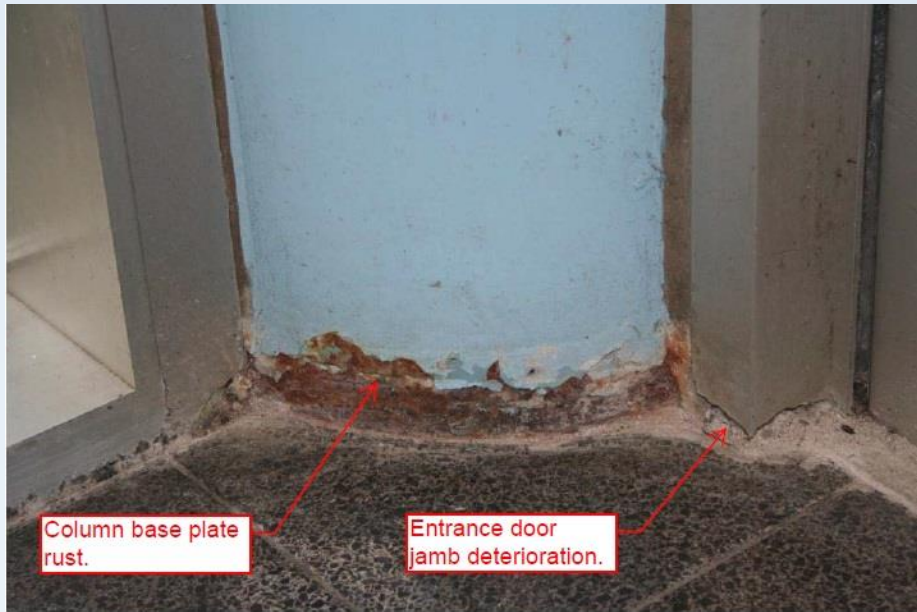
Column base plate rust.

Entrance door jamb deterioration.

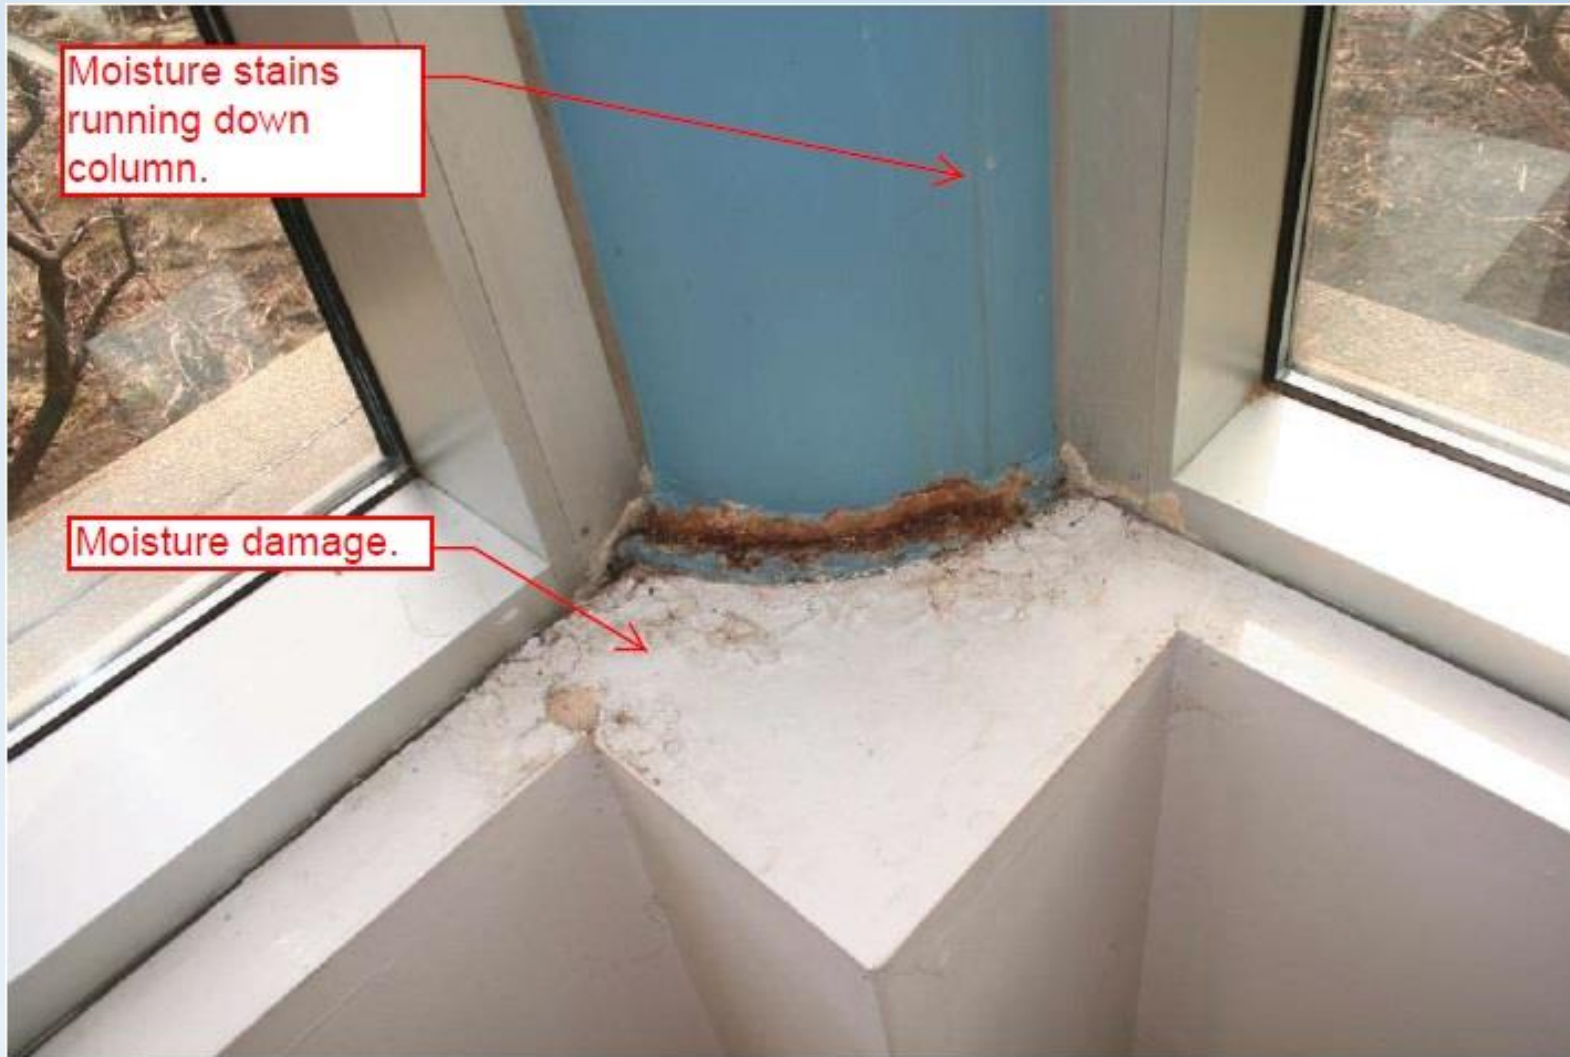
- A lack of proper insulation thickness in the wall assembly at column and beam locations was evident.
- There was no wall stud cavity (plane of wall) insulation installed at any column or beam locations creating a high opportunity for the dew point to fall inside the wall and condense into water droplets.

Columns have condensation issues due to improper insulation and installation. Significant rust has already formed on columns on the east and west walls.

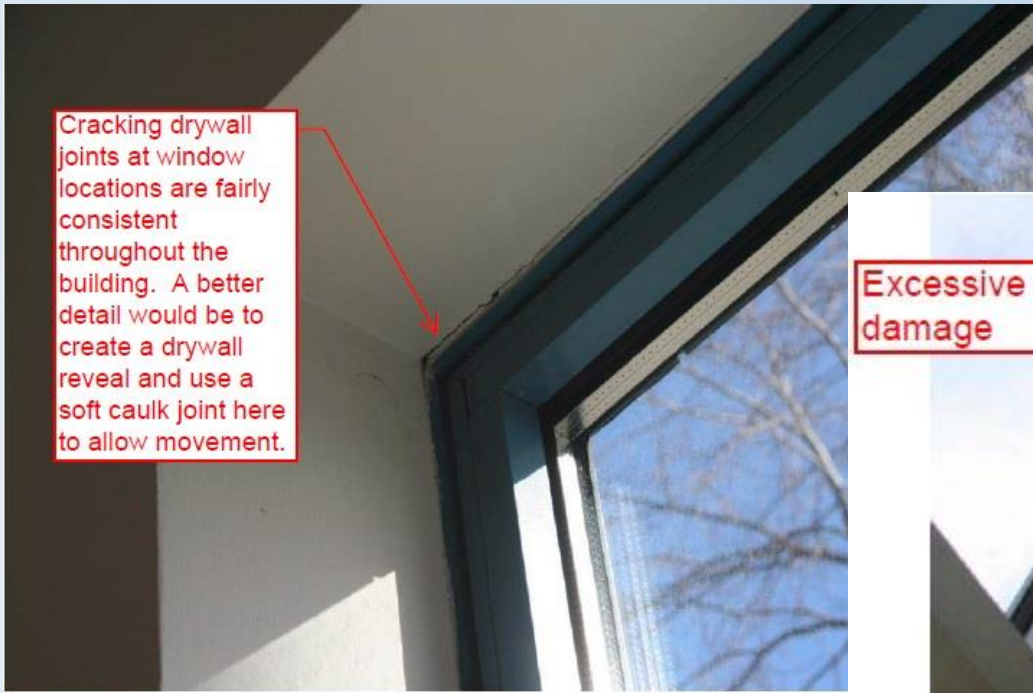
Cracking drywall joints at window locations are fairly consistent throughout the building. A better detail would be to create a drywall reveal and use a soft caulk joint here to allow movement.

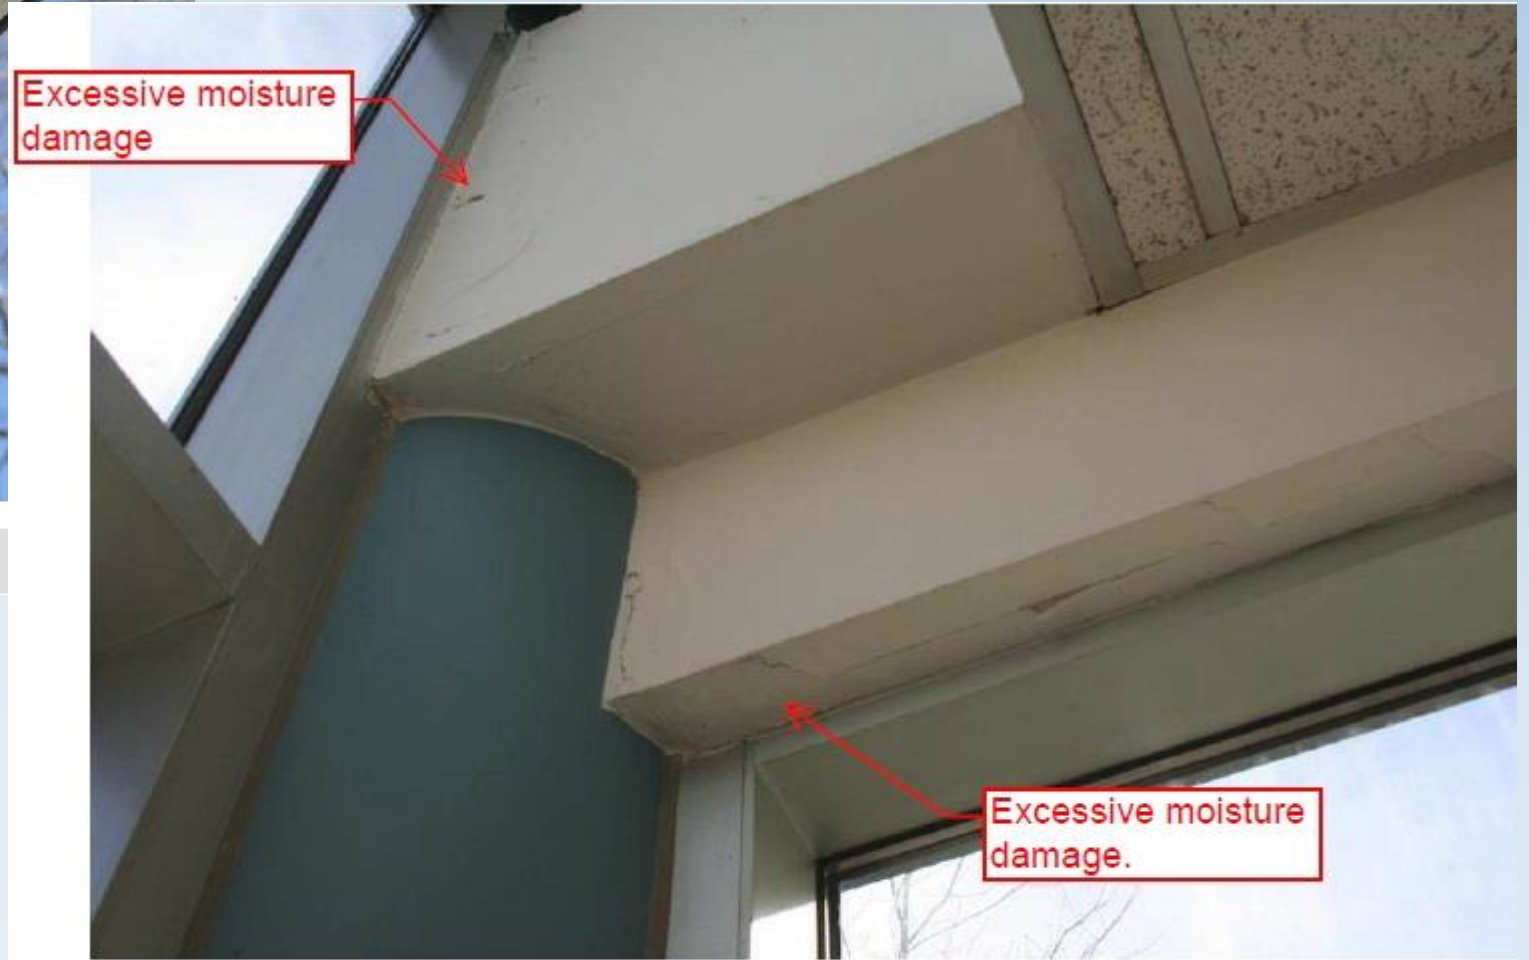
More evidence of water damage.

Excessive moisture damage

Excessive moisture damage.

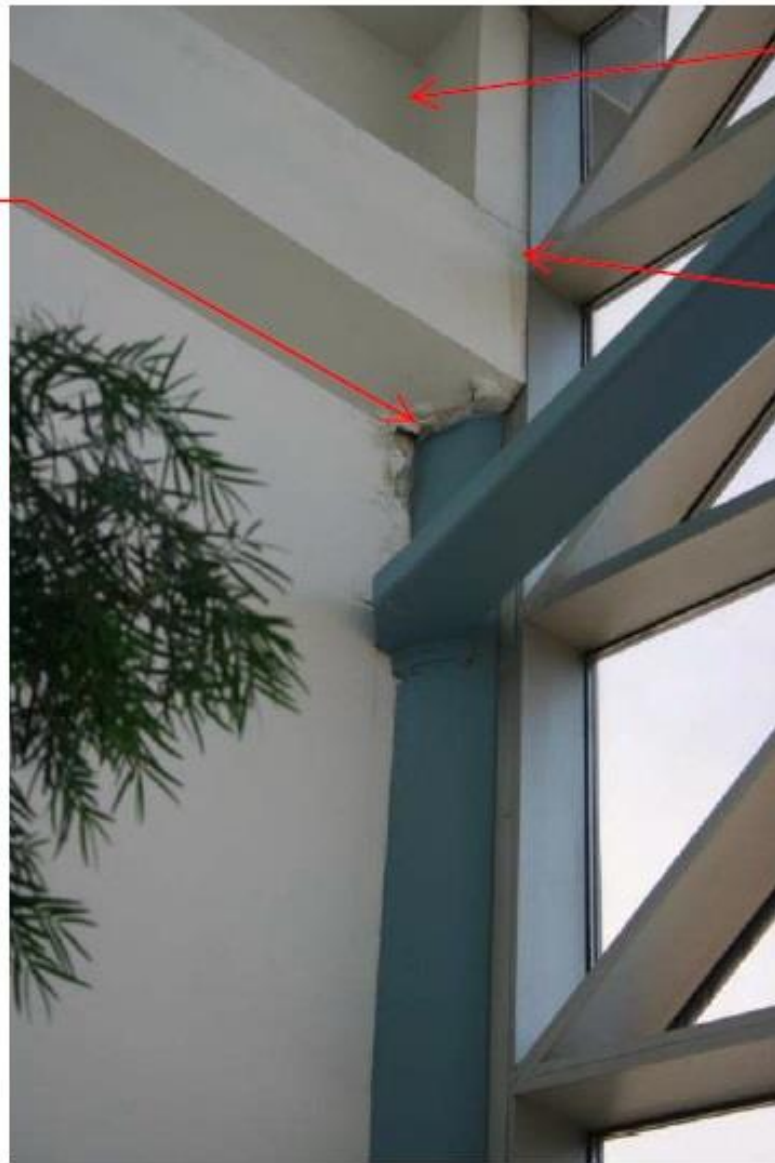
Significant water infiltration here likely caused by the false louver above and conduction of the steel column.

Location of false exterior louver.

Note water stain "running" down wall at this location suggests the false louver may have a flashing / installation problem.

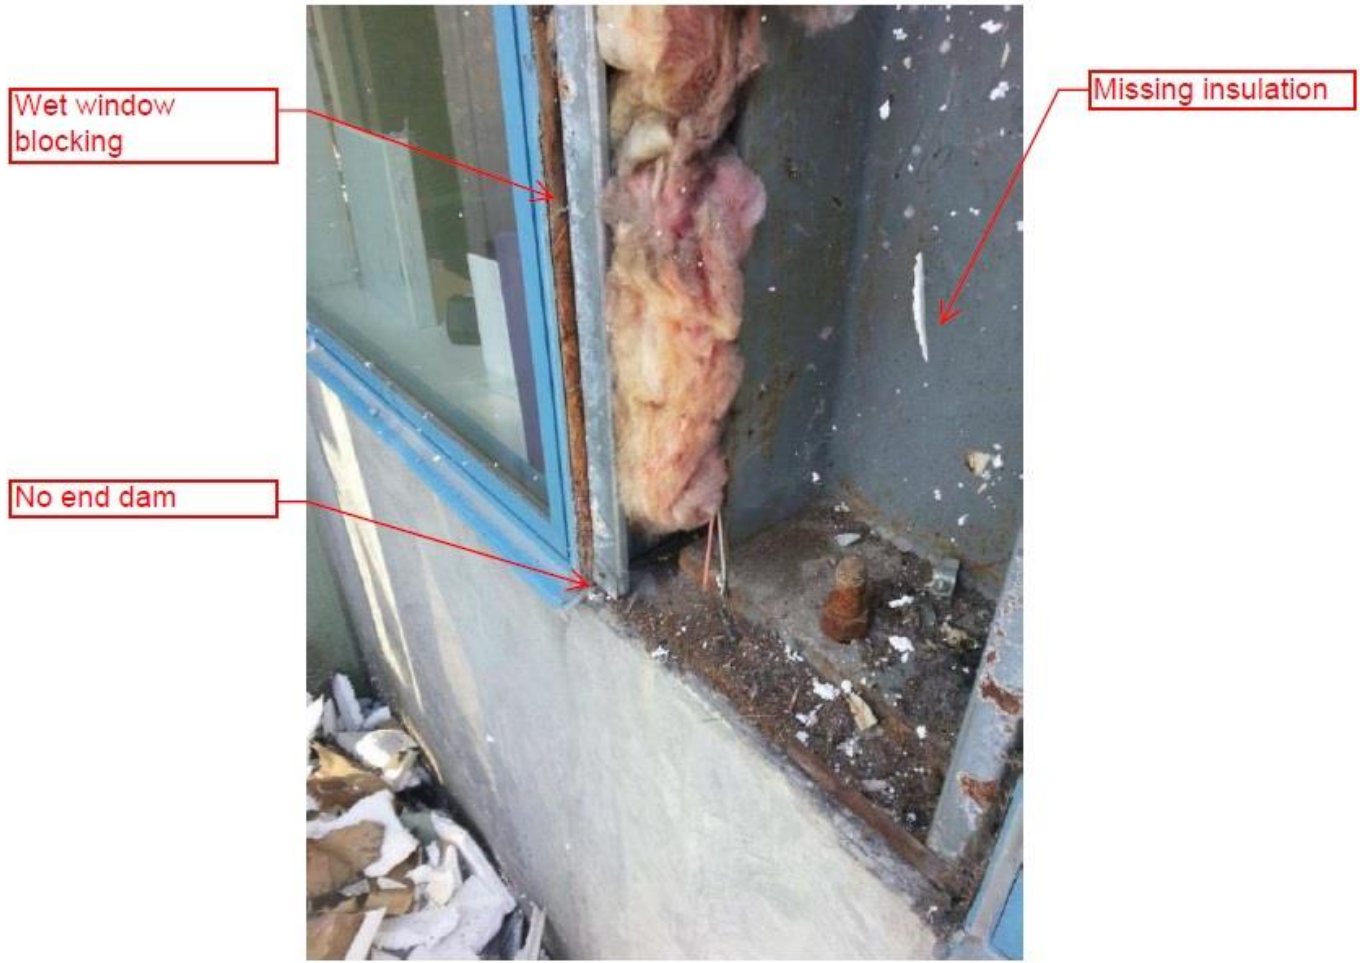
Photo Number: A3203

Description: Photo shows no insulation at column location and lack of end damming at window sills. Significant rust noted at base plate location. Wood window jamb liner board is water saturated.

- Project cost: \$1.5 - \$2.5 million (based on 2015 cost estimates)
- Project timeline ranging from 7-10 months
- The only option for repair is a rebuild & proper insulation process.  
There are no stop-gap measures that will suffice.
