- LaGrange Park Public Library
- Water Infiltration Investigative Study
- April 28, 2015
- Kluber Project No. 15-357-960

Re: Water Infiltration Investigative Study
Kluber, Inc. Project No. 15-357-960

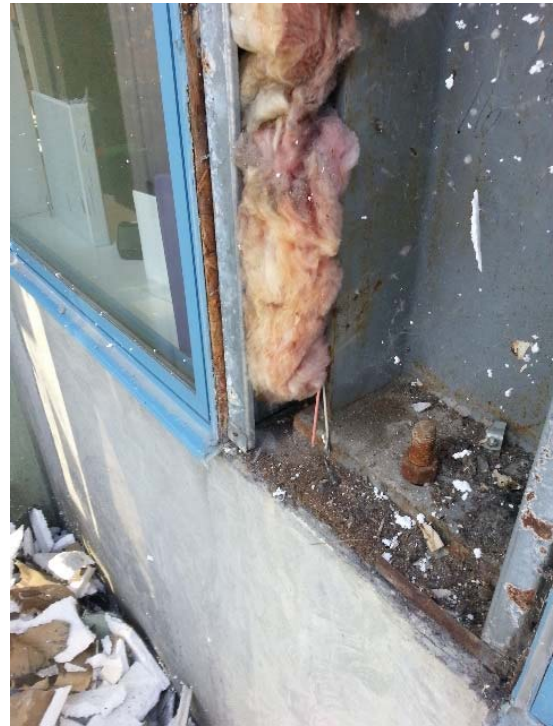
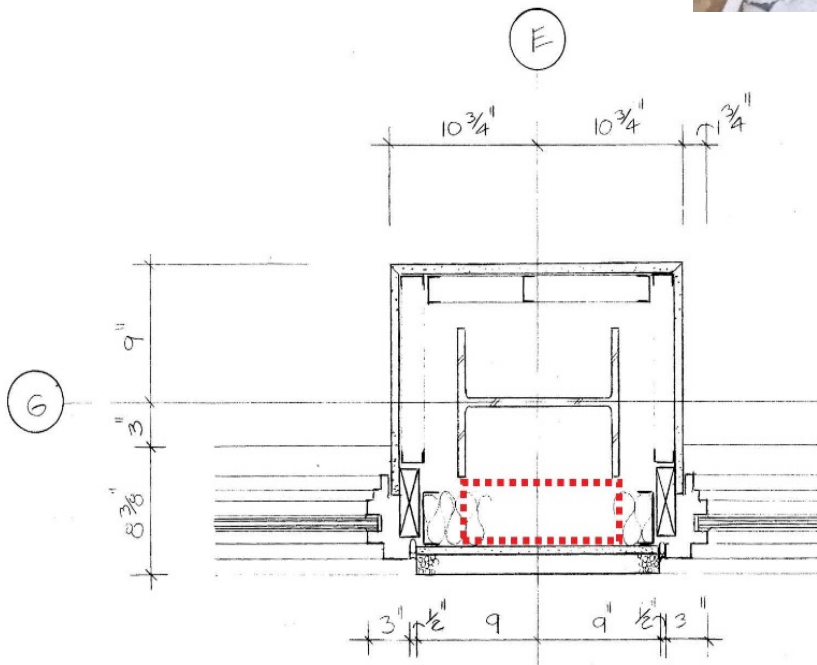
Jamb Detail At Col

The detail below is for a typical exterior column at the east wall assembly. One column was exposed during invasive inspection. Refer to Photo A3203 in section 3 of this report and as shown at the right. We found no insulation installed at the exterior face of the column in the location shown in red. Only a 5/8" thickness of exterior wall sheathing and 1" thickness of EIFS products covered this location. This means a significant amount of water vapor will be in the wall assembly because the dew point of the existing wall assembly will fall inside the wall cavity.

There is only one way to stop this condition and that is to wrap the steel columns fully on interior and exterior sides with a cladding product and fully insulate the resultant cavity with insulation materials. Failure to do so will result in continued deterioration of the interior drywall surfaces due to condensation damage.

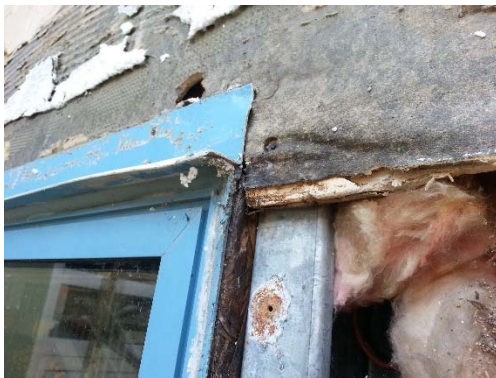
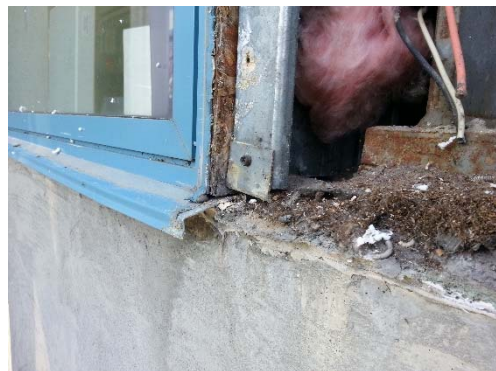
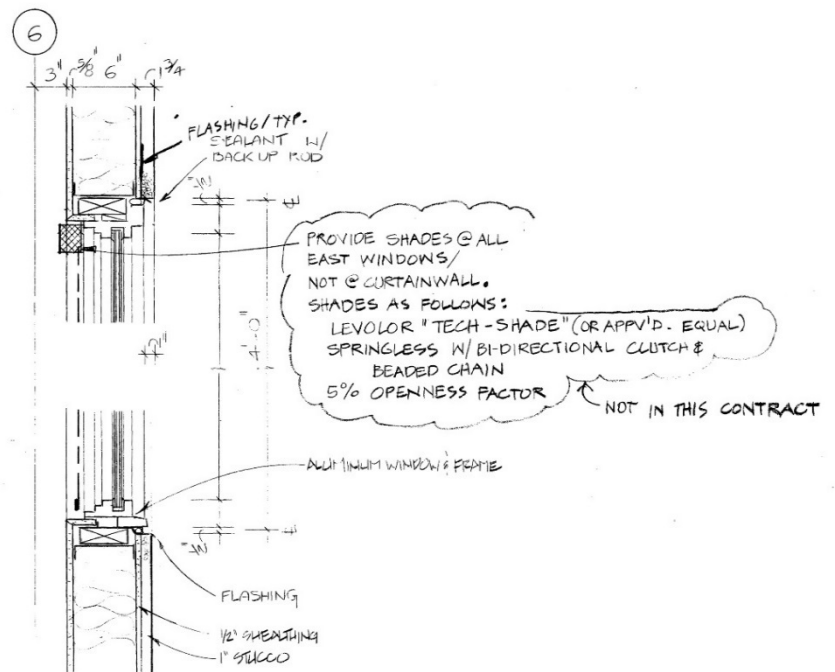
7 Head And Sill Details

The photos below are representative of a typical head and sill flashing detail for the fixed and operable window systems at the east façade of the building. Two items to note: The top photo has no rubber butyl tape installed over the top edge of the metal window head flashing and the bottom photo shows no evidence of end dams being installed at the window sills. Both conditions do not allow water to exit the wall assembly above these flashings as commonly seen today.

To compound the matter, all sill and head flashing were continuously caulked. So if any water did get into the wall system, it could not flow back to the outside of the building; defeating the primary purpose of a sill flashing. Rainwater likely found the path of least resistance through a failed sealant joint and made its way to the head and sill "ends" and got into the exterior wall assembly causing water damage on the inside of the building. You will note that the original construction detail to the right of these photos do not clearly indicate the full design intent to shed water away from this assembly.

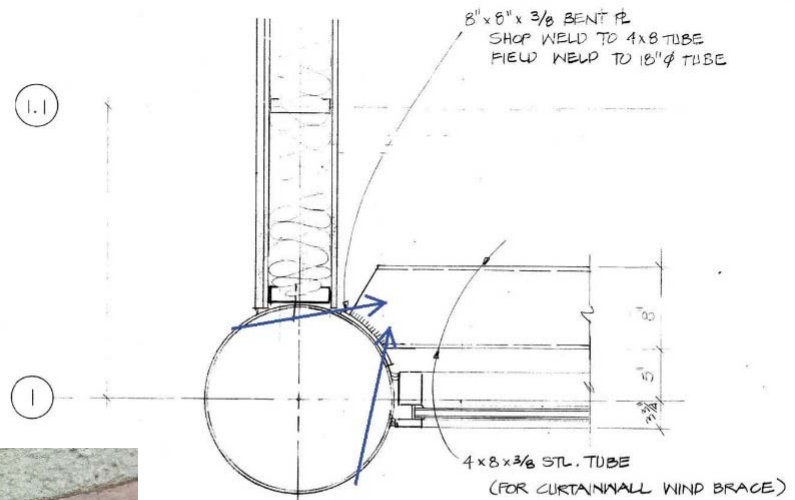
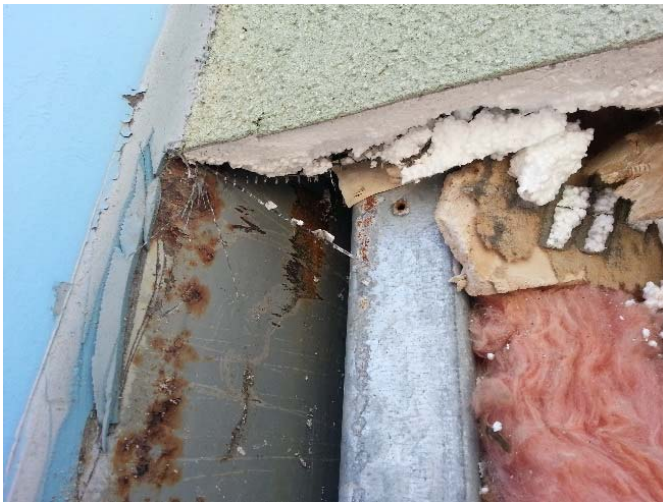
4 Detail Typ At Corner

The photo below and the associated design detail are the transition point between the round steel column and the EIFS products at the point of transition. You will note the EIFS insulation board has been tapered at the point of joining to the steel column. Because dis-similar materials are present, and very little surface area was provided for a proper sealant joint, failure of the sealant joint is likely.

Significant water infiltration has been noted along these exposed steel columns. This is due to failed sealant joints but also because the steel columns will conduct cold air and condense water vapor on the interior of the building.

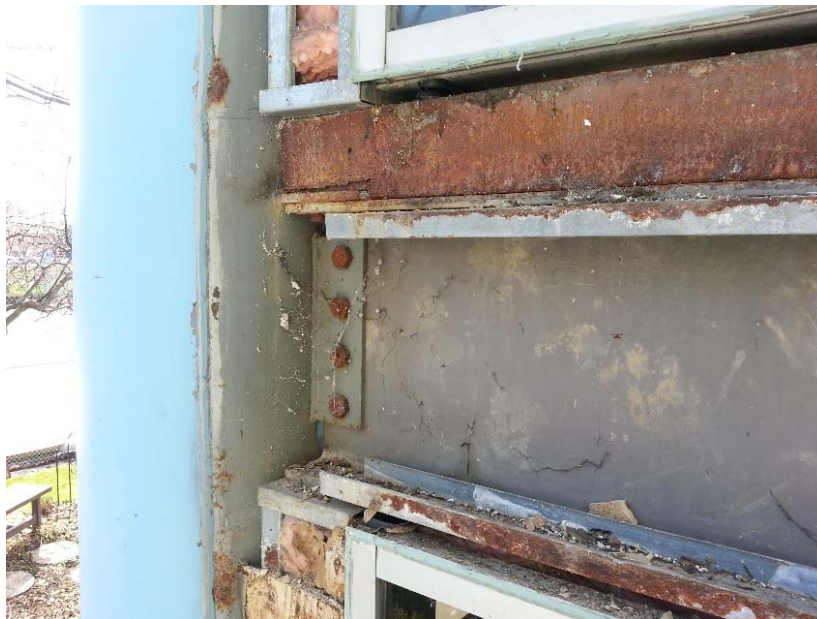
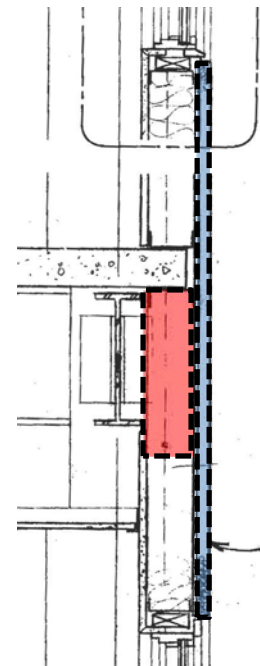
No insulation was found to have been placed at steel beam or column locations as shown in red below and in the below photo. For this reason, it is believed that all exterior wall insulation was installed after the exterior envelope was completed and reasonably water tight. With no access to these areas from the interior side, insulation is assumed to have been omitted at all steel column and beam locations of the exterior wall assembly.

At these locations, the building envelope is then limited to the thermal performance of the 1 inch thick EIFS products in conjunction with the 5/8" thick exterior wall sheathing shown in blue below. Limited thermal insulation at these points will cause the wall system to fail because the dew point will fall inside the wall assembly. We suspect this is the major reason why the majority of the exterior wall systems are showing signs of water damage.

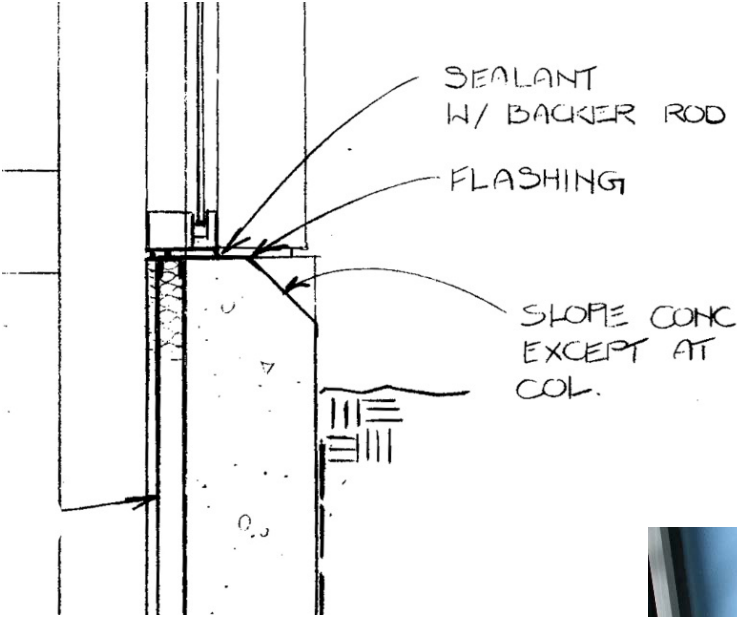
The photo and detail below shows the curtainwall sill detail at the east façade of the building. You will note the original detail calls for a sloped concrete foundation wall at the window sill location in combination with under window sill "flashing". Neither of these details were installed. See below photo of the as-installed condition.

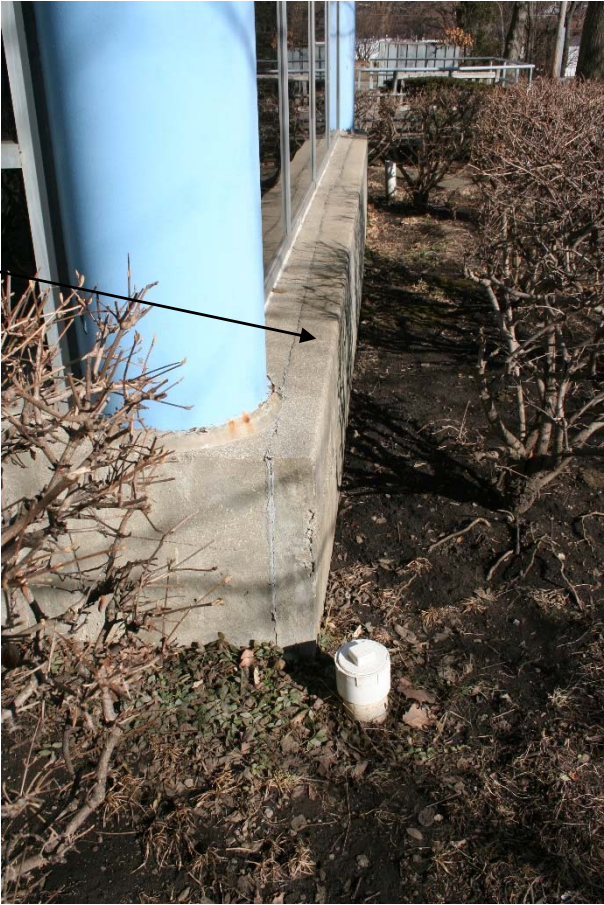
No sloping concrete sill has been installed as shown in detail above.

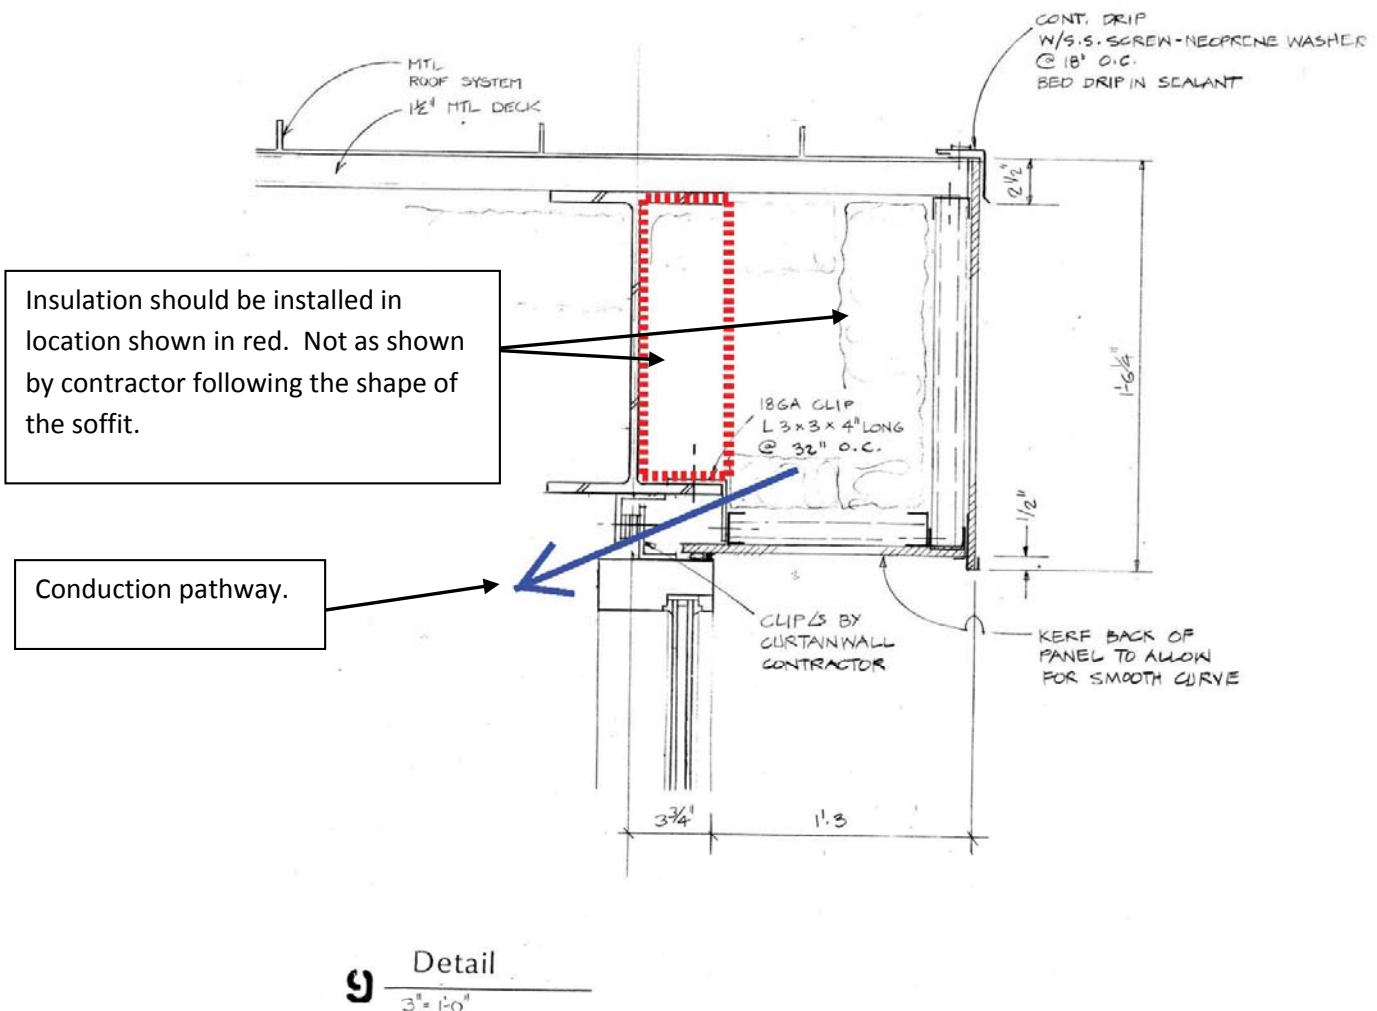
The design detail below depicts the soffit condition at the barrel vault roof at the east and west facades of the building at the aluminum curtainwall framing system. The placement of the insulation in the soffit location is suspect as drawn in by the general contractor on his as-built drawings. The contractor mark-ups indicate insulation placed following the "shape" of the soffit framing.

In a properly installed system, the insulation would be placed at the face of the beam (as shown in red); in the same plane as the window framing system. We also believe that thermal conduction is occurring at the joint between the window head and the steel framing as shown in the blue arrow. This means some level of condensation may occur on the face of the window framing system that could damage the interior drywall surfaces.

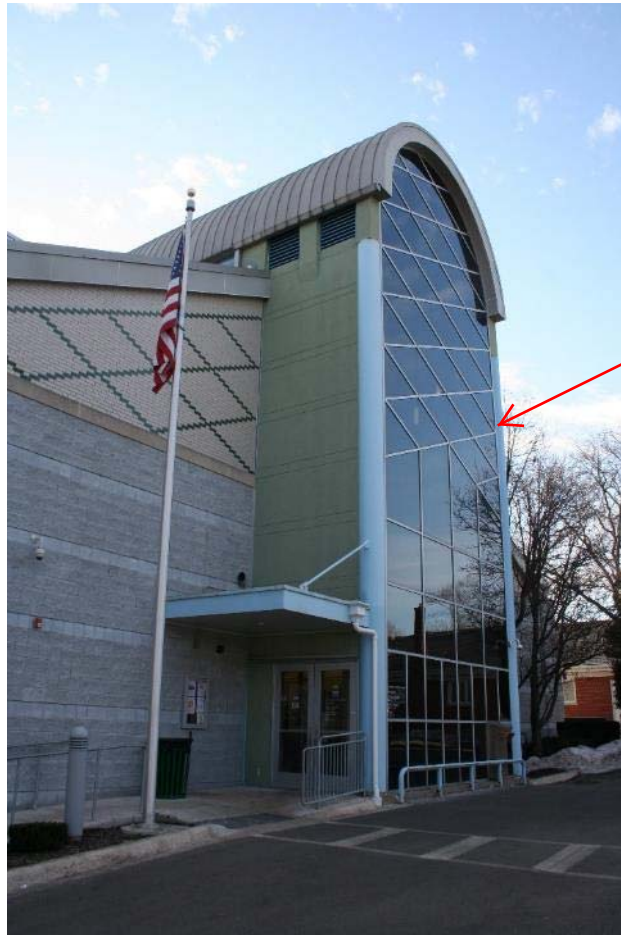
Overall west elevation of the building. The glass curtain wall system is not believed to be thermally broken nor drainable. Water infiltration was evidenced at the sill of the curtain wall system on the inside of the lobby.

Moisture infiltration
at second floor on
interior side here.

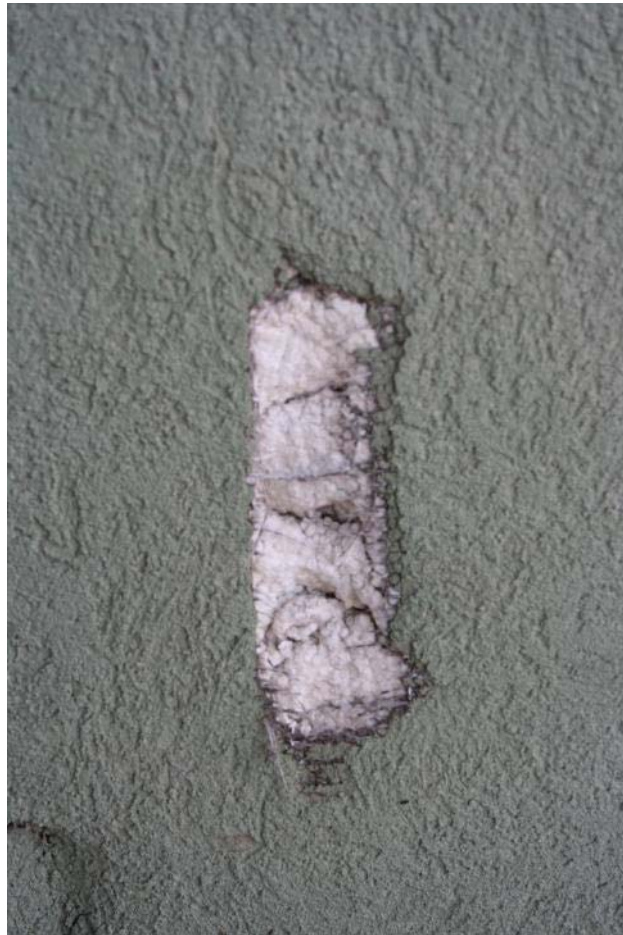
Damage to the exterior eastern door jamb EIFS adjacent to the main entrance doorway at the NW corner of the building.

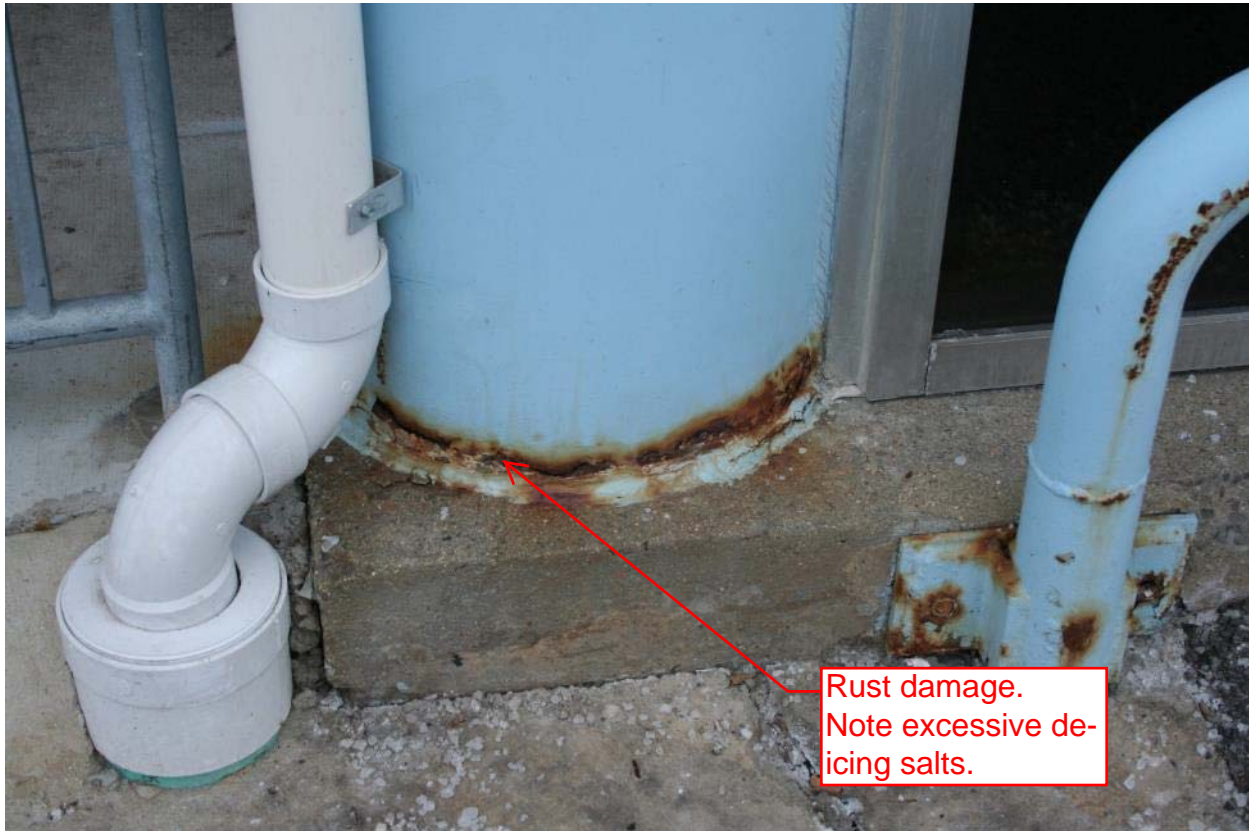
The base of the exposed steel column near the main entrance doorway. The deterioration of the column baseplate can be contributed to the de-icing salts being used in the winter. Further deterioration is most likely due to the columns conducting from outside to inside; creating a "sweating" effect in the winter months.

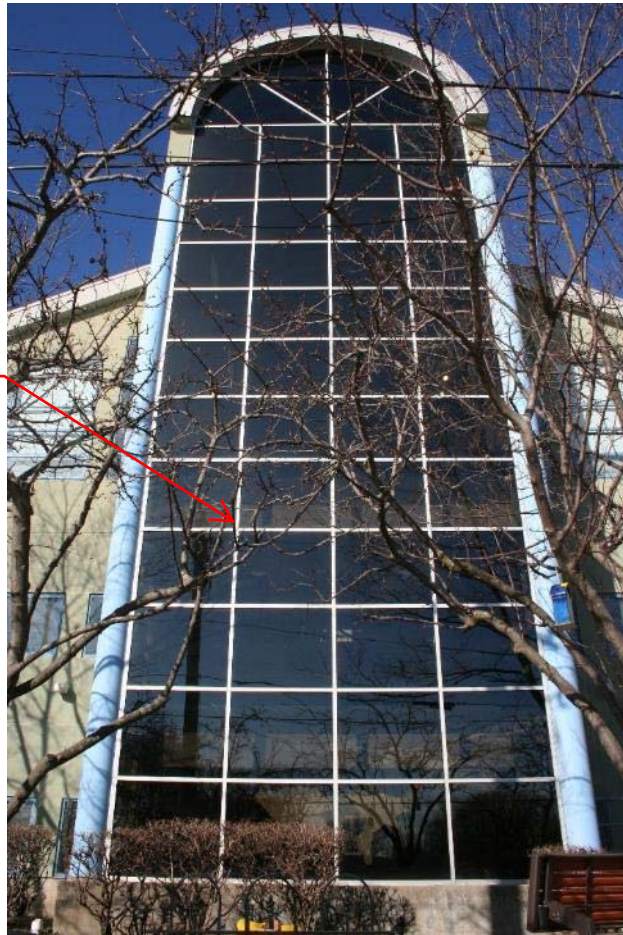
East façade looking towards the NE corner of the building. Excessive moisture was found in the western wall system. Invasive testing to determine the source of the moisture was requested by Kluber to be performed.

Conventional window framing system with horizontal and vertical mullions.

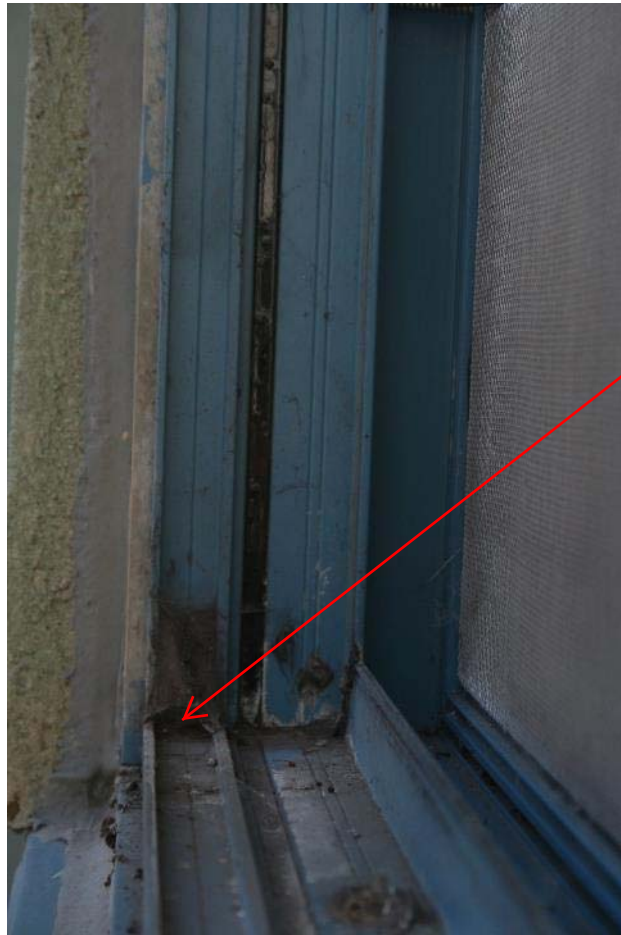
Moisture collection point. Water appears to drain towards jamb ends. It appears no end dams were installed for the window sills which may cause water to infiltrate the exterior wall system.

A view of the east façade operable window system with the operable window pane open. This photo shows moisture collecting in the window sill track. It appears the water passing into the operable window system will run to the “edges” of the window jambs. Once at the jambs, it appears to enter the building because no window sill “end dams” were installed that would redirect this water to the exterior of the building.

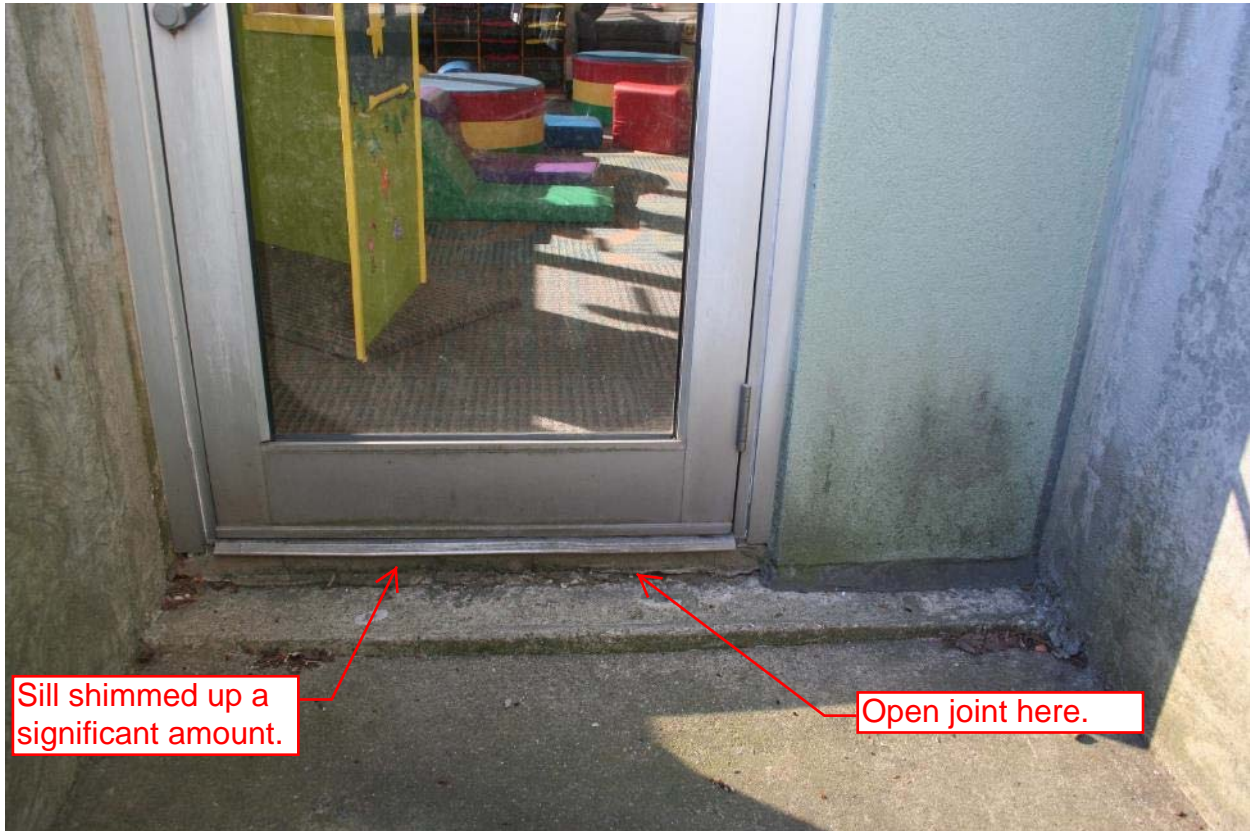
NE Exit doorway from the Children's Department to the exterior showing signs of mold and mildew stains. Note that the doorway sill appears to have been shimmed up a significant amount (Approx 1.5 inches) at the doorway and filled with a concrete patching compound. The concrete joint under this doorway is beginning to crack and fail. For an exit doorway, this high sill also poses a tripping hazard that should be corrected.

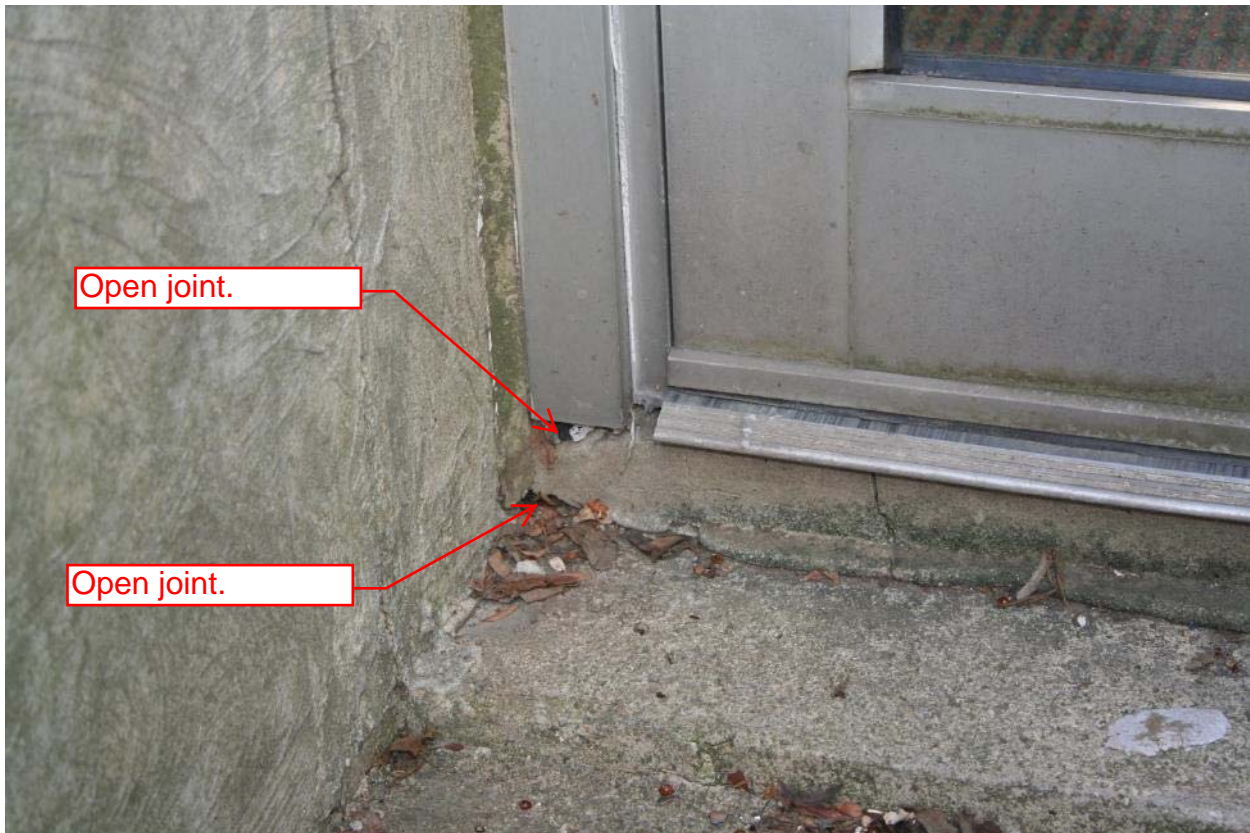
A closer view of the east jamb of the Children's Department exterior exit doorway. Note the open sealant joints and excessively high sill height.

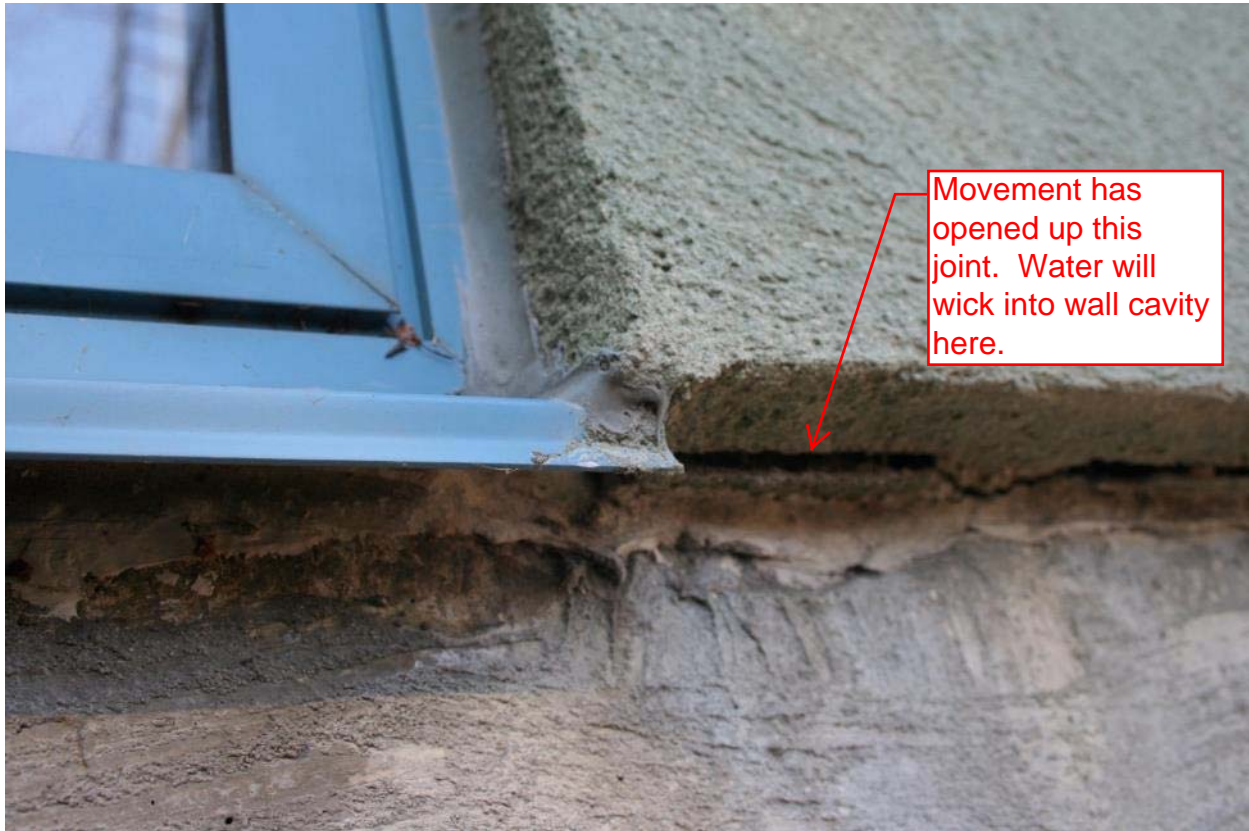
East wall operable window sill from the underside that sits on top of the east foundation wall. Note the movement of the exterior EIFS above the foundation wall at the location of the crack. Very little rain drip has been installed at the bottom of the EIFS panel. For this reason, water sheeting down the wall face can enter into the building wall system at this open joint and get into the lower level.

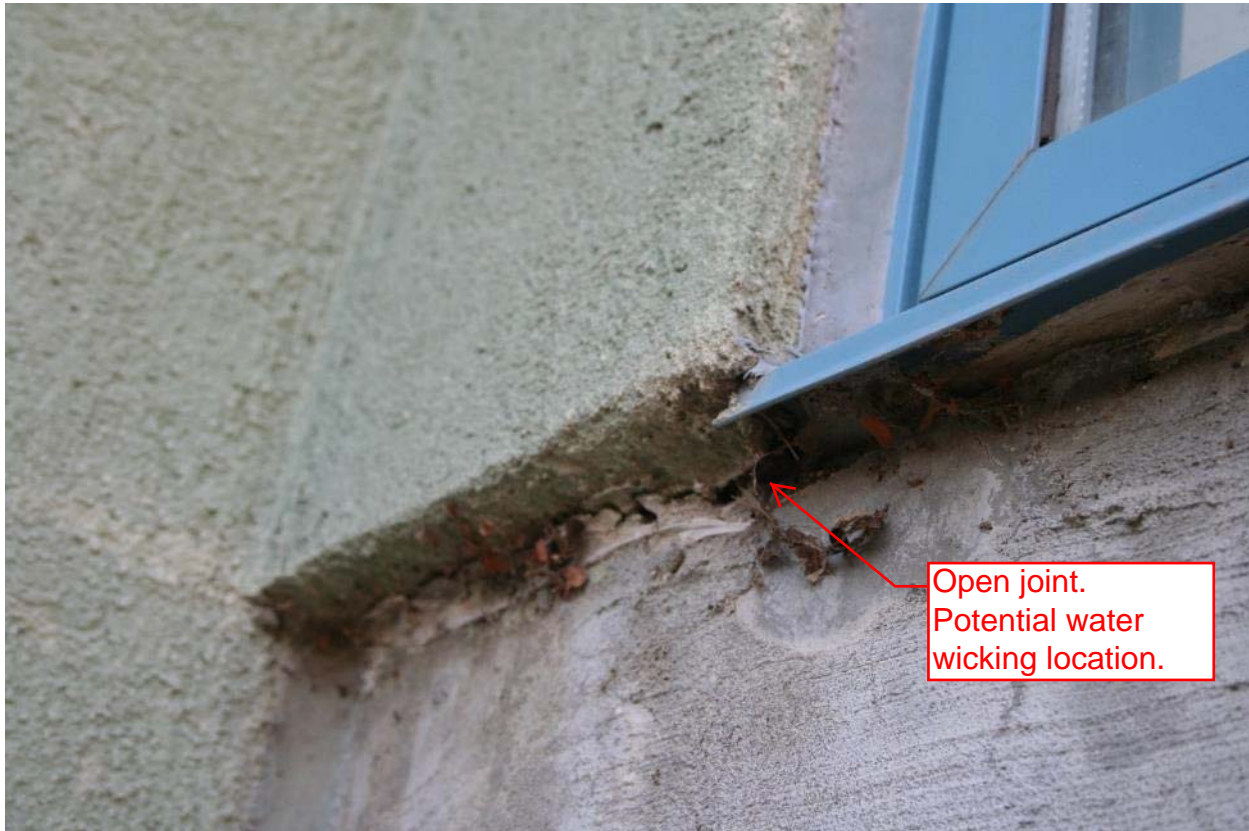
Another view of the window sitting on top of the east foundation wall and the failed sealant joint below the EIFS. No rain drip was installed at this point of the EIFS system.

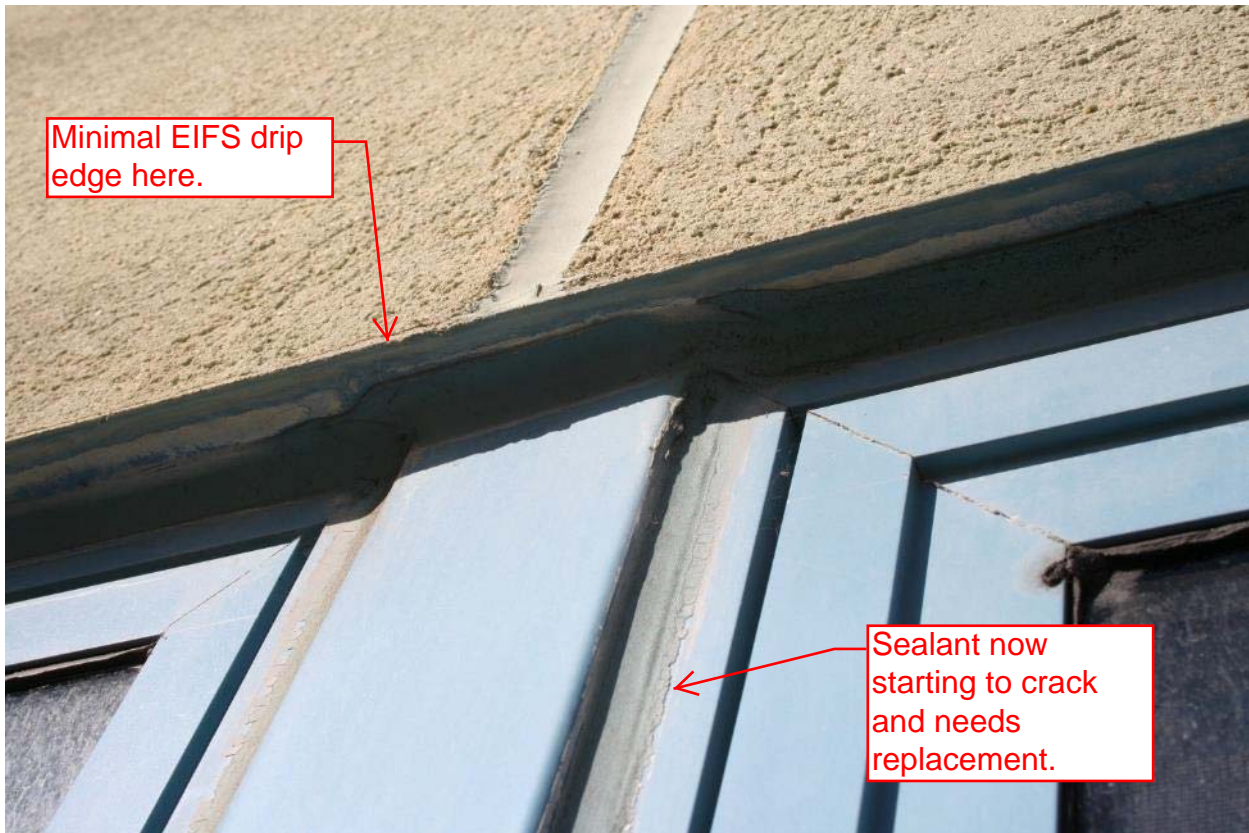
Operable window head detail at field mulled units. Drip edge appears to have been installed and top of aluminum window frame appears to have been recently re-sealed. Note vertical window frame sealant is now showing signs of cracking and should be replaced within the next two years.

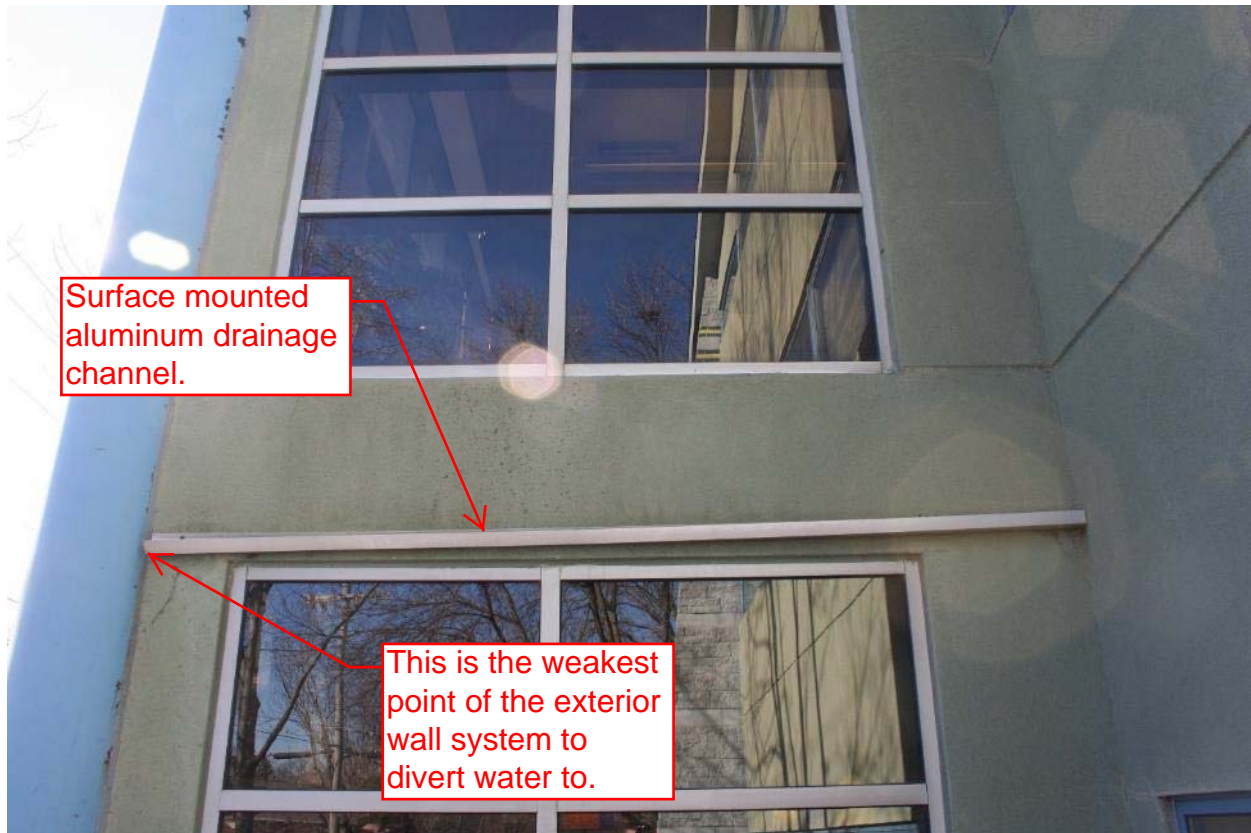
NE exit doorway head of curtainwall system. Note the surface applied drainage channel (in silver that is sloping towards the blue steel column). This channel is believed to have been installed post construction to divert water sheeting down wall surface from above, away from the building. This channel actually promotes water runoff towards the weakest point the exterior façade. That is the joint between the round steel column (in blue) and the EIFS panel system.

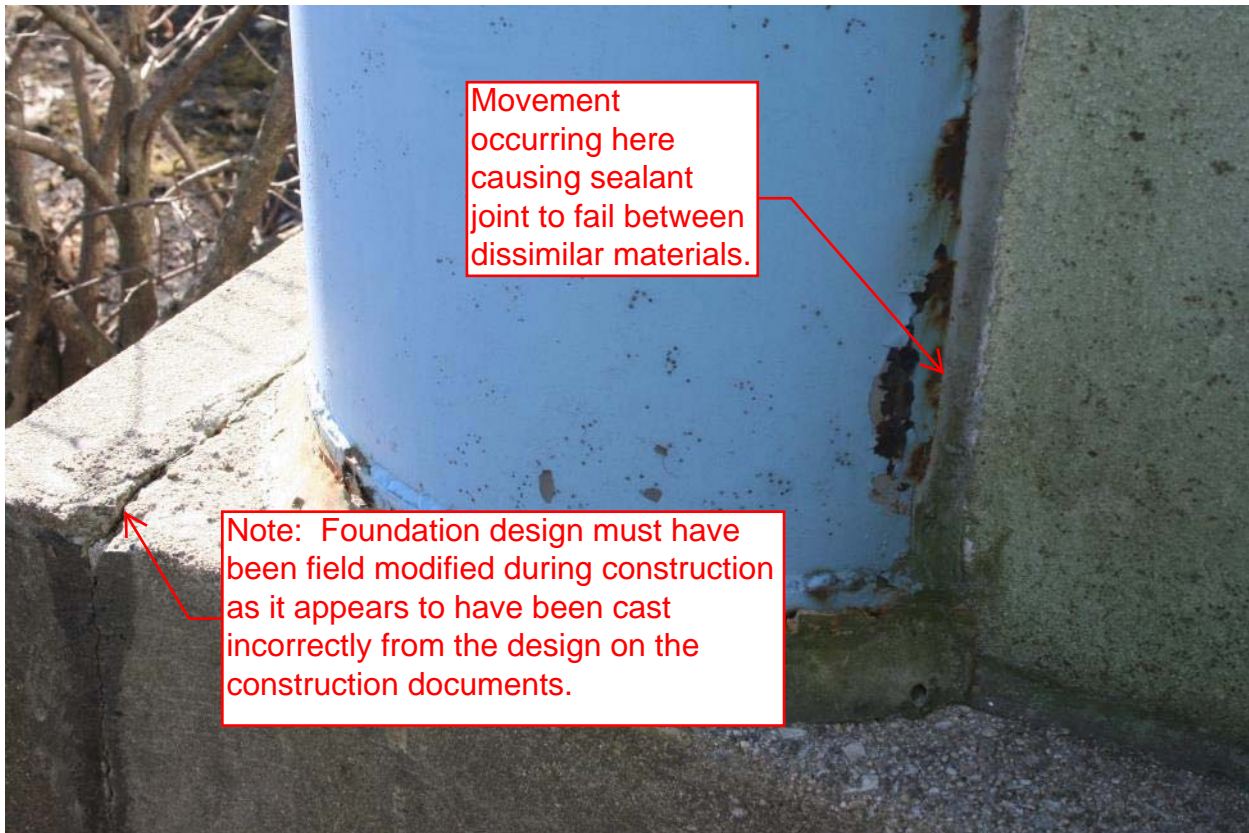
East façade EIFS to the top of the foundation wall. The top of the foundation wall is nearly flat causing water to sit on the concrete ledge adjacent to the sealant joints.

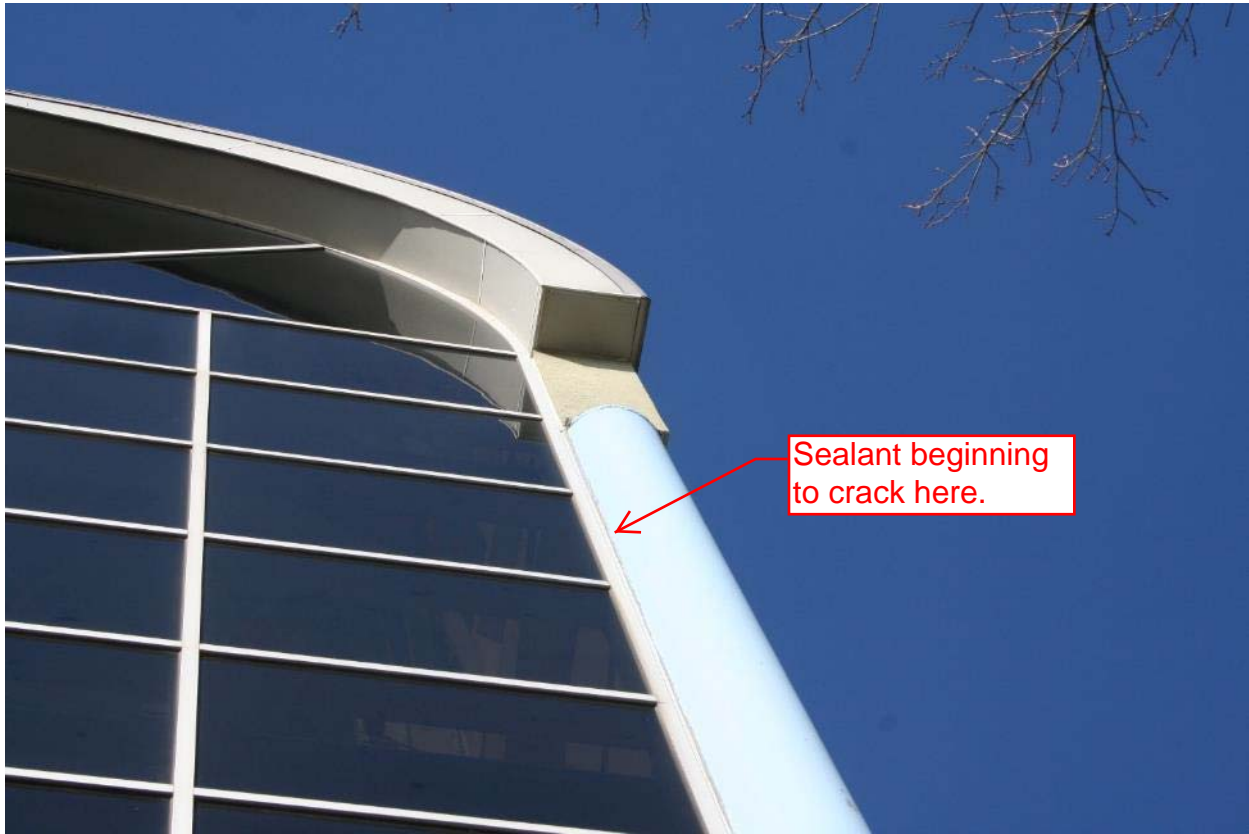
East wall at base of curtain wall window framing system. Note base has been caulked and the sealant joint has failed. Window to steel column sealant joint has also failed and needs to be repaired.

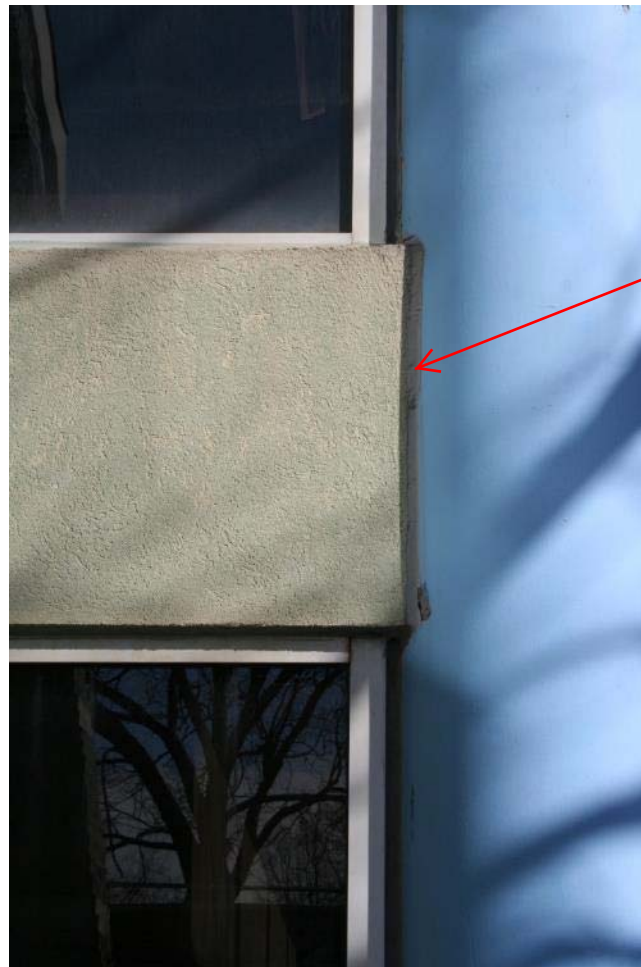
Stressed sealant joint here between dissimilar materials.

SE Steel column at the first floor line. The First floor window is at the top of the photo and the lower level Children's Department is behind the window at the bottom of the picture.

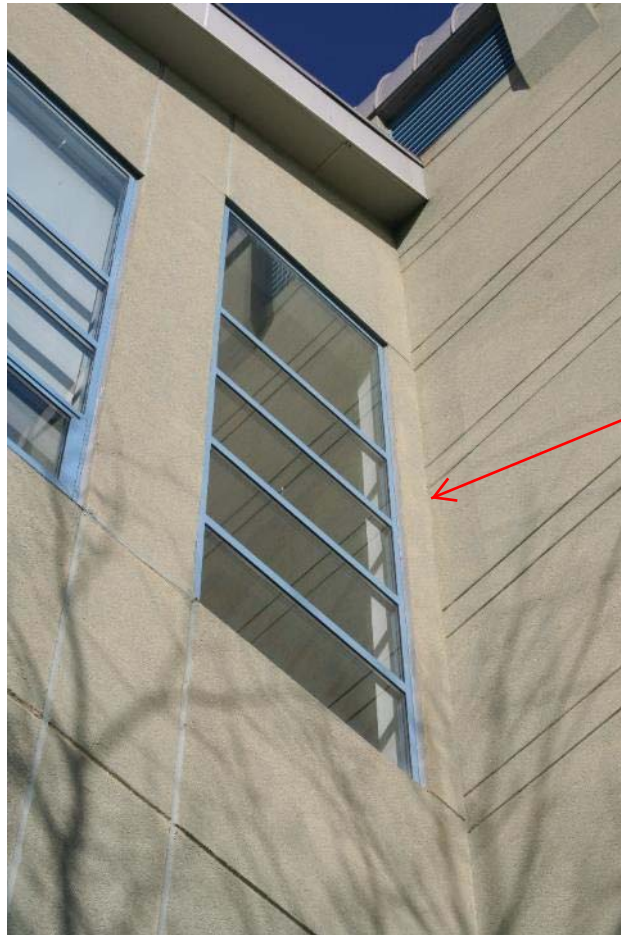
Photo Number: A9760

Hairline cracking
between EIFS
panels noted at this
location.

Description:
SE inside building corner south of main east staircase looking towards the roof area.

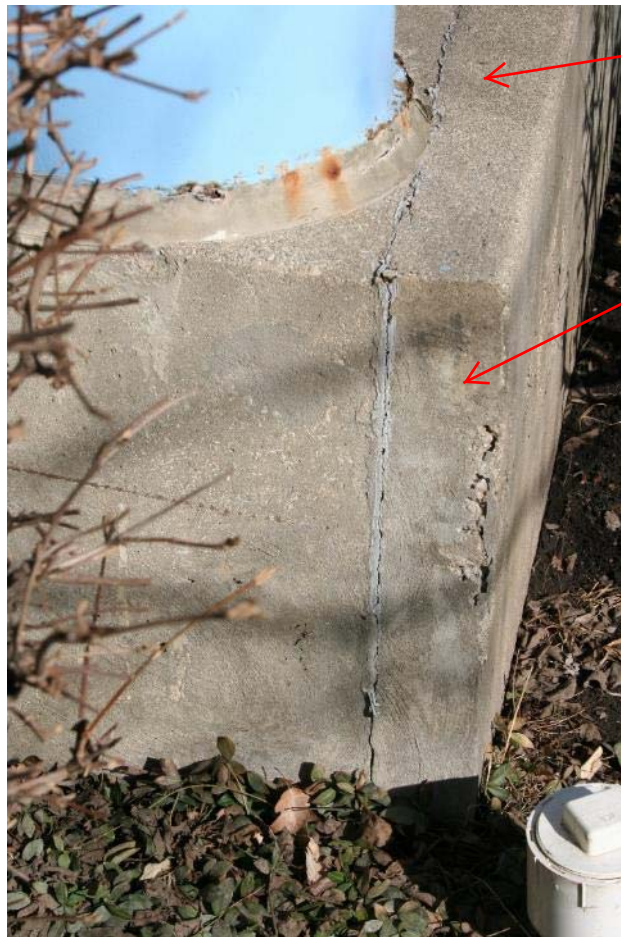
Flat foundation wall does not drain moisture away from the building.

Added concrete section.

This photo is taken at the SE corner of the glass curtain wall window system at the top of the foundation wall. Note that approximately 8" of additional concrete foundation was poured to the east of the original casting. The top of the foundation wall is poured flat in lieu of sloped as shown on the contract documents. This flat surface can collect water that may make its way into the building.

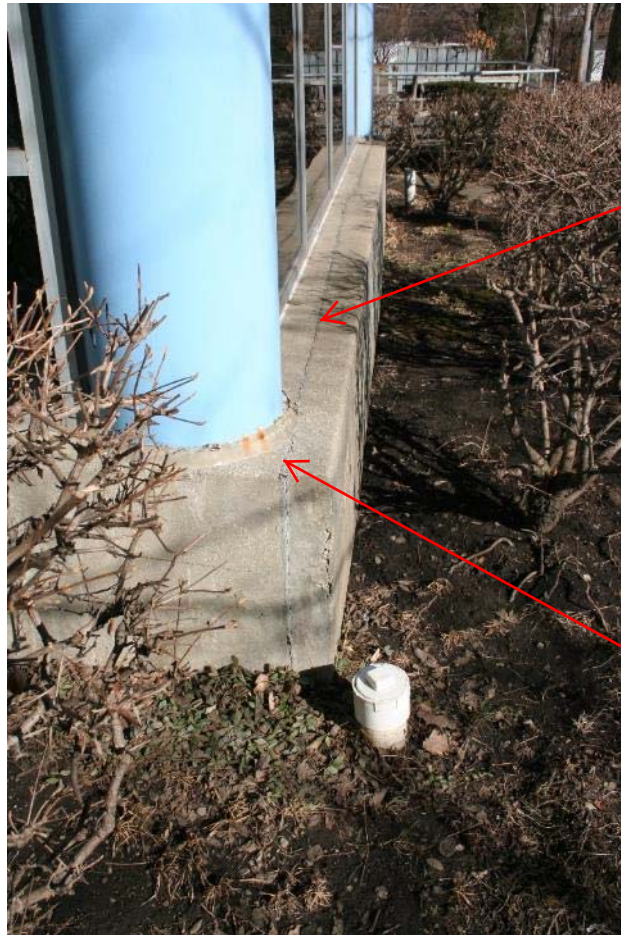
Note flat concrete sill ledge. Original drawings had this sill designed to be sloped. The round column corners were designed to be flat at the base of the round columns.

Designed to be flat here.
