- LaGrange Park Public Library
- Water Infiltration Investigative Study
- April 28, 2015
- Kluber Project No. 15-357-960

Re: Water Infiltration Investigative Study
Kluber, Inc. Project No. 15-357-960

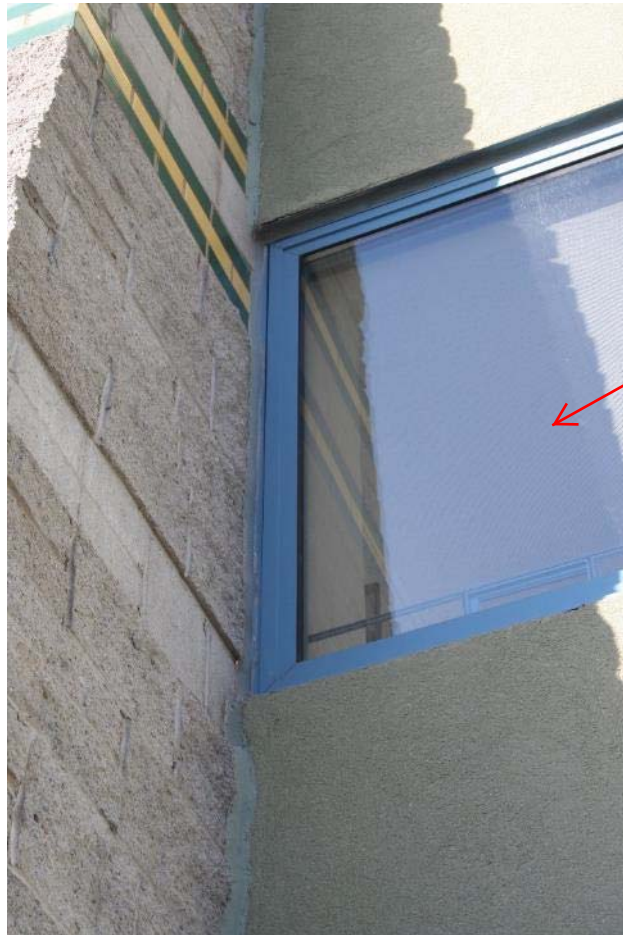
SW building corner at operable windows. Note sealant near windows appears to be in good condition. Sealant above window head at EIFS appears to be cracking.

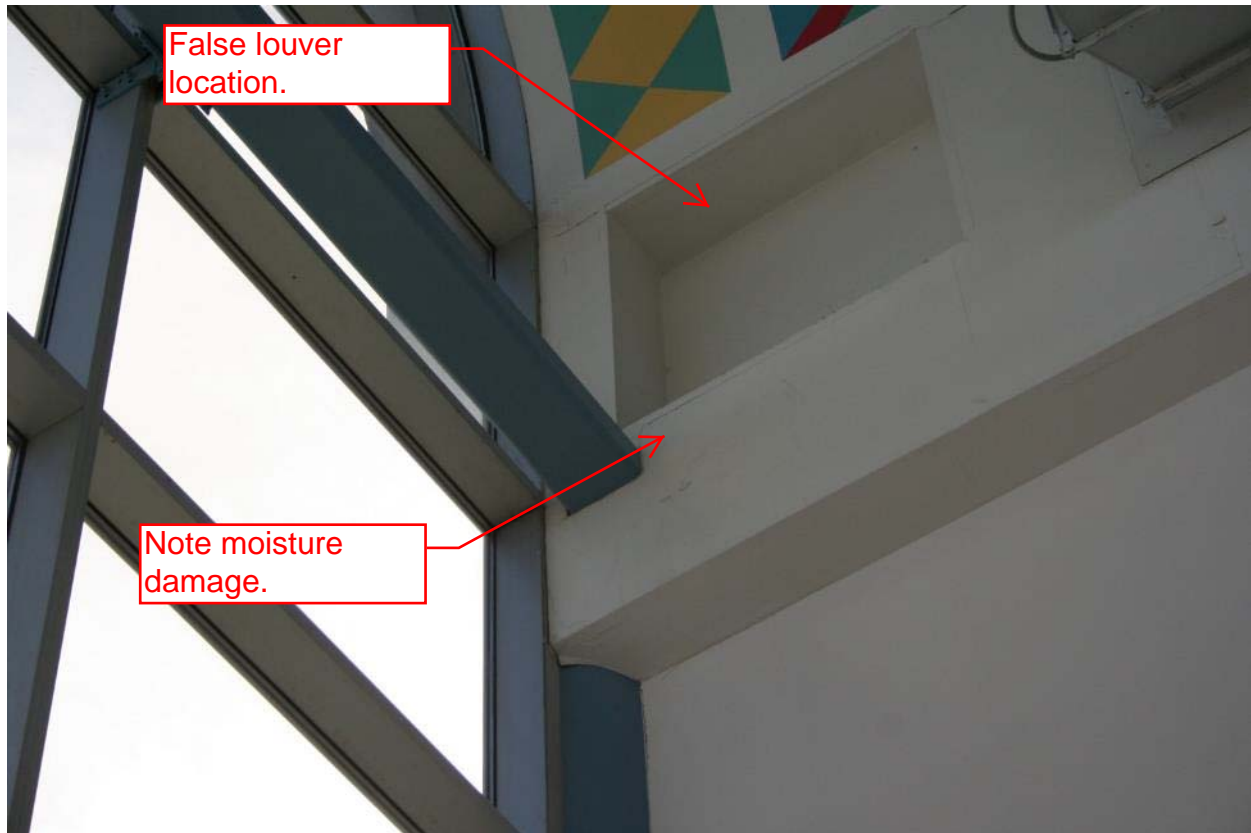
A view looking up from the second floor towards the SW round steel column. Note the cracked corner bead at the recess leading to the false louver at the exterior and some moisture damage to the drywall near the column to beam location.

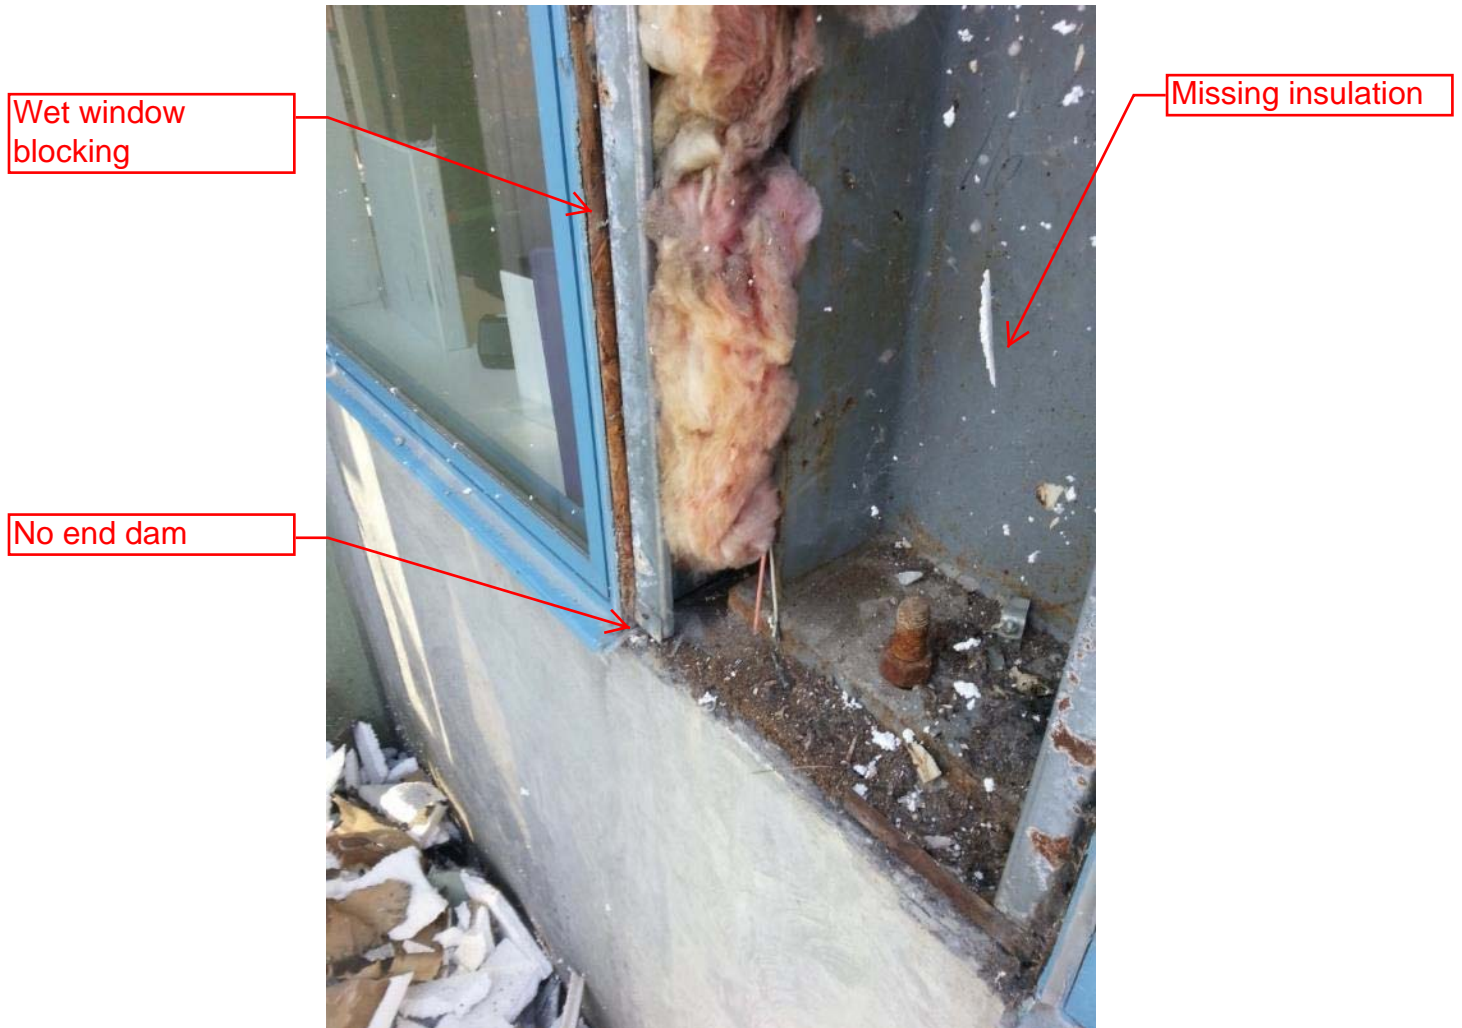
Lower level Children's Department window sill locations at south window location. Note significant moisture damage to the drywall at the end of the sill run.

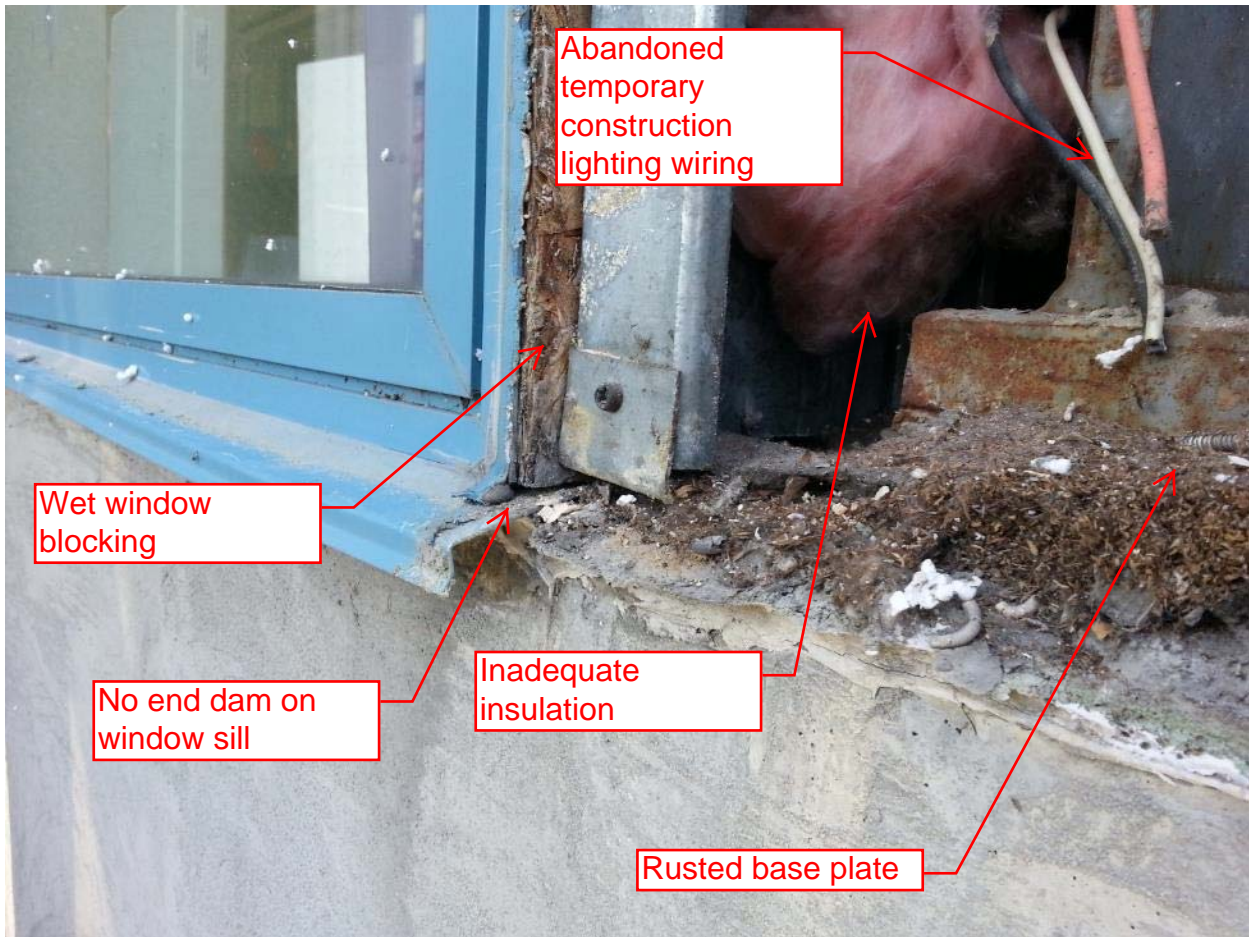
Photo shows no insulation at column location and lack of end damming at window sills. Significant rust noted at base plate location. Wood window jamb liner board is water saturated.

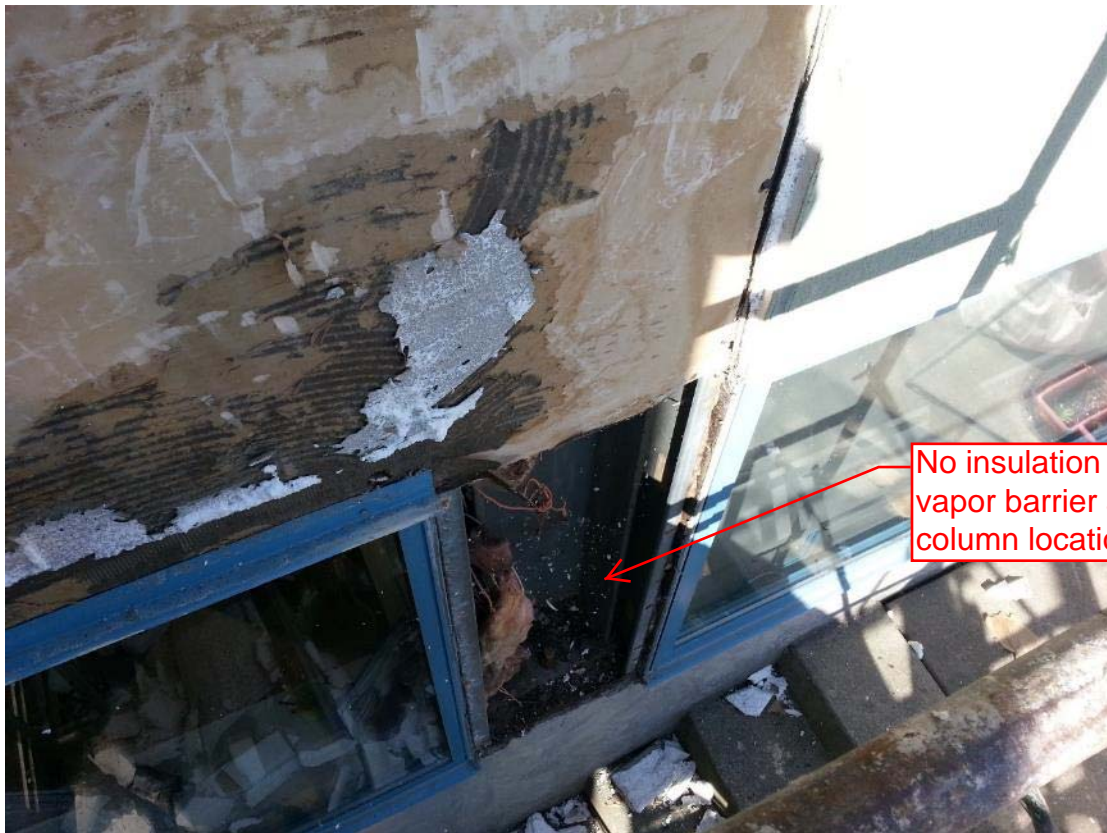
There was no insulation found in the wall cavity at the locations of the steel floor beams or columns. There were also visible open joints above and below the steel members where the reviewer could see inside the building. This means that conditioned air is escaping the building envelope and getting into the wall cavity. This will cause the dew point of the wall to fall inside the cavity of the wall system and condense.

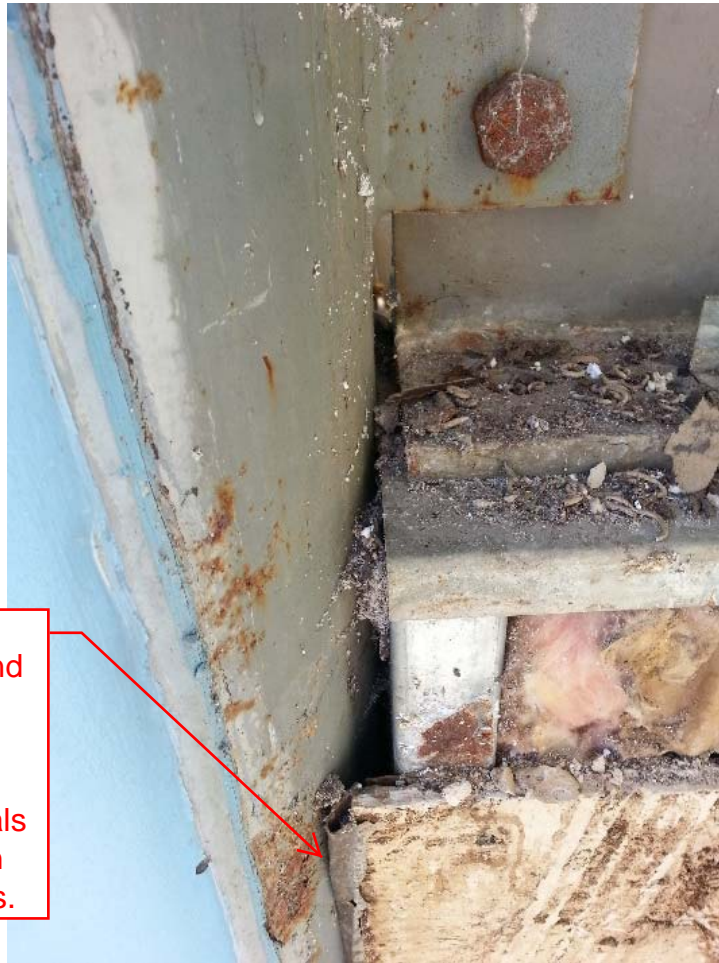
Round column to beam location at the first floor, NE corner of the building. In this photo you will note the "gap" between the beam to the round column. At the top center of the photo, you can see into the building cavity. This means conditioned air from inside the building can flow into the exterior wall cavity and create a dew point inside the cavity. A dew point inside the cavity means water vapor will condense and form water which will deteriorate surfaces.

Difficult joint to install sealant and backer rod. Differential movement between materials will put stress on the sealant joints.

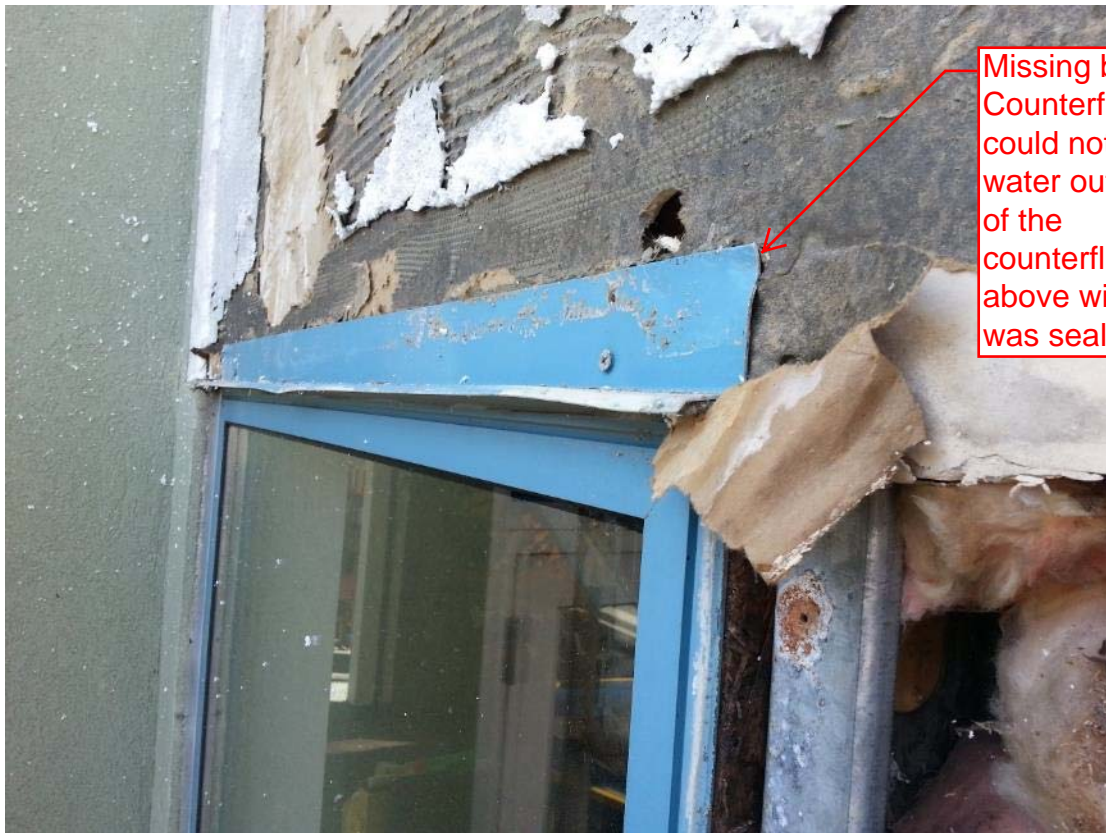
Another view of the column to beam at the NE round column – looking down. Where the sheathing meets the round column is problematic. There is not enough “backing” for a sealant joint to be placed at this location. When you add movement between the dis-similar materials at this joint, you are asking for water to infiltrate at this corner.

Missing butyl tape. Counterflashing could not weep water out. The top of the counterflashing above windows was sealed tight.

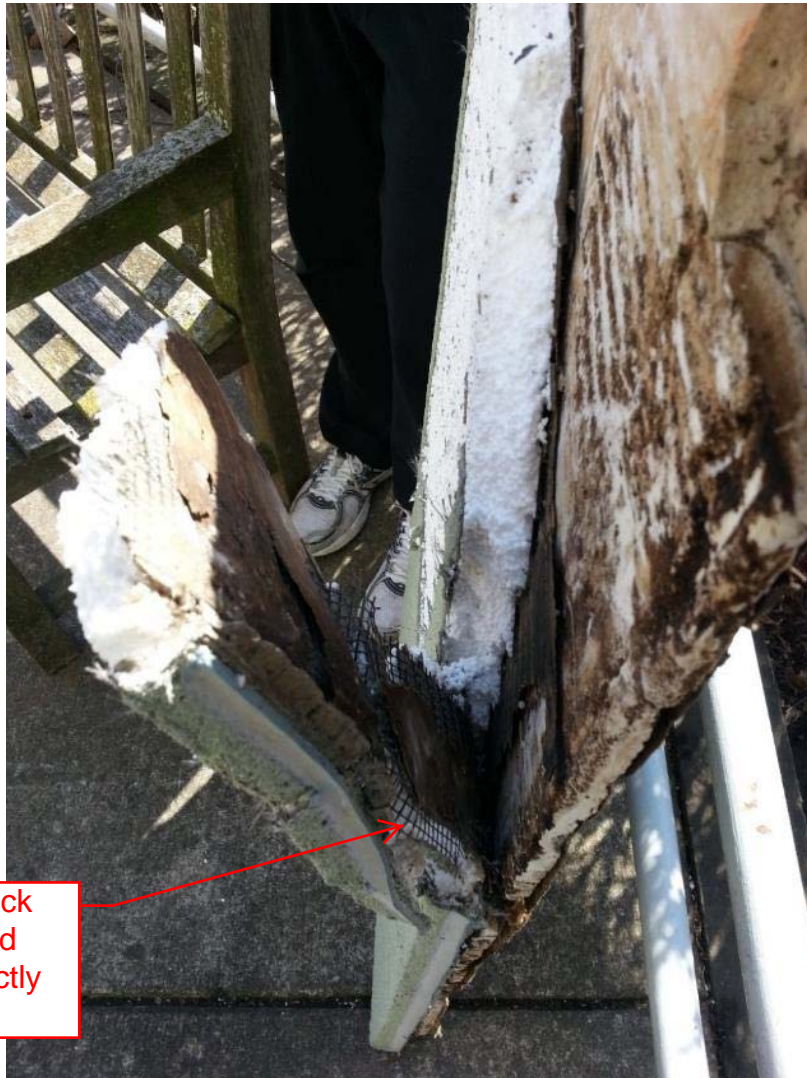
Typical window head flashings. Note that there is no butyl rubber tape joints at the head flashing that was installed over the windows. EIFS Insulation board was applied directly over this counterflashing and caulked solid thus eliminating the functionality of the head flashing to allow water to exit the wall assembly.

EIFS mesh back wrapping noted which is correctly installed.

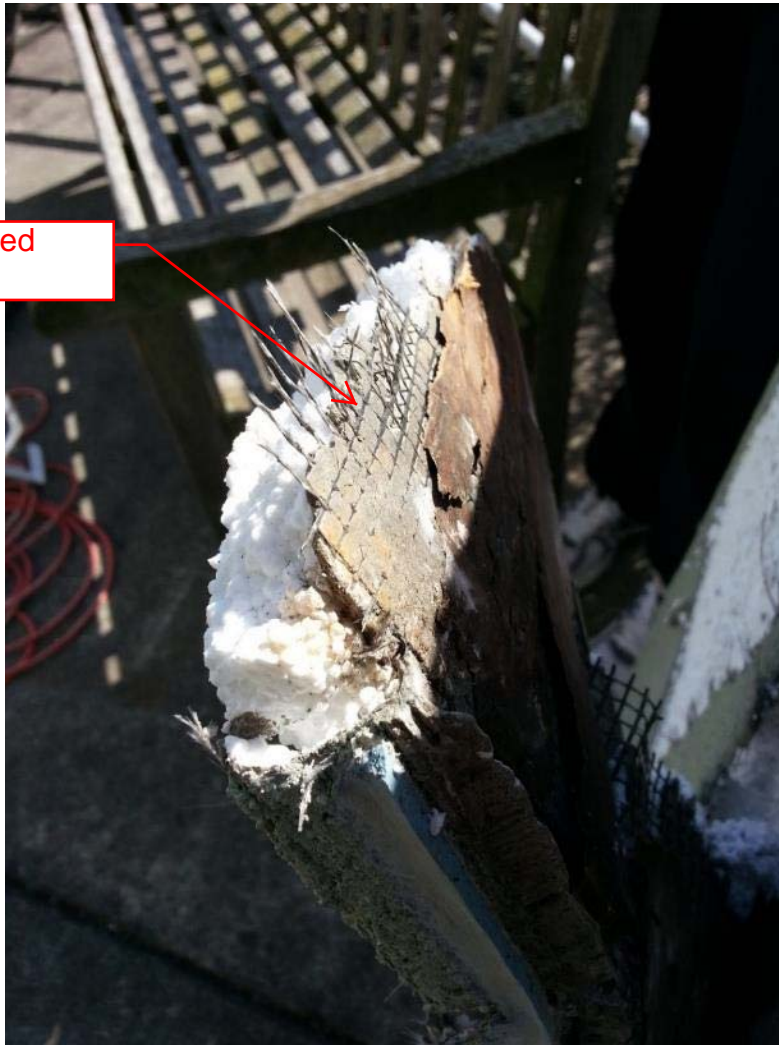
This is a photo of the 1 inch thick EIFS insulation board attached to the wall sheathing. Note the sheathing is very wet along the edge. Also note that the insulation board was back-wrapped with the EIFS mesh as required by the manufacturer for the original installation.

Back wrapped
mesh.

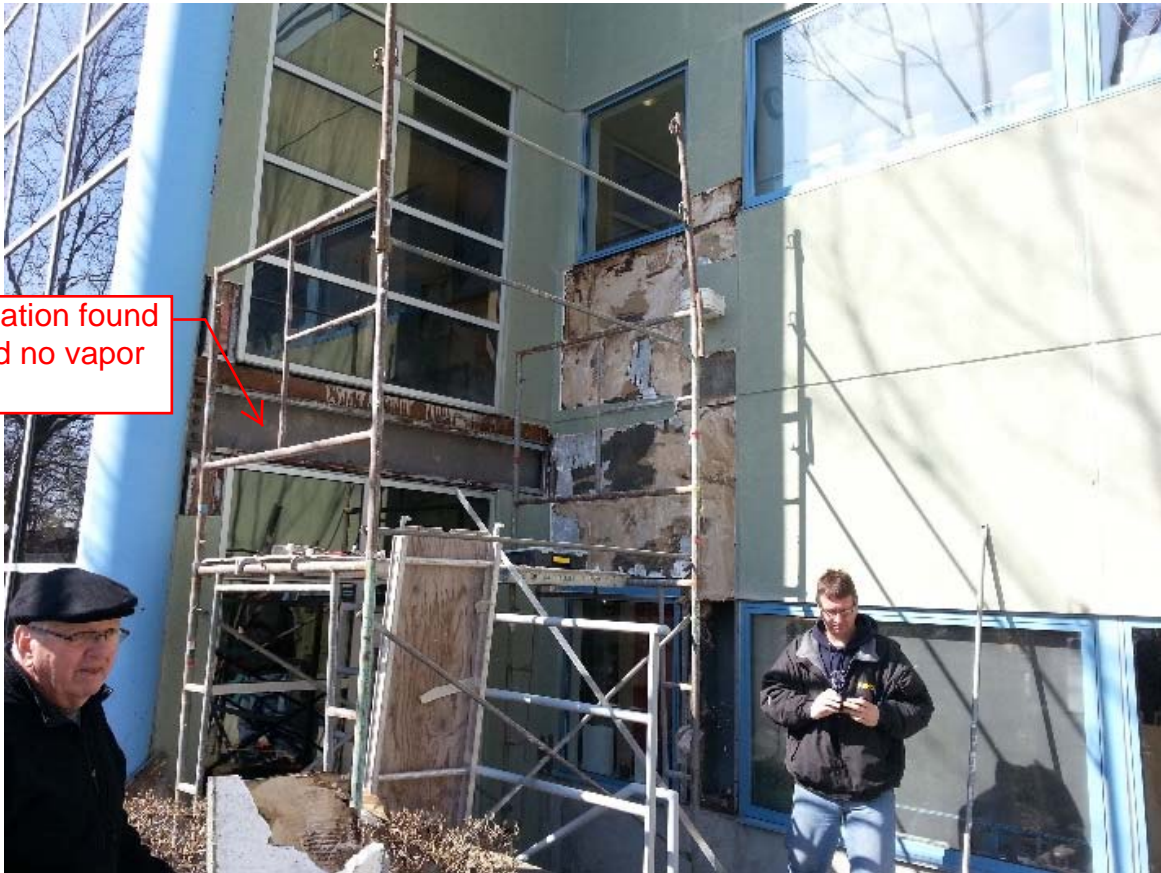
Description:
Another view of the back-wrapped, EIFS mesh.

No insulation found here and no vapor barrier.

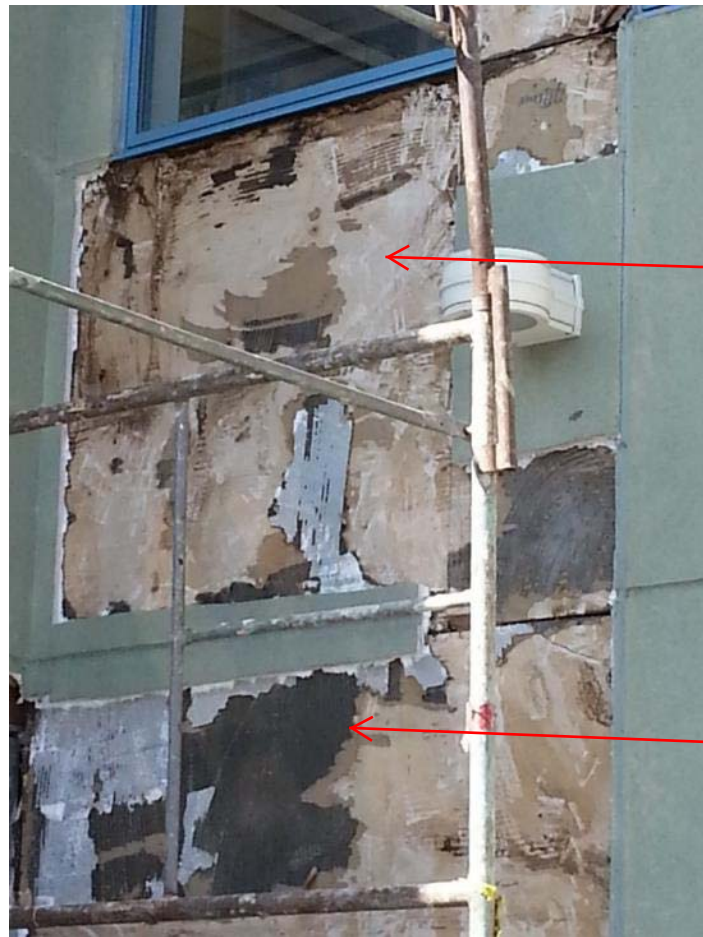
This photo indicates the location of the invasive testing that was performed at the NE corner of the building. The reviewer noted that the wall sheathing was fairly well saturated across the majority of the wall cavity.

Wall sheathing was moisture damaged and the felt facing released from the gypsum core when the EIFS was removed.

Exterior gypsum sheathing facing (black material) material still attached to gypsum core.
