- LaGrange Park Public Library
- Water Infiltration Investigative Study
- April 28, 2015
- July 18, 2015 - Updated
- Kluber Project No. 15-357-960

EXPANDED INVESTIGATIVE STUDY: North & South Facades

Re: Water Infiltration Investigative Study
Additional Services - Report Addendum
North & South Building Façade Review
Kluber, Inc. Project No. 15-357-960

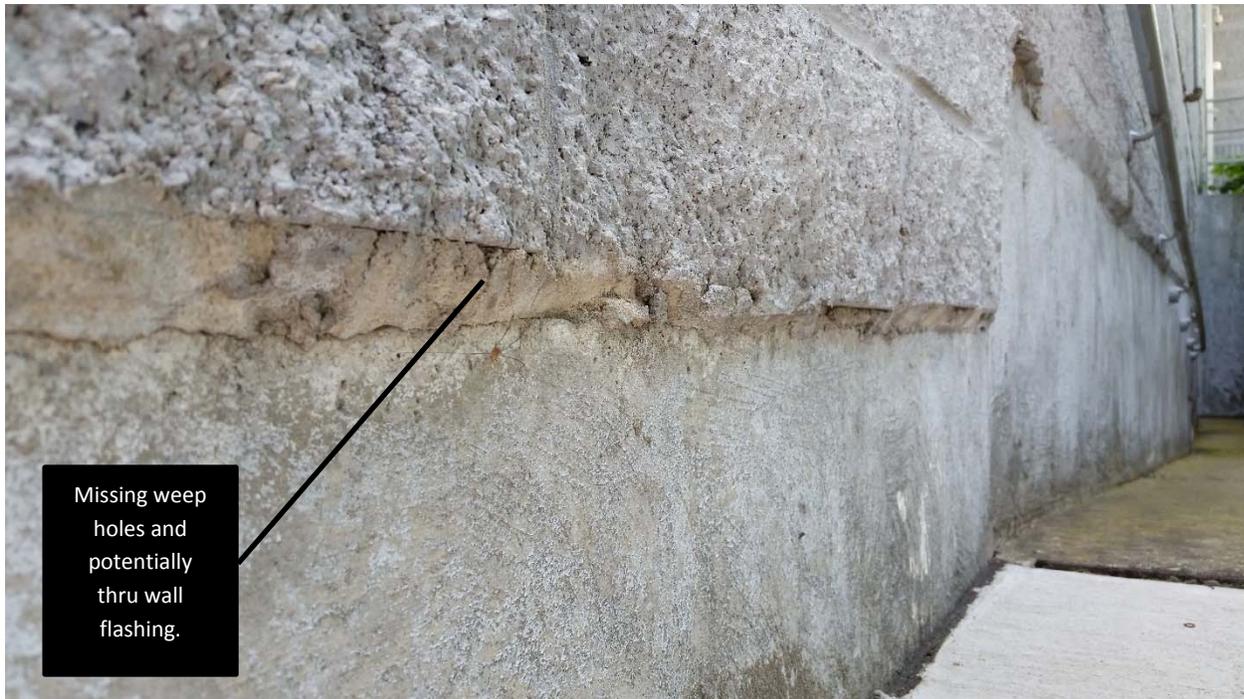
Of particular concern was the exterior masonry wall systems do not appear to have any type of rope weeps or venting installed at the base of the wall system. Weep holes and thru wall flashings allow moisture that might get into the exterior wall system to escape to the exterior of the building. Almost all base-of-wall joints reviewed appear to have been struck flush to the foundation wall surfaces. It is common to visibly see a small portion of the thru wall flashings extending into view at the base of the wall to divert water away from the building. You will note in the photo on the next page that no flashing or weep holes are visible. We suspect that thru wall flashing may have been omitted at all masonry wall locations. See photo on the next page.

The larger masonry concern is the current installation at the base of the masonry wall surfaces placed immediately on top of existing concrete foundation wall systems. No visible thru wall flashing was observed nor were weep holes. These two products are designed to shed water out of the masonry wall cavity and away from the building. Although water infiltration at the base of the masonry wall systems was only observed at the basement mechanical room exterior wall louver, the Library board may wish to consider installing the recommended flashing and weep holes to further protect the building asset from water infiltration. Costs to perform this work have been identified separately as an alternate on our cost estimate noted in section 10 of this report.

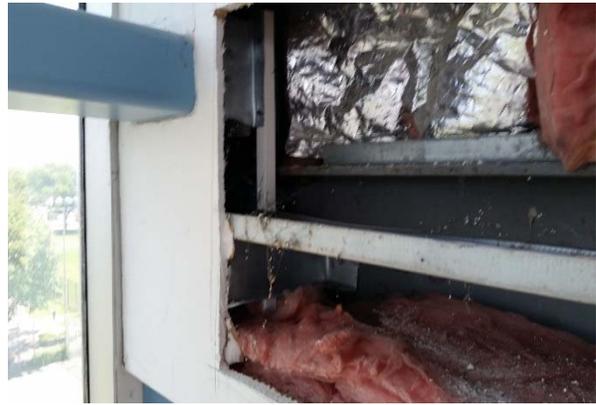
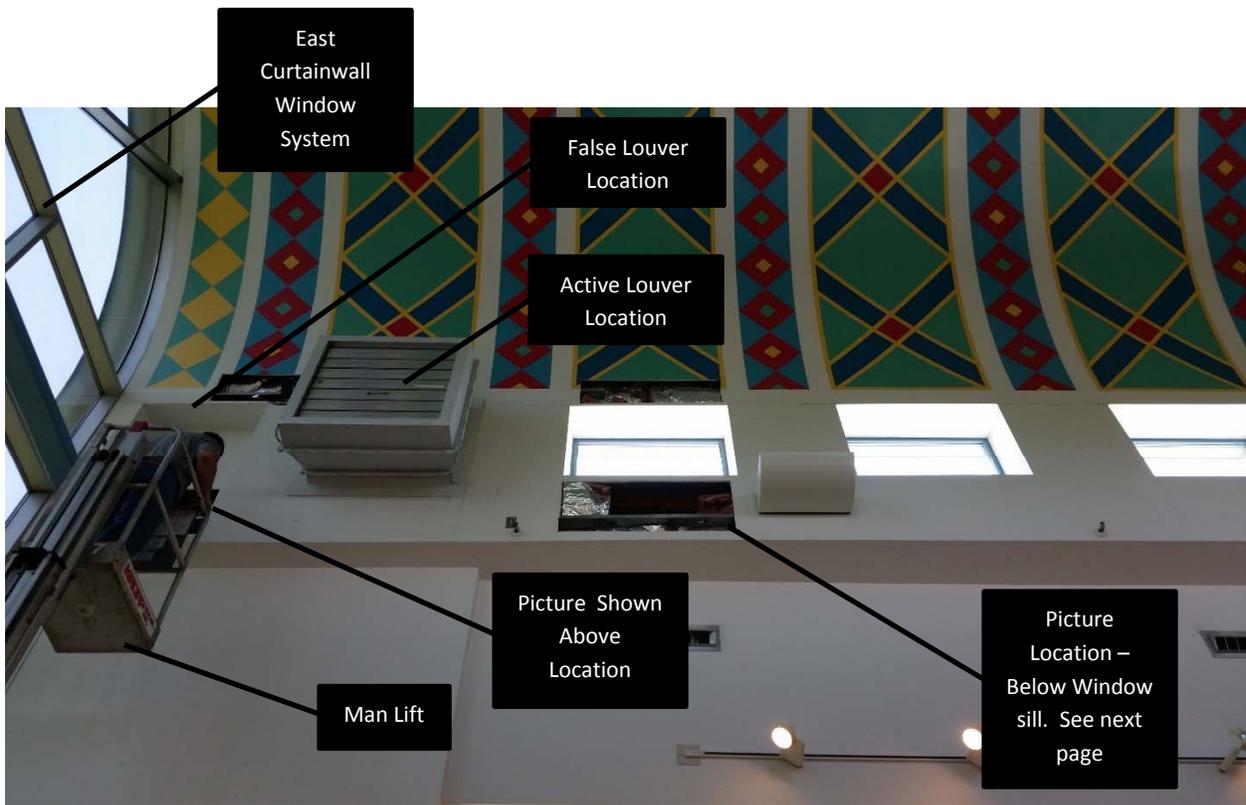
The photo at the right was taken near the structural support tube steel at the east curtainwall wall system just below the false and active wall louvers. Minimal moisture was present in the wall cavity. The moisture staining on some framing members is believed to have been the result of water infiltration at the sills of the wall louvers immediately above this location. The batt insulation has been installed as noted on the Owner's as-built drawings in this location and incorporates a foil reinforced kraft paper (FRK) vapor barrier. (The silver facings on the insulation) It appears that the joints in the insulation have been taped between sections to maintain an occlusive seal.

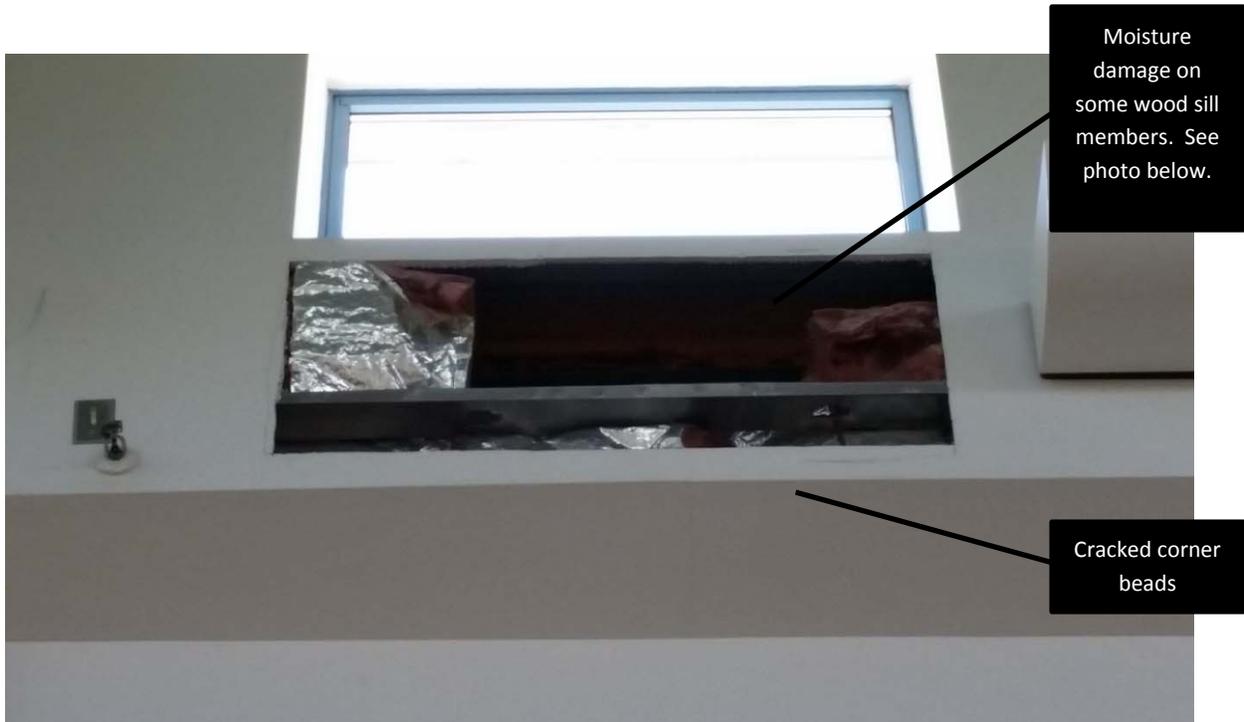
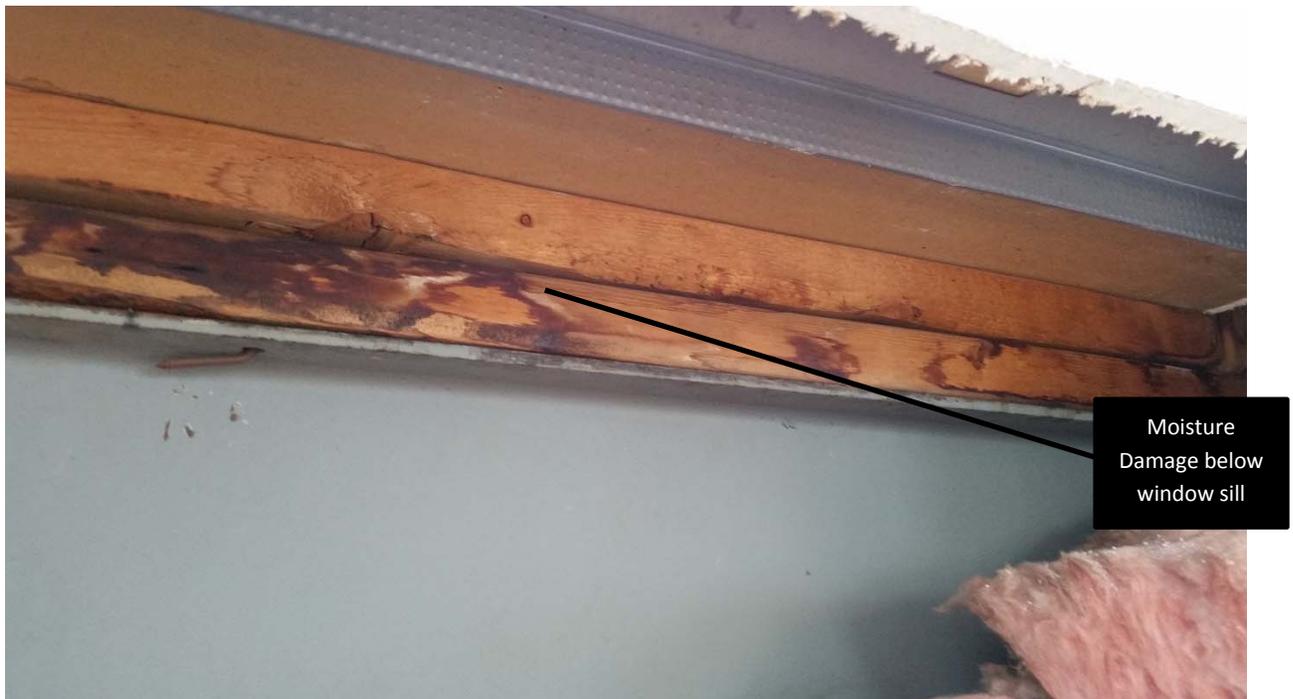
The photo above was taken at the location of one of the clerestory windows at the southeast portion of the building. The photo below is take at the juncture between the sloping roof system and the window sill above. You can see some evidence of water infiltration in the wood members. This may suggest that the window sills do not have end dams similar to the findings of the east and west window locations.

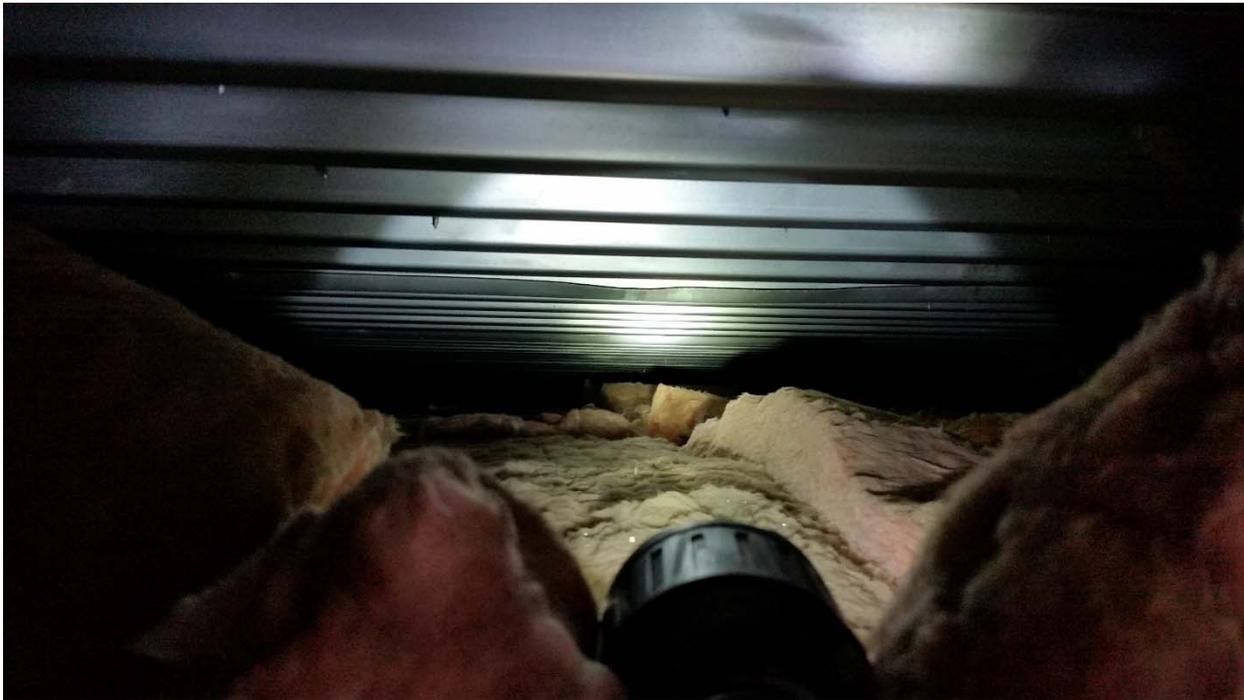
The photo above is looking down the sloped ceiling cavity towards the south building elevation above the suspended batt insulation layer and below the roof decking. See original details this page for more location information. We suggest adding small square roof vents at the top of the sloped roof section so the louver vents in the EIFS below the window sills can be removed.

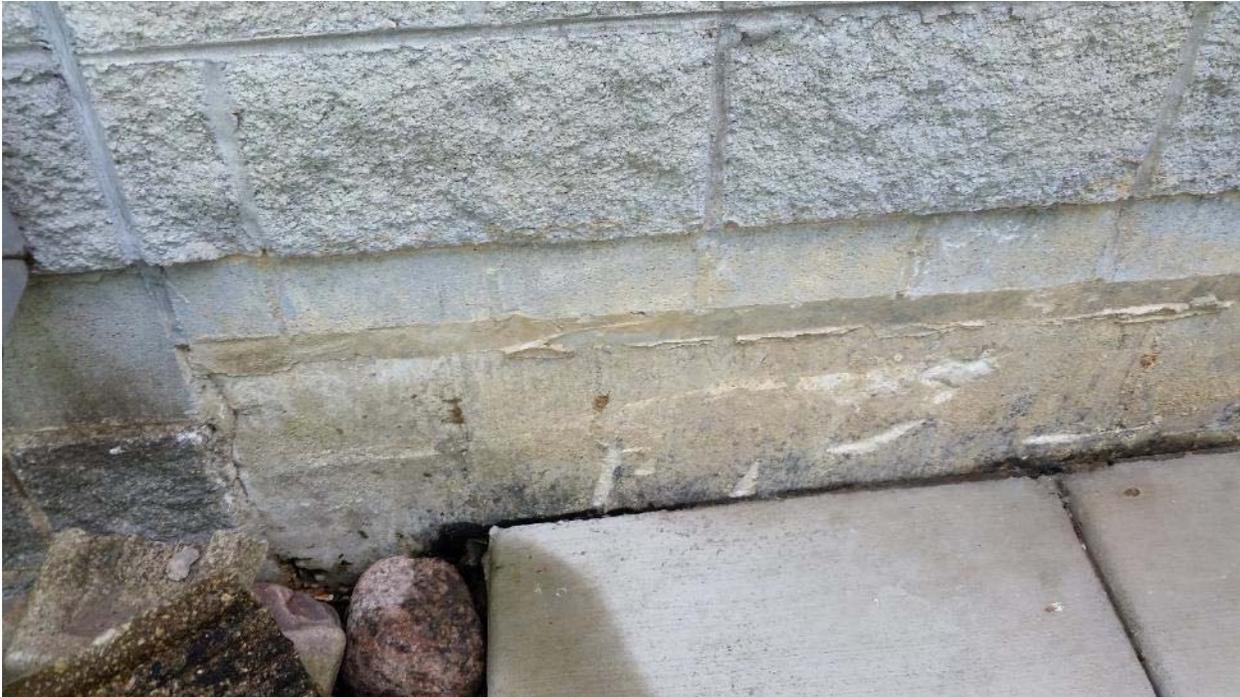
Looking east on the north side of the building towards the park. Block masonry appears to have some water "wicking". Split face block is a porous material and requires a clear or opaque sealer to be installed to retard moisture infiltration.

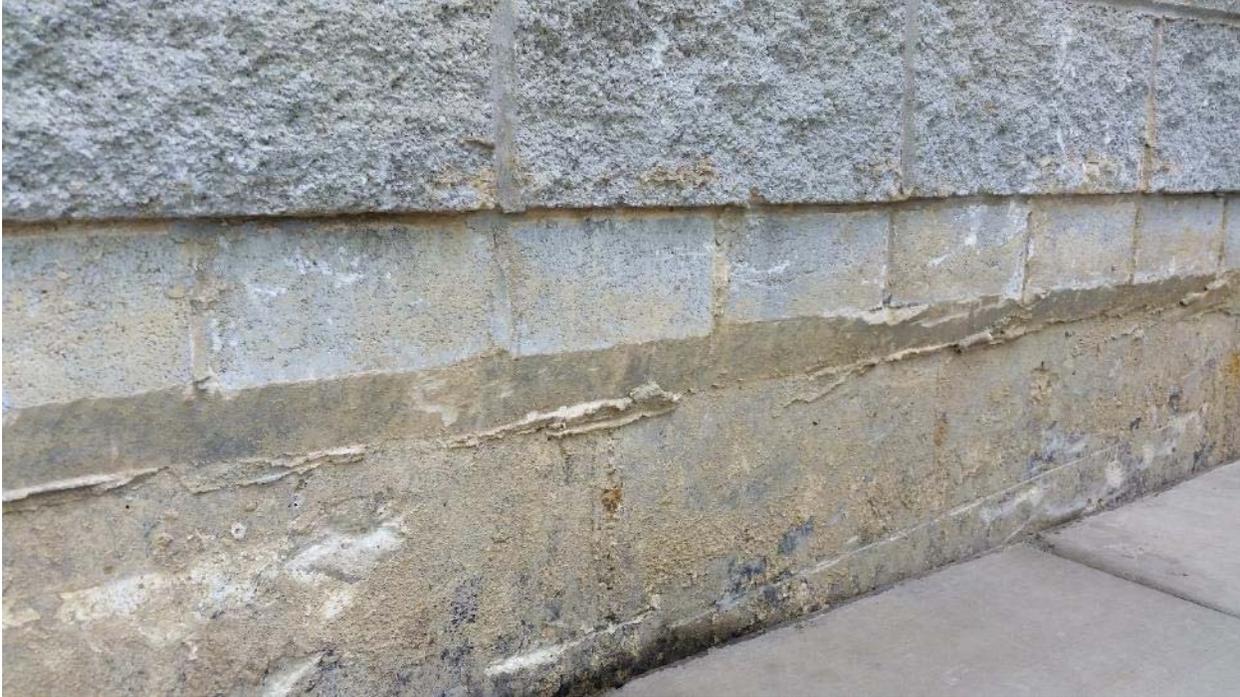
Base of masonry wall condition at North side of the building. No weep vents are noted at this location. Thru-wall flashing is also not visible.

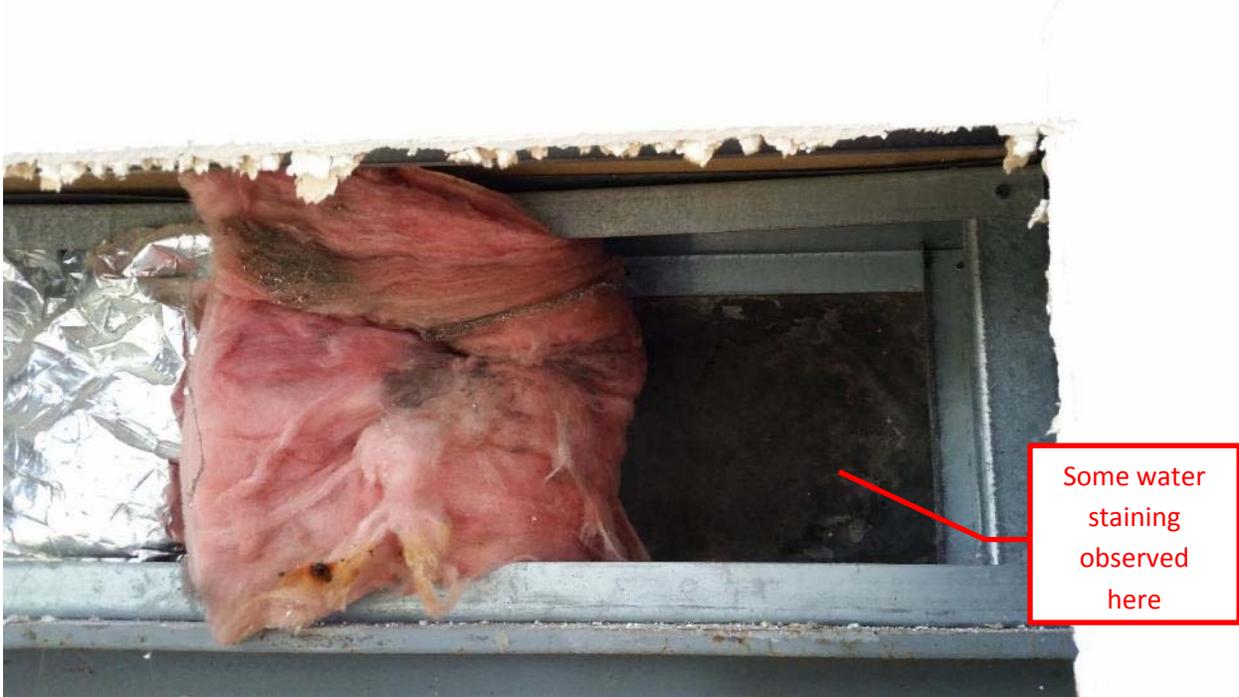
Condensation was noted in the ceiling cavity at the Library Directors office. This was likely due to condensation build-up and not from water infiltration from the exterior. This area is just below the diagonal roof framing in the previous photo that showed an open gap in the "top of wall surfaces".

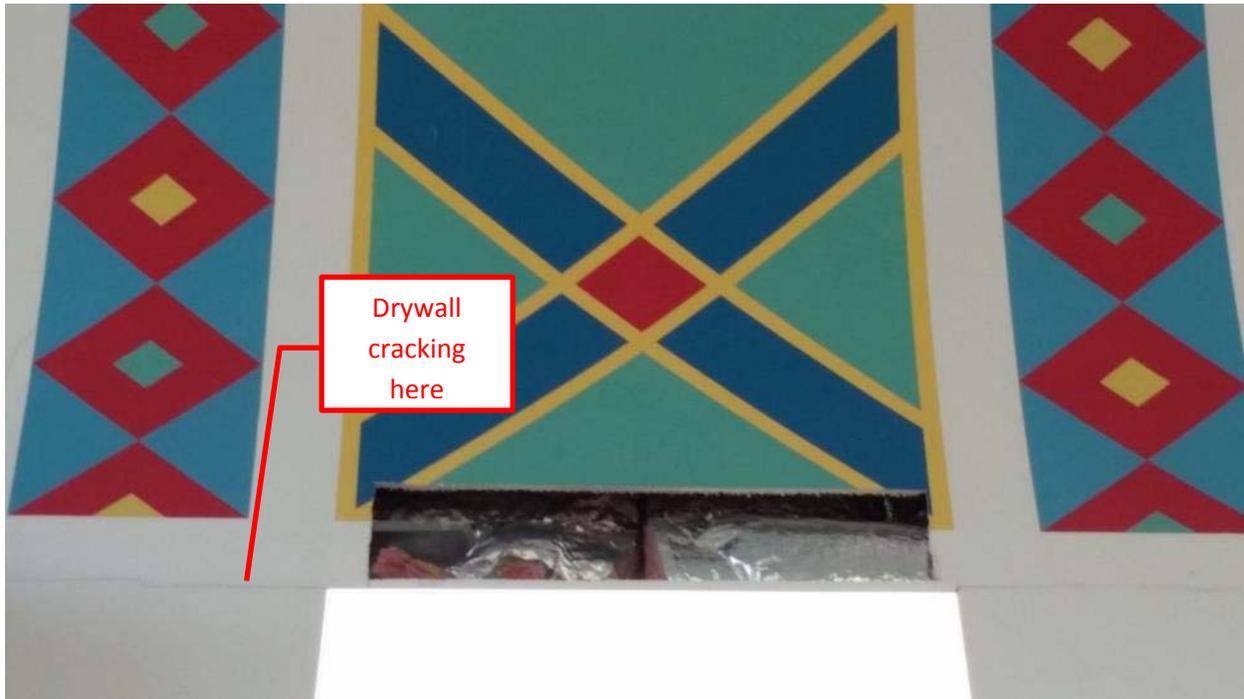
Invasive location just below the far southeast clerestory window location that was opened up for review.

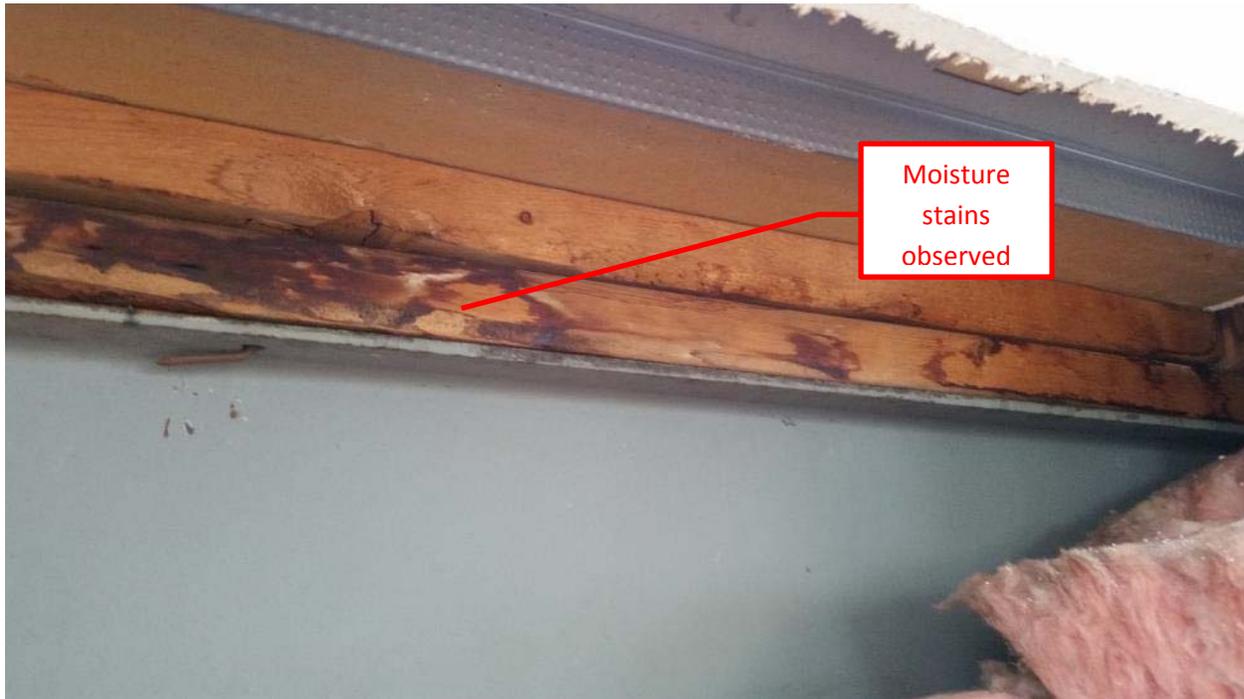
A view to the head location of the southeast "false louver" location that was opened up for inspection.

Moisture
stains
observed

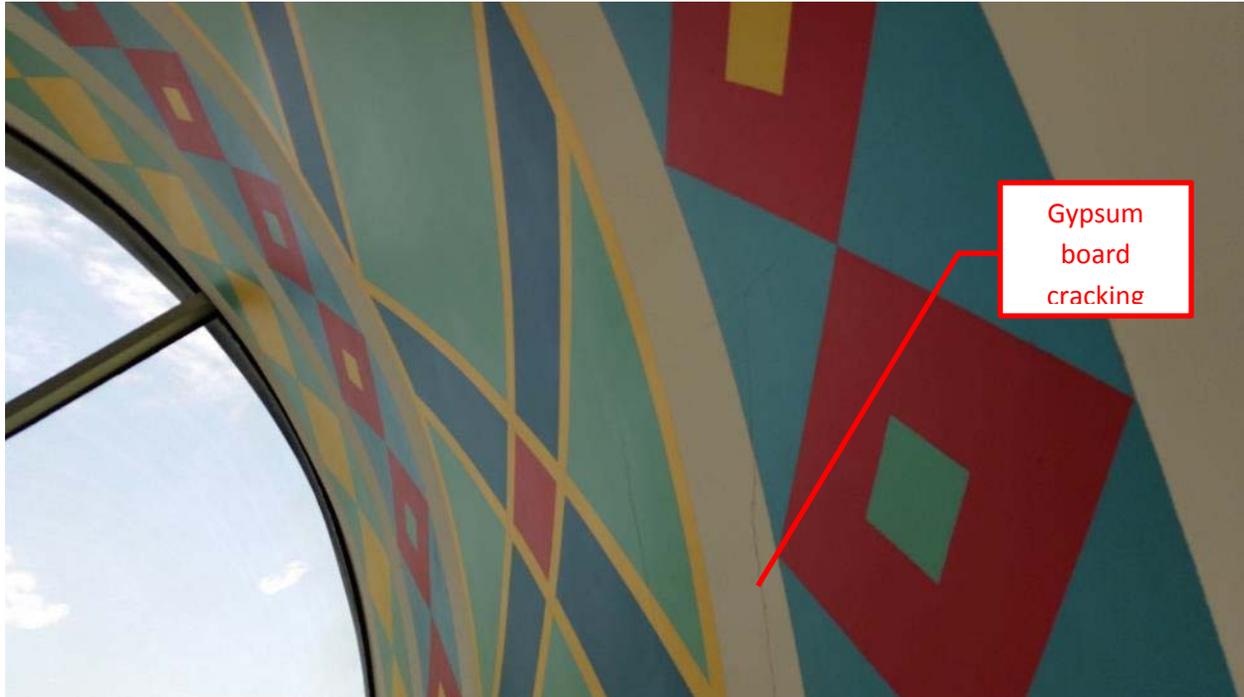
Additional cracks in the drywall at the barrel vault. These cracks occur approximately every 10 feet across the length of the barrel vault. In modern day applications, drywall control joints would be installed to allow for movement and controlled cracking at designated control joint locations.

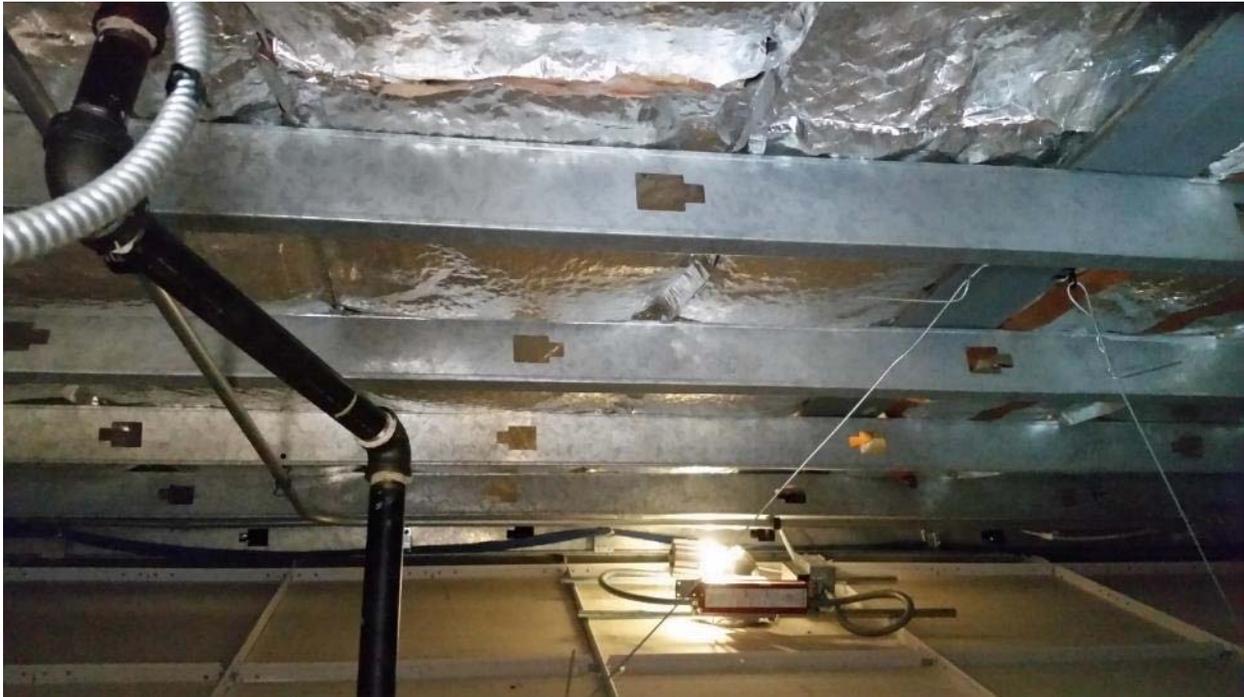
View to sloped ceiling cavity at second floor southeast corner. Metal framing was installed to support the foil reinforced kraft (FRK) paper vapor retarder insulation products. The insulation products were stapled between the batt insulation sections.
