# Community Forum

La Grange Park Public Library  
Facility Discussion

# Our Findings: Structural Damage

Project: LaGrange Park Public Library Water  
Infiltration Investigative Study

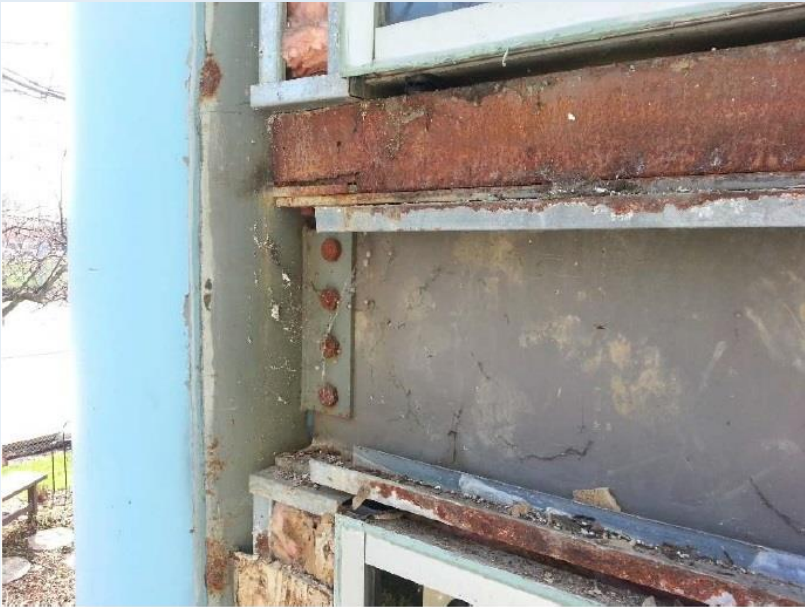
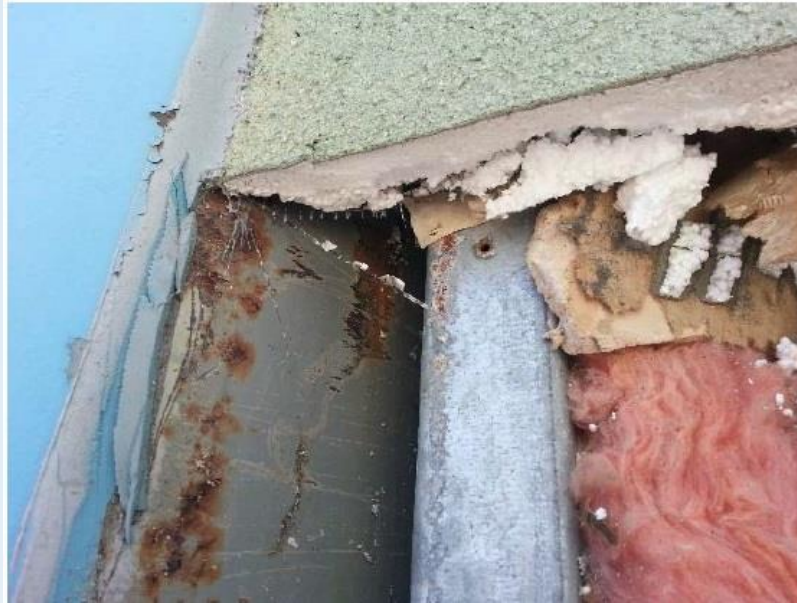
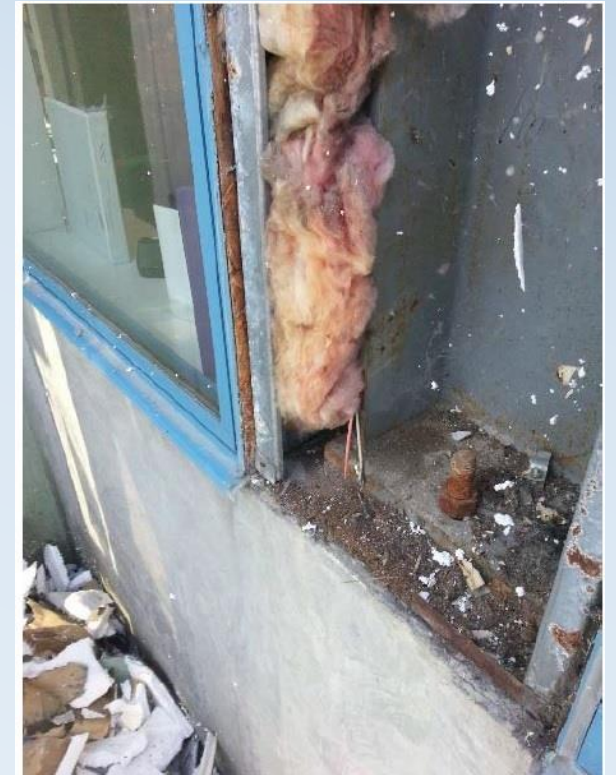
What is wrong with our building structurally?
